To Inspect Vehicle No:

SLD 3536M

BMW X6

Preliminary Advice

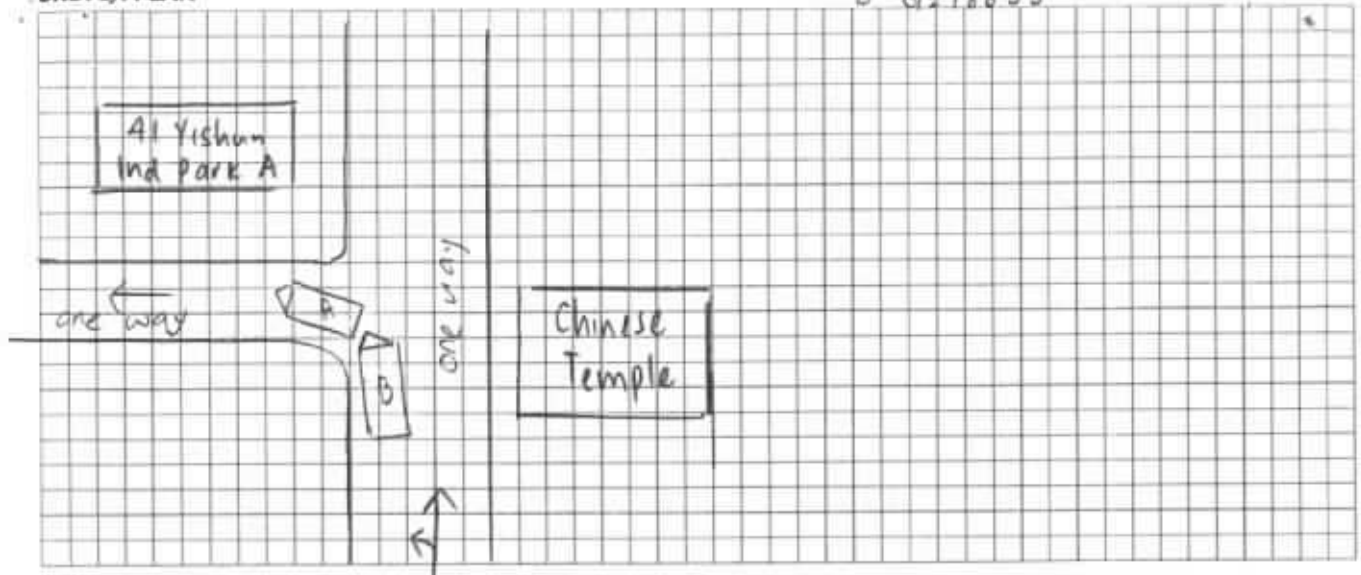
SKETCH PLAN

It was raining at that time. I slowed down to make a left turn when suddenly I felt an impact on the rear. I then realized that m/lorry (B) had collided onto my vehicle.

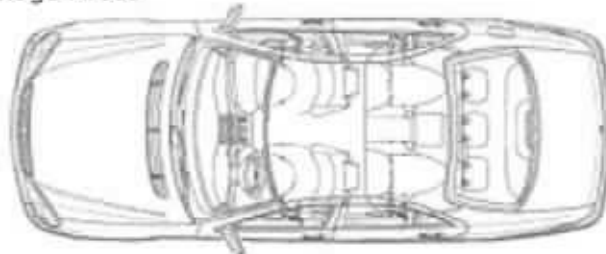
CHENG HOE MOTOR PTE LTD**Claim Reference:****Assessment Number: CSLD3536****Version: CHENGHOE/1****Date Calculated: 26/06/2018 03:30****Full Report - V1****Registration: SLD3536M****Printed: 26/06/2018 10:33****Damage Areas:**
