### ASSIGNMENT

Veh No: SKM1731T Yr Regn: 2017, Jve

Make: Audi Q5 c.c. 1984

### VEHICLE DAMAGE INSPECTION REPORT

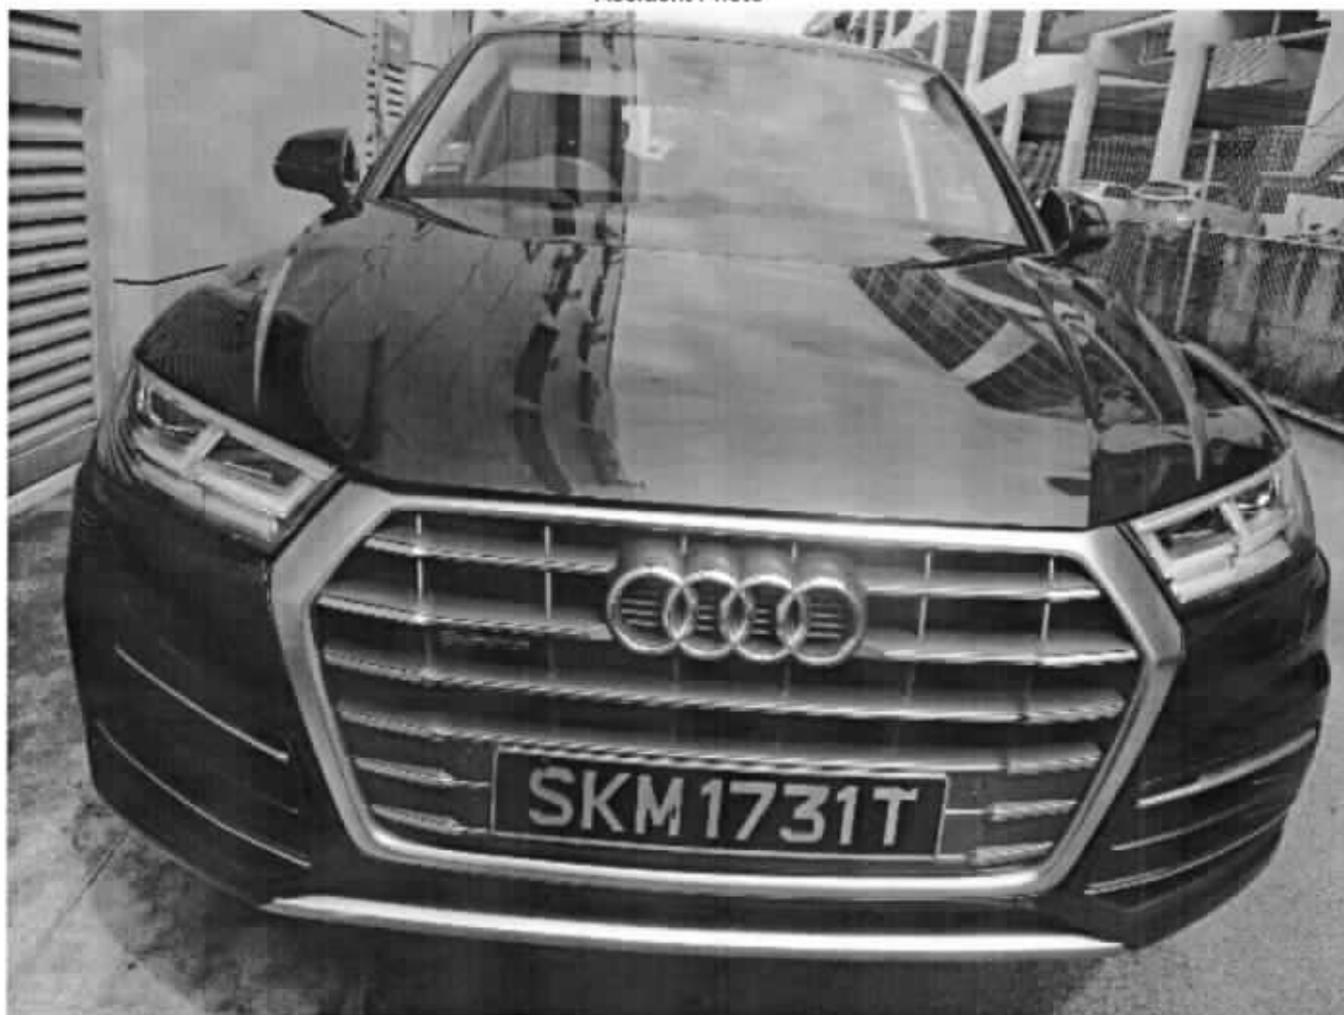
Accident Photo

Des. of Damages: Frnt / Rear / O/S / N/S / U/C / Rooftop or

Frnt o/s.

The U/C / Chassis frame / Body Structure affected due to collision.
