ASSIGNMENT

Preliminary Advice

Insured Vehicle No	: SLV3487B		
TP Vehicle No	: SLB1106U	Accident Date	: 25/06/2018
Make	: BMW 640I	Assignment Date	: 28/06/2018
Date of Inspection	: 27/07/2018	Est. Duration of Repair	: 3.00
Inspection At	: PERFORMANCE MOTORS LIMITED (ALEXANDRA) 303 ALEXANDRA ROAD, SIME DARBY PERFORMANCE CENTRE SINGAPORE 159941

VEHICLE DAMAGE INSPECTION REPORT

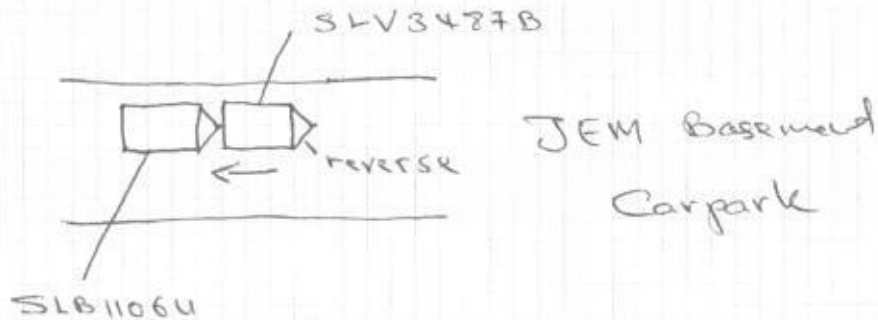
SKETCH PLAN

ON 25th JUNE 2018 AT ABOUT 13:55 I WAS WAITING TO ENTER BASEMENT CARPARK OF JEM (JURONG EAST). SLV3487B WAS IN FRONT OF MY VEHICLE. THE DRIVER MADE A SUDDEN REVERSE AND HIT MY VEHICLE. (SEE ATTACH IN VEHICLE CAMERA VIDEO).

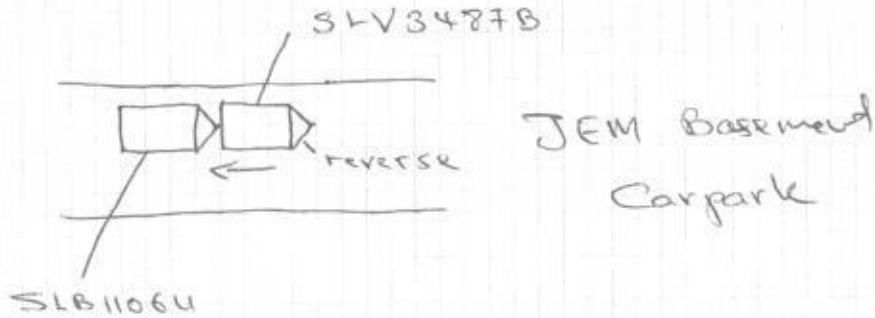
SKETCH PLAN

ON 25TH JUNE 2018 AT ABOUT 13.55 I WAS WAITING TO ENTER BASEMENT CARPARK OF JEM (JURONG EAST). SLV3487B WAS IN FRONT OF MY VEHICLE. THE DRIVER MADE A SUDDEN REVERSE AND HIT MY VEHICLE. (SEE ATTACH IN VEHICLE CAMERA VIDEO).

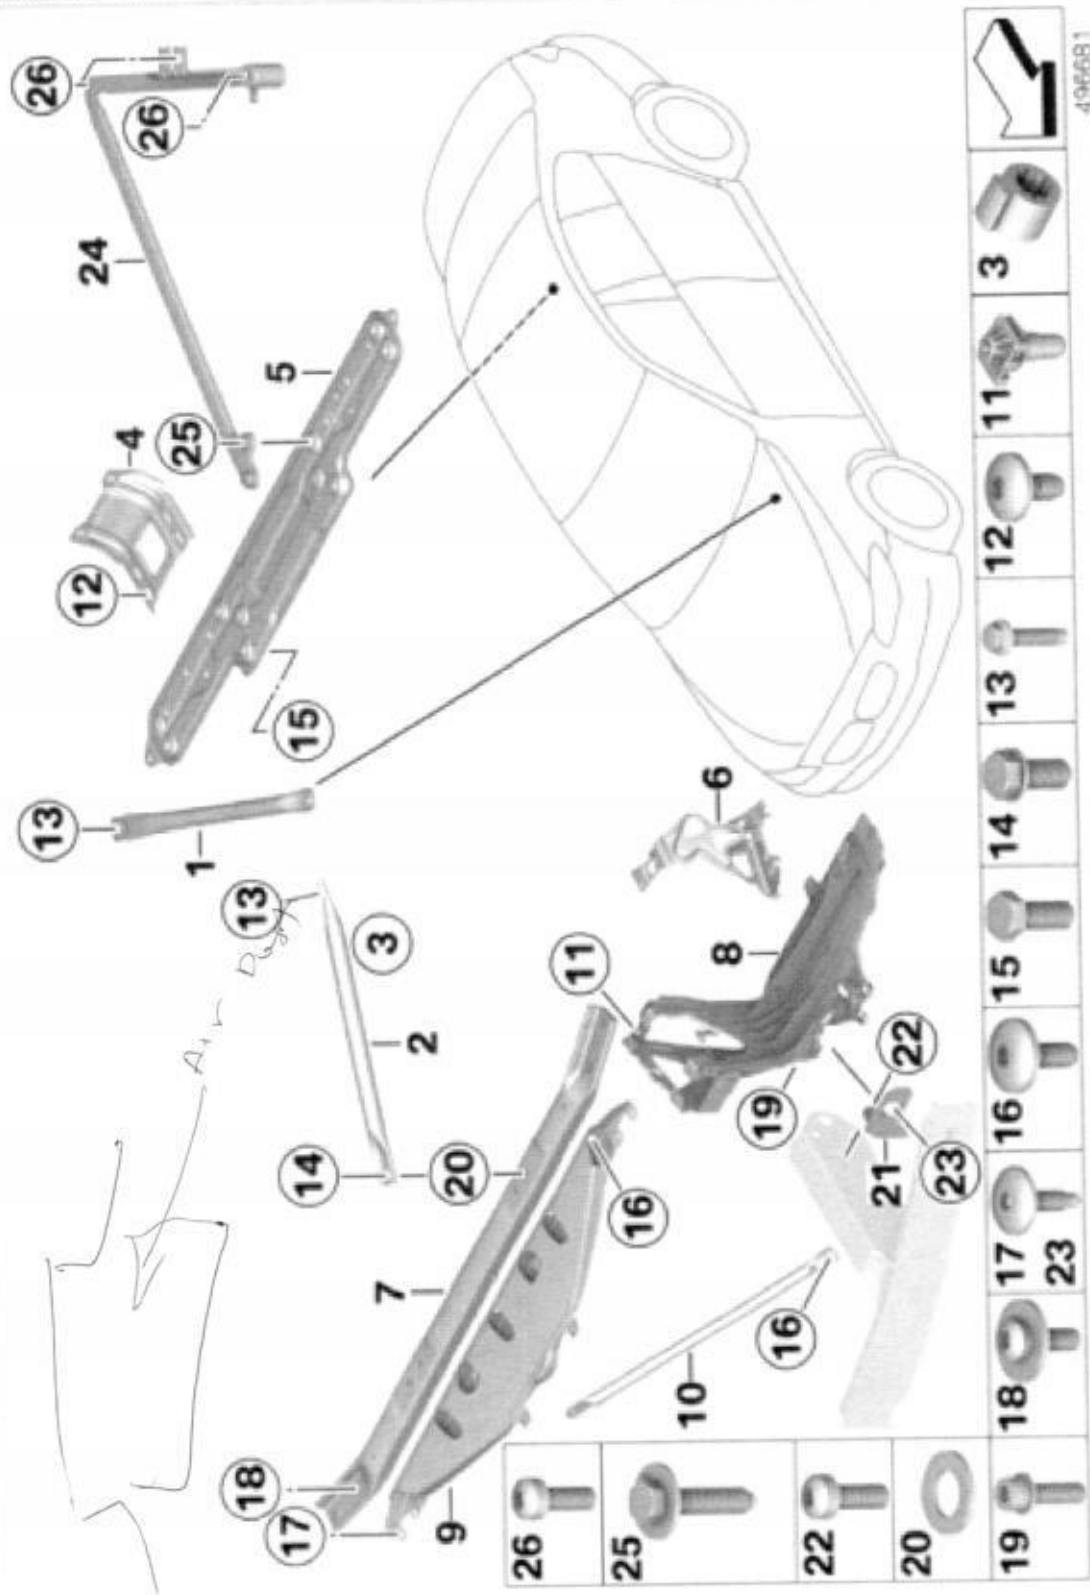
Nr	Description	Supplement	Me	Von	Bis	Kat	Ge	Le
01	Air duct		1

Display of Diagrams - Keirotings not taken into account - filter
 D989320 6D02 M416 LCEZ 6' F06 Gran Coupé LCI Gran Coupé 640i ECE R A 2016/05: 5

Inthiran did not send me diagram for supplement 'frt air duct' yet, because photograph did not show clearly.
