## VEHICLE DAMAGE INSPECTION REPORT

Our File No: CS/CT118011937/KRD3N2

Handling Insurer:	China Taiping Insurance (Singapore) Pte. Ltd.	Policy No:	DMPCSN1555271702
Claimant Vehicle No :	SLD3364S	Insured Vehicle No :	SJU5801T
Date of Loss:	26/06/2018	Nature of Claim:	TP
		Claim No:	SNM18D03202C02

Reg No:	SLD3364S	Engine No:	2ZR4404515
Make & Model:	TOYOTA PRIUS, 1.5 HYBRID (A)	Chassis No:	JTDKN36U605060289
Reg. Date:	06/10/2009 (Man. Year: 2009)	Odometer:	188572 km
Colour:	Metallic Silver		
Engine Capacity:	1798 cc		
Market Value/New Car Price:	N/A		
Sum Insured (S\$):	Market Value/New Car Price

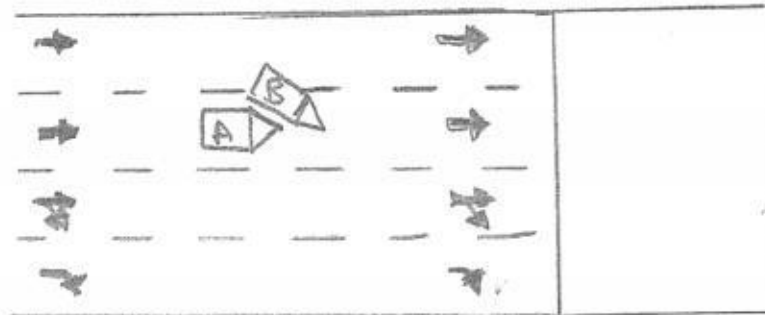
Sketch Plan #2 Pg. 1

Ang Mo Kio Ave 1 → Lorong Chuan

Traffic Junction

A: SHD 8364S

B: SJU 5801T

I was driving along Lor Chuan at around 71900 for dinner with my friend when I was about to reach the traffic junction, I was behind a car that want to make a right turn, as the traffic is quite heavy, so I waited for my left lane to clear ~~and~~ proceed to ~~turn~~ out, ~~and~~ ~~turn~~ ~~out~~ with my signal on, when the traffic on my left is clear, I turn out slowly into my left lane, suddenly ~~the~~ car just cut into my lane and h.t my front left bumper, there is no injury.
