INITIAL INSPECTION REPORT OF VEHICLE NO. SHC 6231A

ESTIMATE REPAIR BILL FOR KIA OPTIMA REGN NO: SHC 6231 A

ADJUSTMENT ON REPAIR COST FOR VEHICLE NO. SHC 6231A

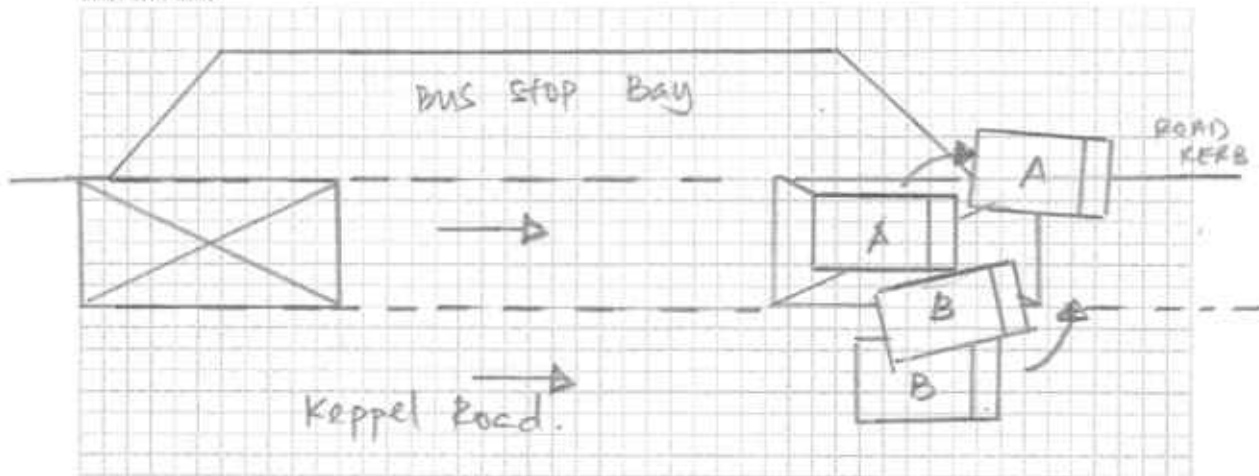
SKETCH PLAN

ON 27/06/2018 AT ABOUT 2240HRS, I WAS DRIVING MY TAXI (SHC 6231 A) TRAVELLING ALONG KEPPEL ROAD TAWARDS CANTONMENT ROAD WITH A PASSENGER ONBOARD, IN THE EXTREME LEFT LANE.

WHILE I WAS MOVING STRAIGHT AHEAD – WITHIN MY LANE, SUDDENLY VEHICLE B (SH 9046 S - COMFORT TAXI) WHICH WAS INITIALLY MIDDLE LANE – FAILED TO KEEP FOR PROPER LOOK OUT, HAD ENCROACHED ONTO MY PATH ON MY RIGHT ABRUPTLY.

DUE TO THE GREAT IMPACT, IT FORCED MY TAXI TO THE LEFT, HIT AGAINST THE ROAD KERB & CAUSING MY TAXI UP "ONTO THE ROAD KERB".

DUE TO THE IMPACT, MY TAXI HAD DAMAGES ON THE RIGHT FRONT & LEFT FRONT PORTION, RIGHT PORTION, FRONT LEFT TYRE & RIMS DAMAGED, THE REAR LEFT PORTION AND PART OF THE UNDERCARRIAGE DAMAGED AS WELL. VEHICLE B HAD DAMAGES ON THE LEFT PORTION.
