**Subject:** Pls expedite final report ( by 01.08.18 ) ; RE: Urgent : Pls assist to conduct rear tyre inspection for our vehicle GBD2586T ; RE: CMTD1802777/GPL - SUV(LKK)/ GBD2586T & XB7128A ACC ON 26.06.18

I have inspected the insured vehicle this morning.

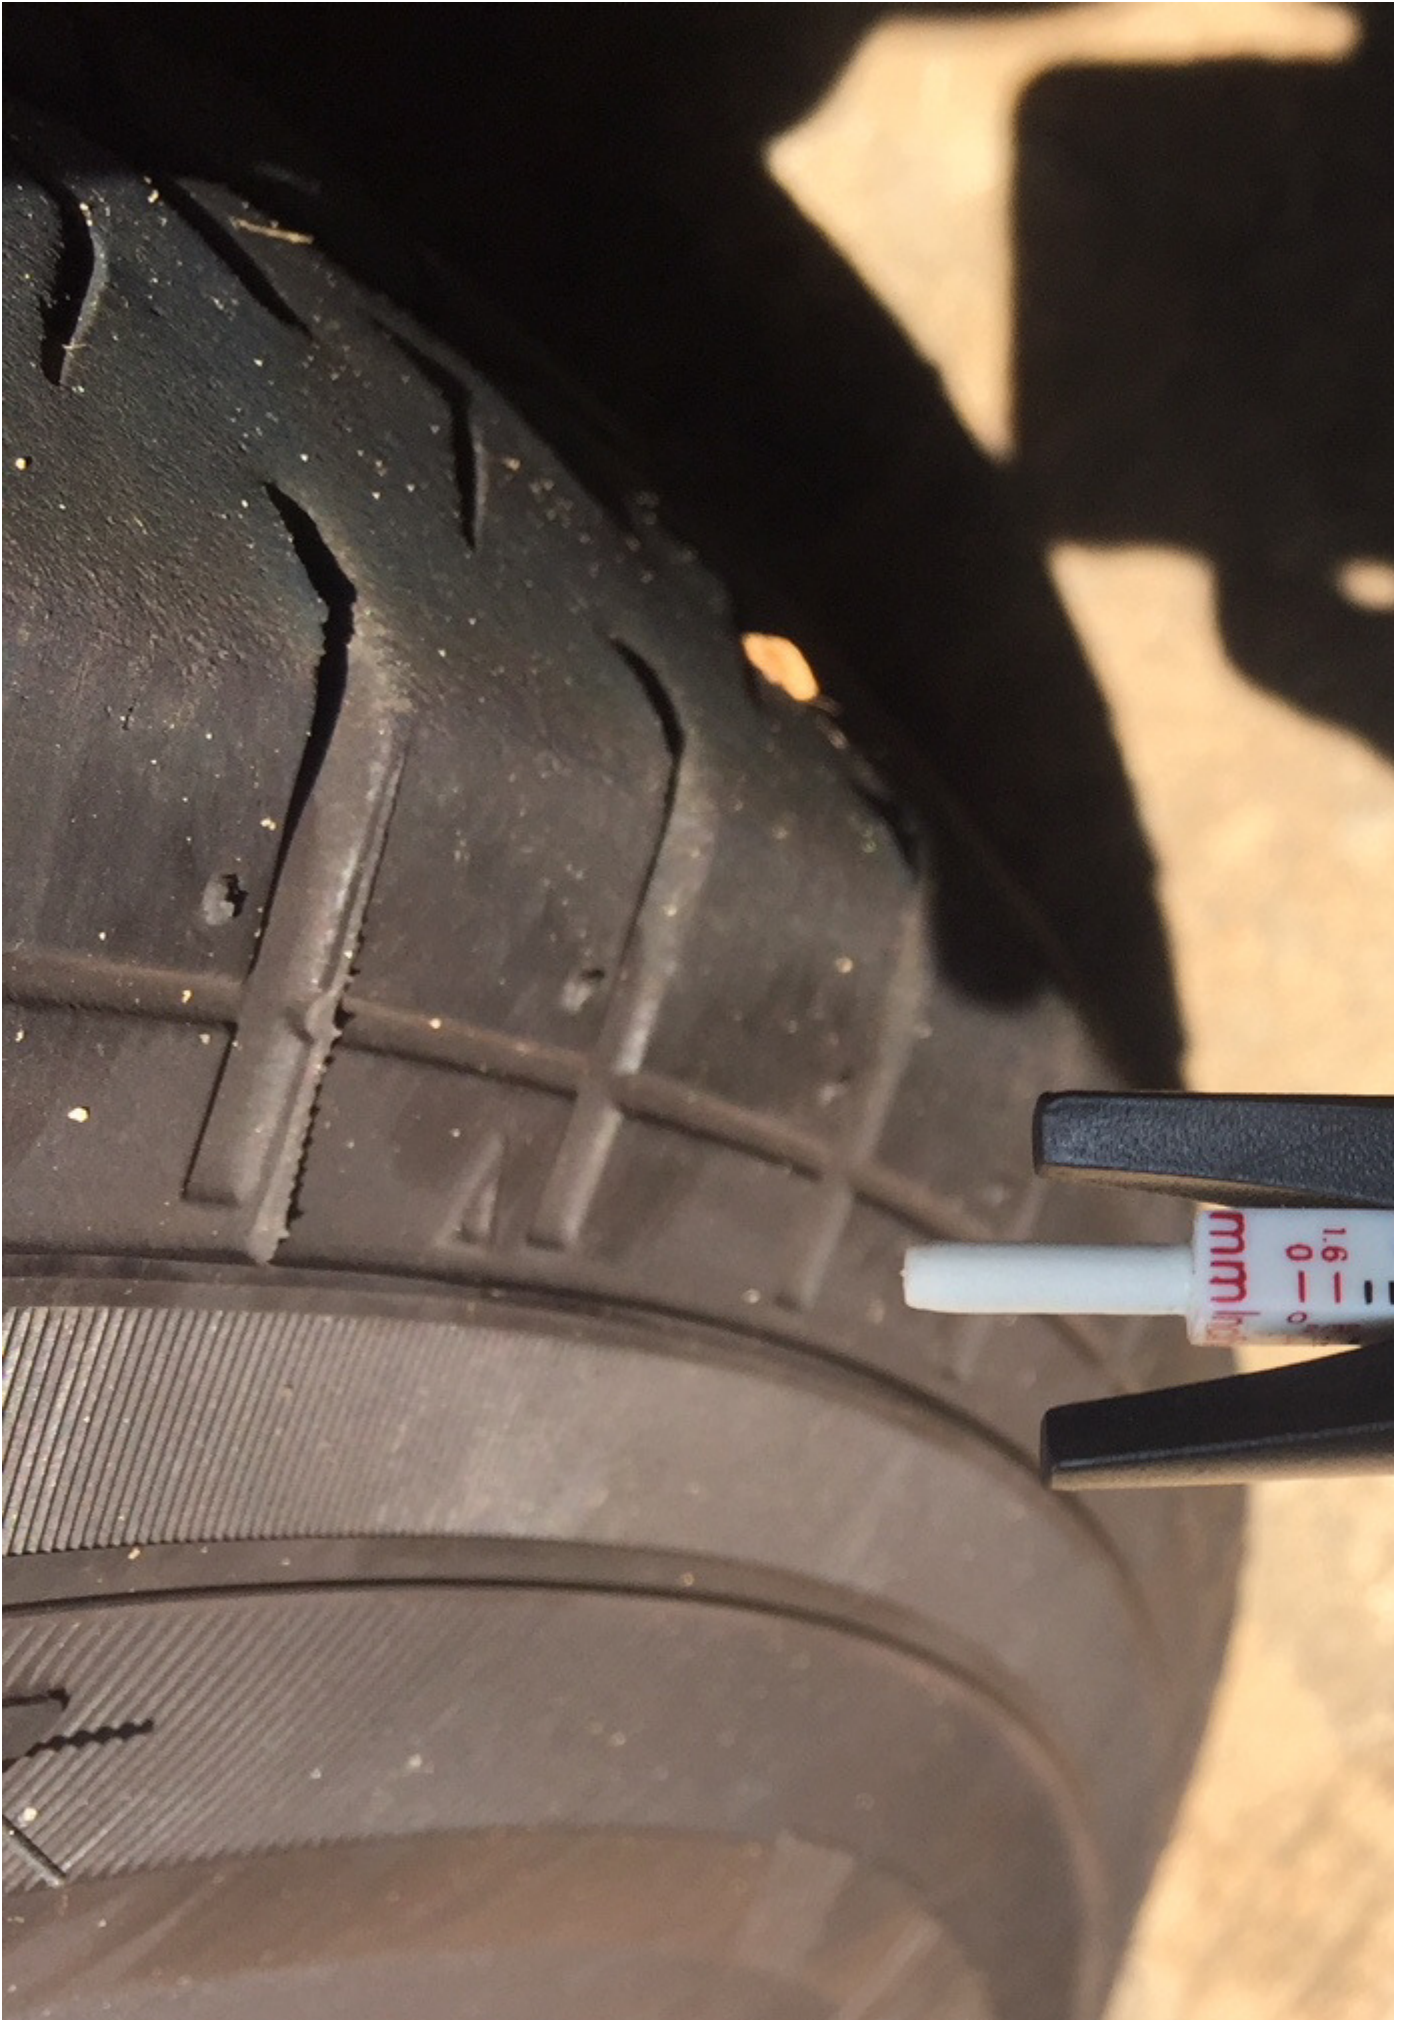
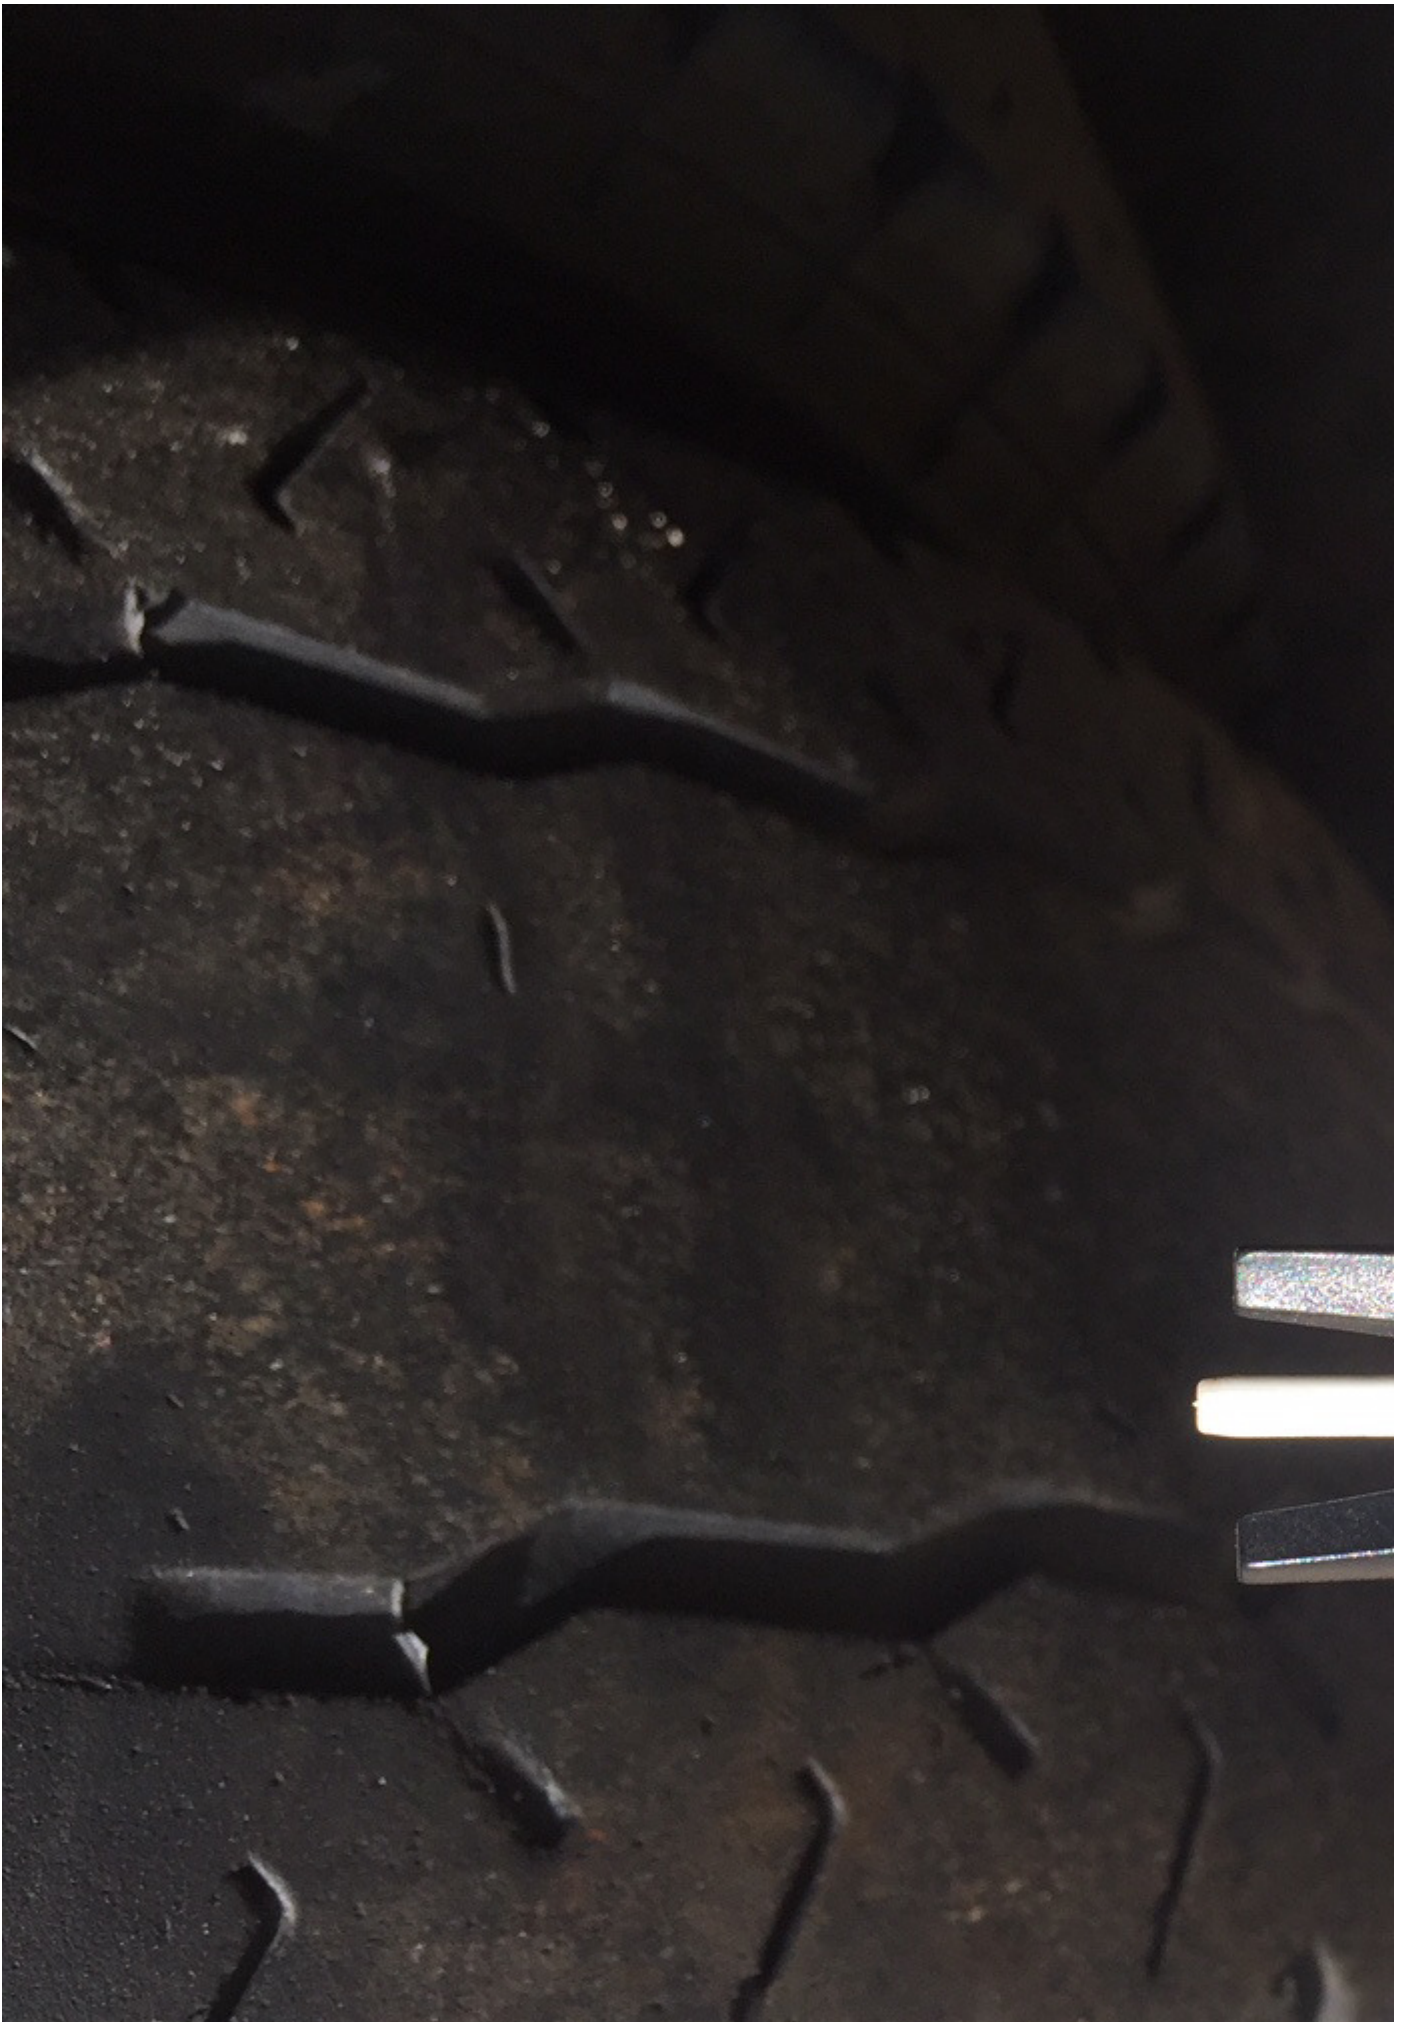
The front 2 tyres were found to be in serviceable condition with remaining tread depth of about 5mm each.

The rear left tyres (inner and outer) were found to be with remaining tread depth of about 1.6mm each. The pattern of the tread for the centre part of both rear left tyres were non-visible at some areas. As the pattern can be seen at some areas, the condition of the rear left tyres may still fall within the legal requirement (borderline case).

The rear right tyres (inner and outer) on the other hand were found to be with remaining tread depth of about 1mm each. The pattern of the tread for the centre part of both rear right tyres were non-visible around the entire circumference of both tyres. Such condition does not comply with the legal requirement :-

Section 109(f) of the **Road Traffic (Motor Vehicles, Construction and Use) Rules** states “where the tyre is fitted to a wheel of a motor vehicle, being a motor cycle whereof the cylinder capacity of the engine does not exceed 50 cubic centimetres, the tread of the tyre does not show throughout at least 75% of the breadth of the tread and round the entire outer circumference of the tyre a pattern the relief of which is clearly visible, or where the tyre is fitted to the wheel of any other motor vehicle or any trailer, the tread pattern (excluding any tie-bar) of the tyre does not have a depth of at least one millimetre throughout at least 75% of the breadth of the tread and round the entire outer circumference of the tyre.”

Attached are the photos taken during the measuring of the tread pattern for all 6 tyres of the insured vehicle.

The accident had occurred when the insured vehicle skidded while braking on a downslope roadway that is wet at the material time. Given the condition of the rear tyres as mentioned above, I am of the opinion that the condition of the rear tyres could have contributed to the insured vehicle skidding. The centre part of the tyres is the area that contacts the road surface the most. The lack of tread pattern prevents water from being “pushed” away when a tyre is rotating (vehicle moving) hence traction (frictional grip) between the insured vehicle and the wet road surface is reduced, ultimately contributing to the insured vehicle skidding.
