Subject: RE: Pls expedite final report (by 01.08.18) ; RE: Urgent : Pls assist to conduct rear tyre inspection for our vehicle GBD2586T ; RE: CMTD1802777/GPL - SUV(LKK)/ GBD2586T & XB7128A ACC ON 26.06.18

As requested, please find attached a soft copy of my report into the tyre condition of the insured vehicle.

Subject: Urgent : Pls assist to conduct rear tyre inspection for our vehicle GBD2586T ; RE: CMTD1802777/GPL - SUV(LKK)/ GBD2586T & XB7128A ACC ON 26.06.18

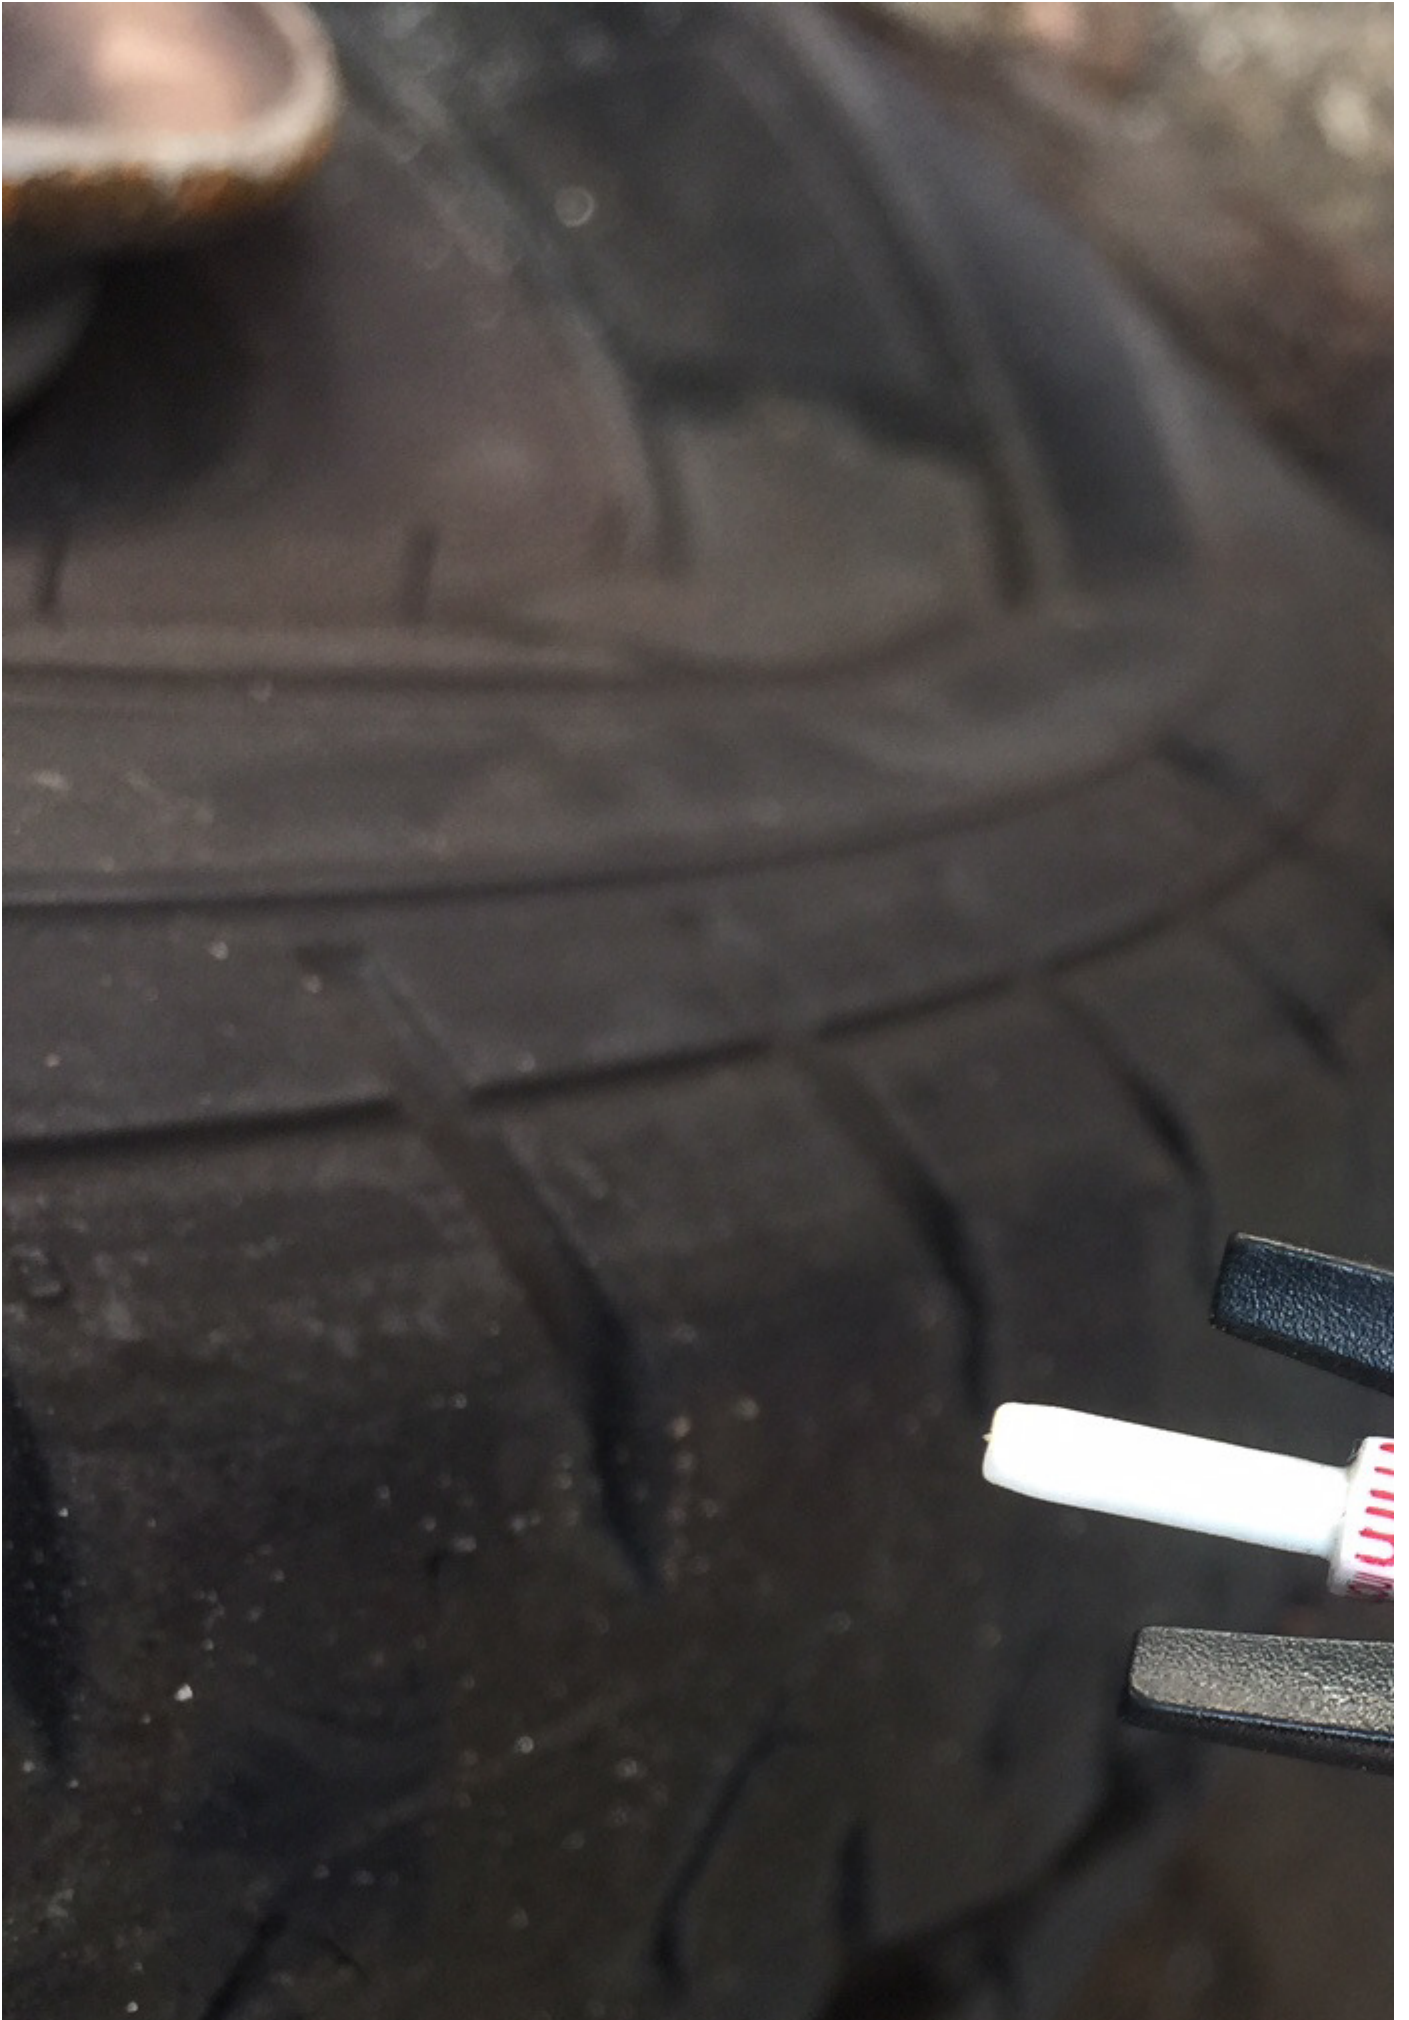
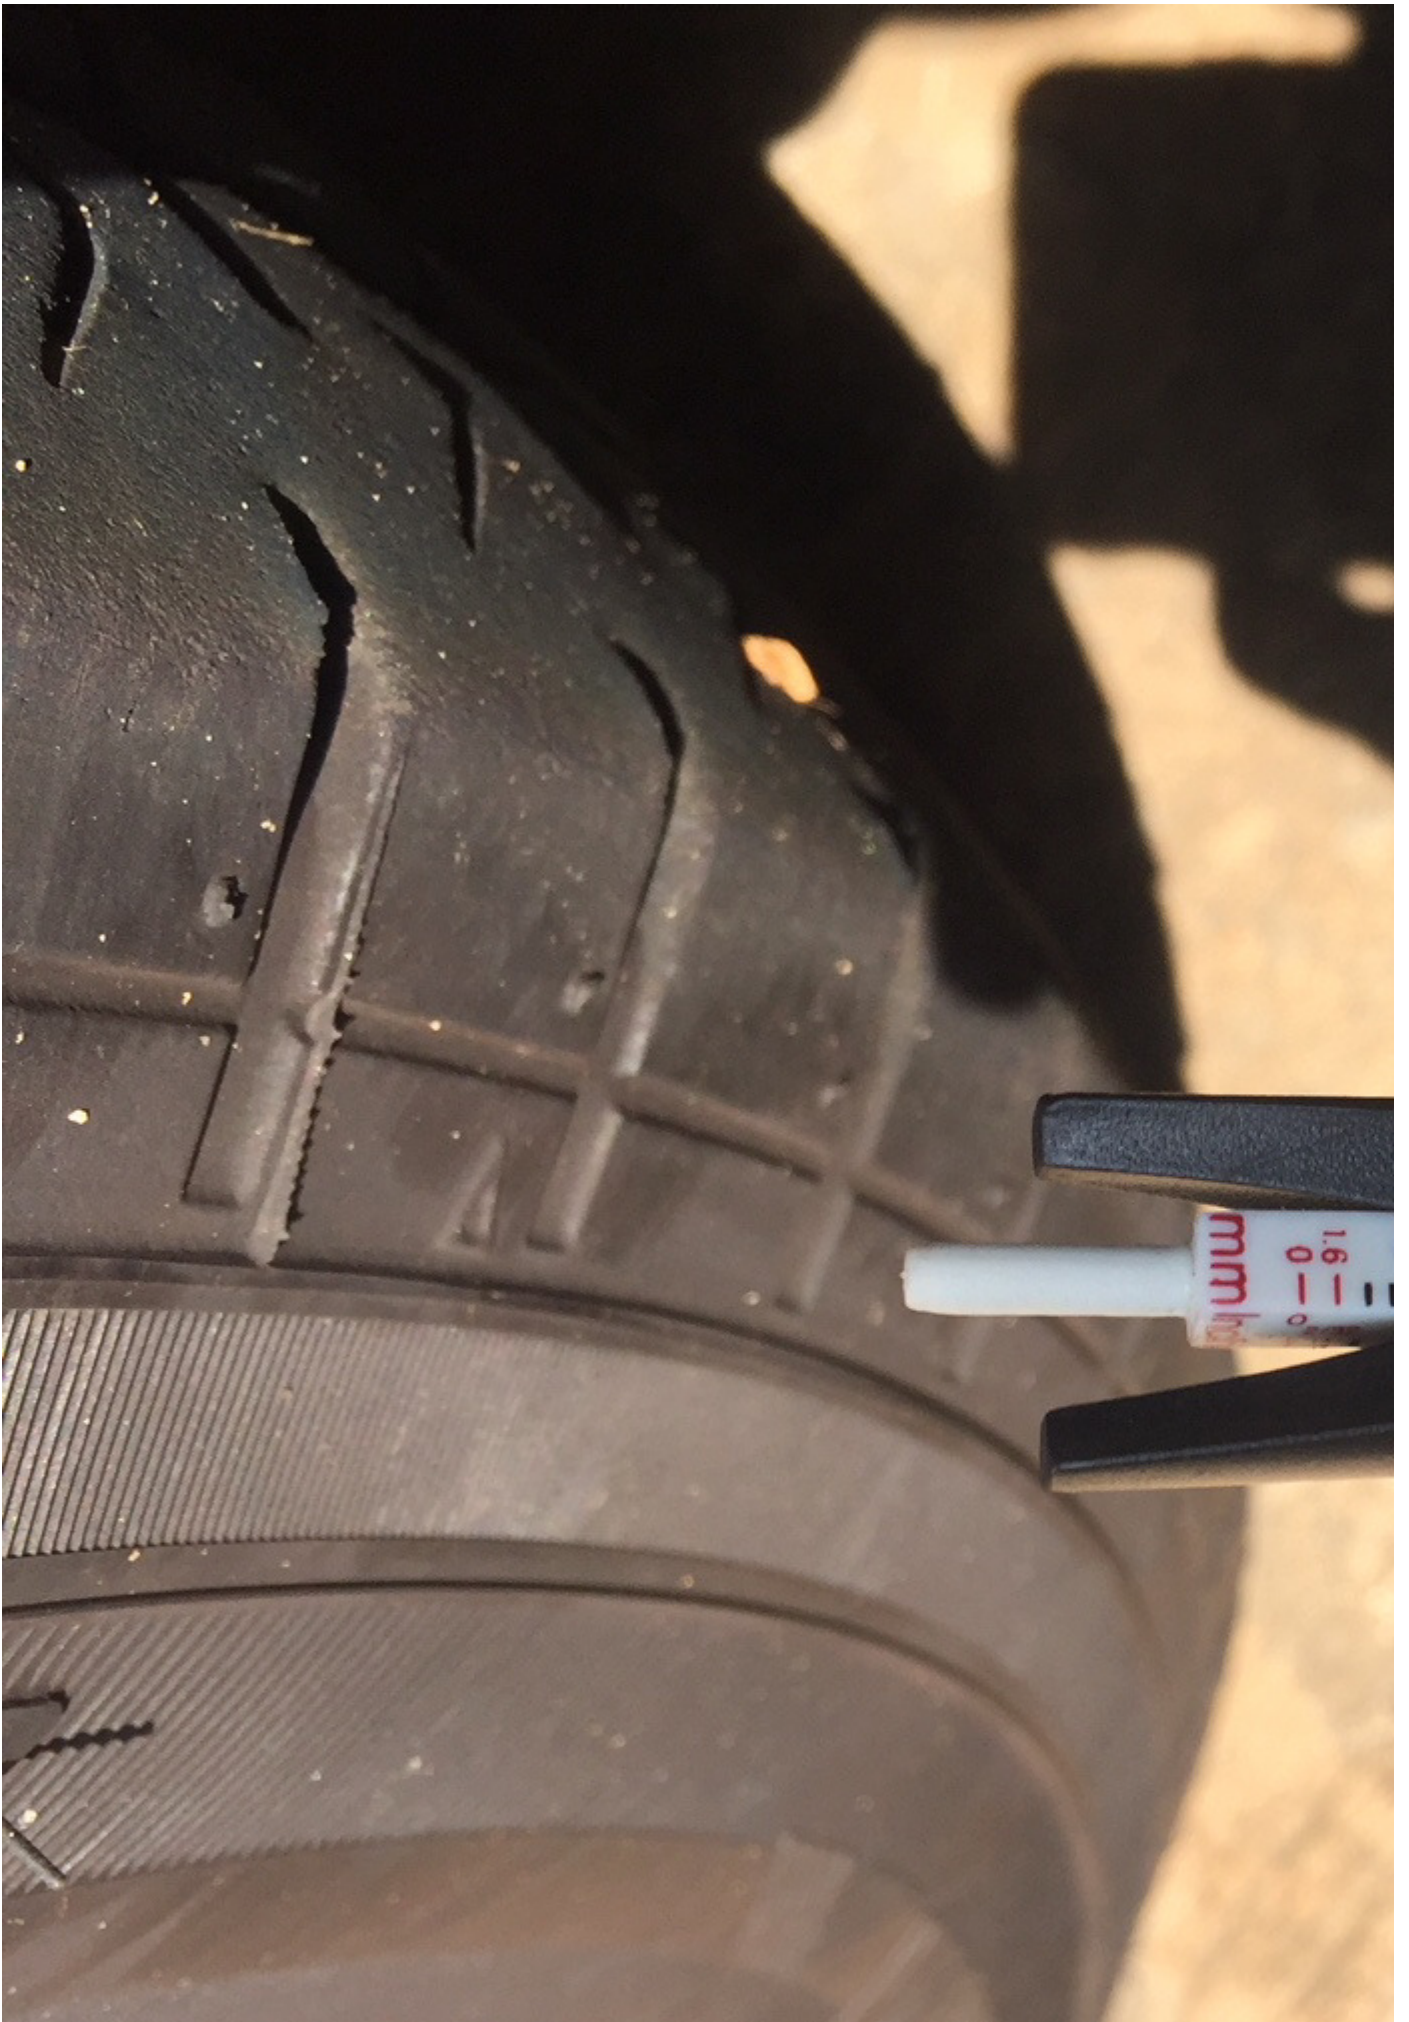
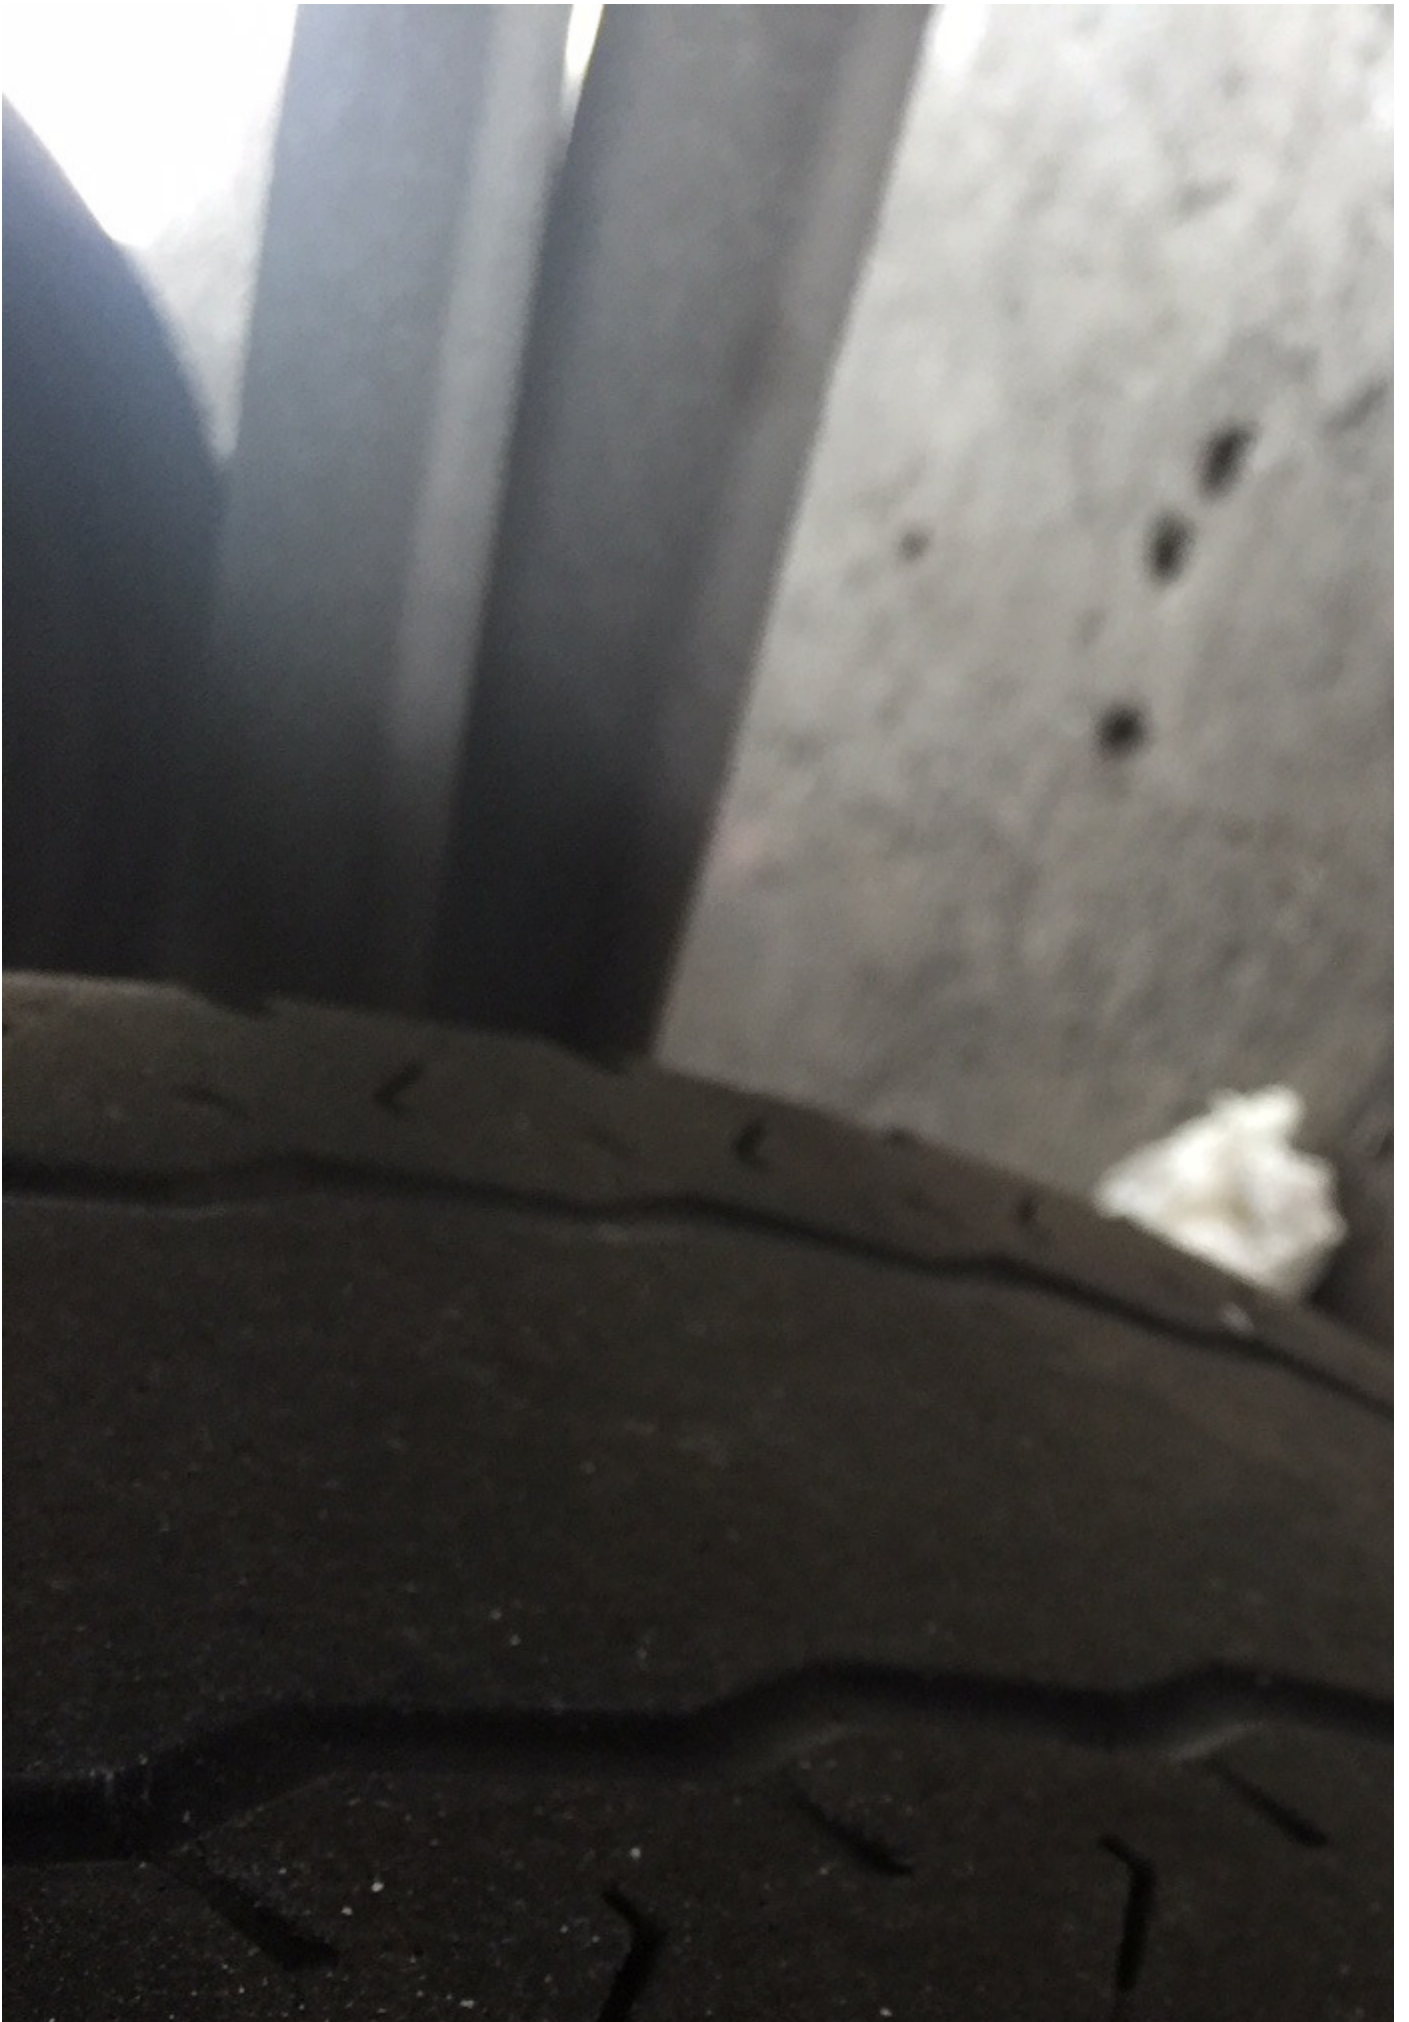
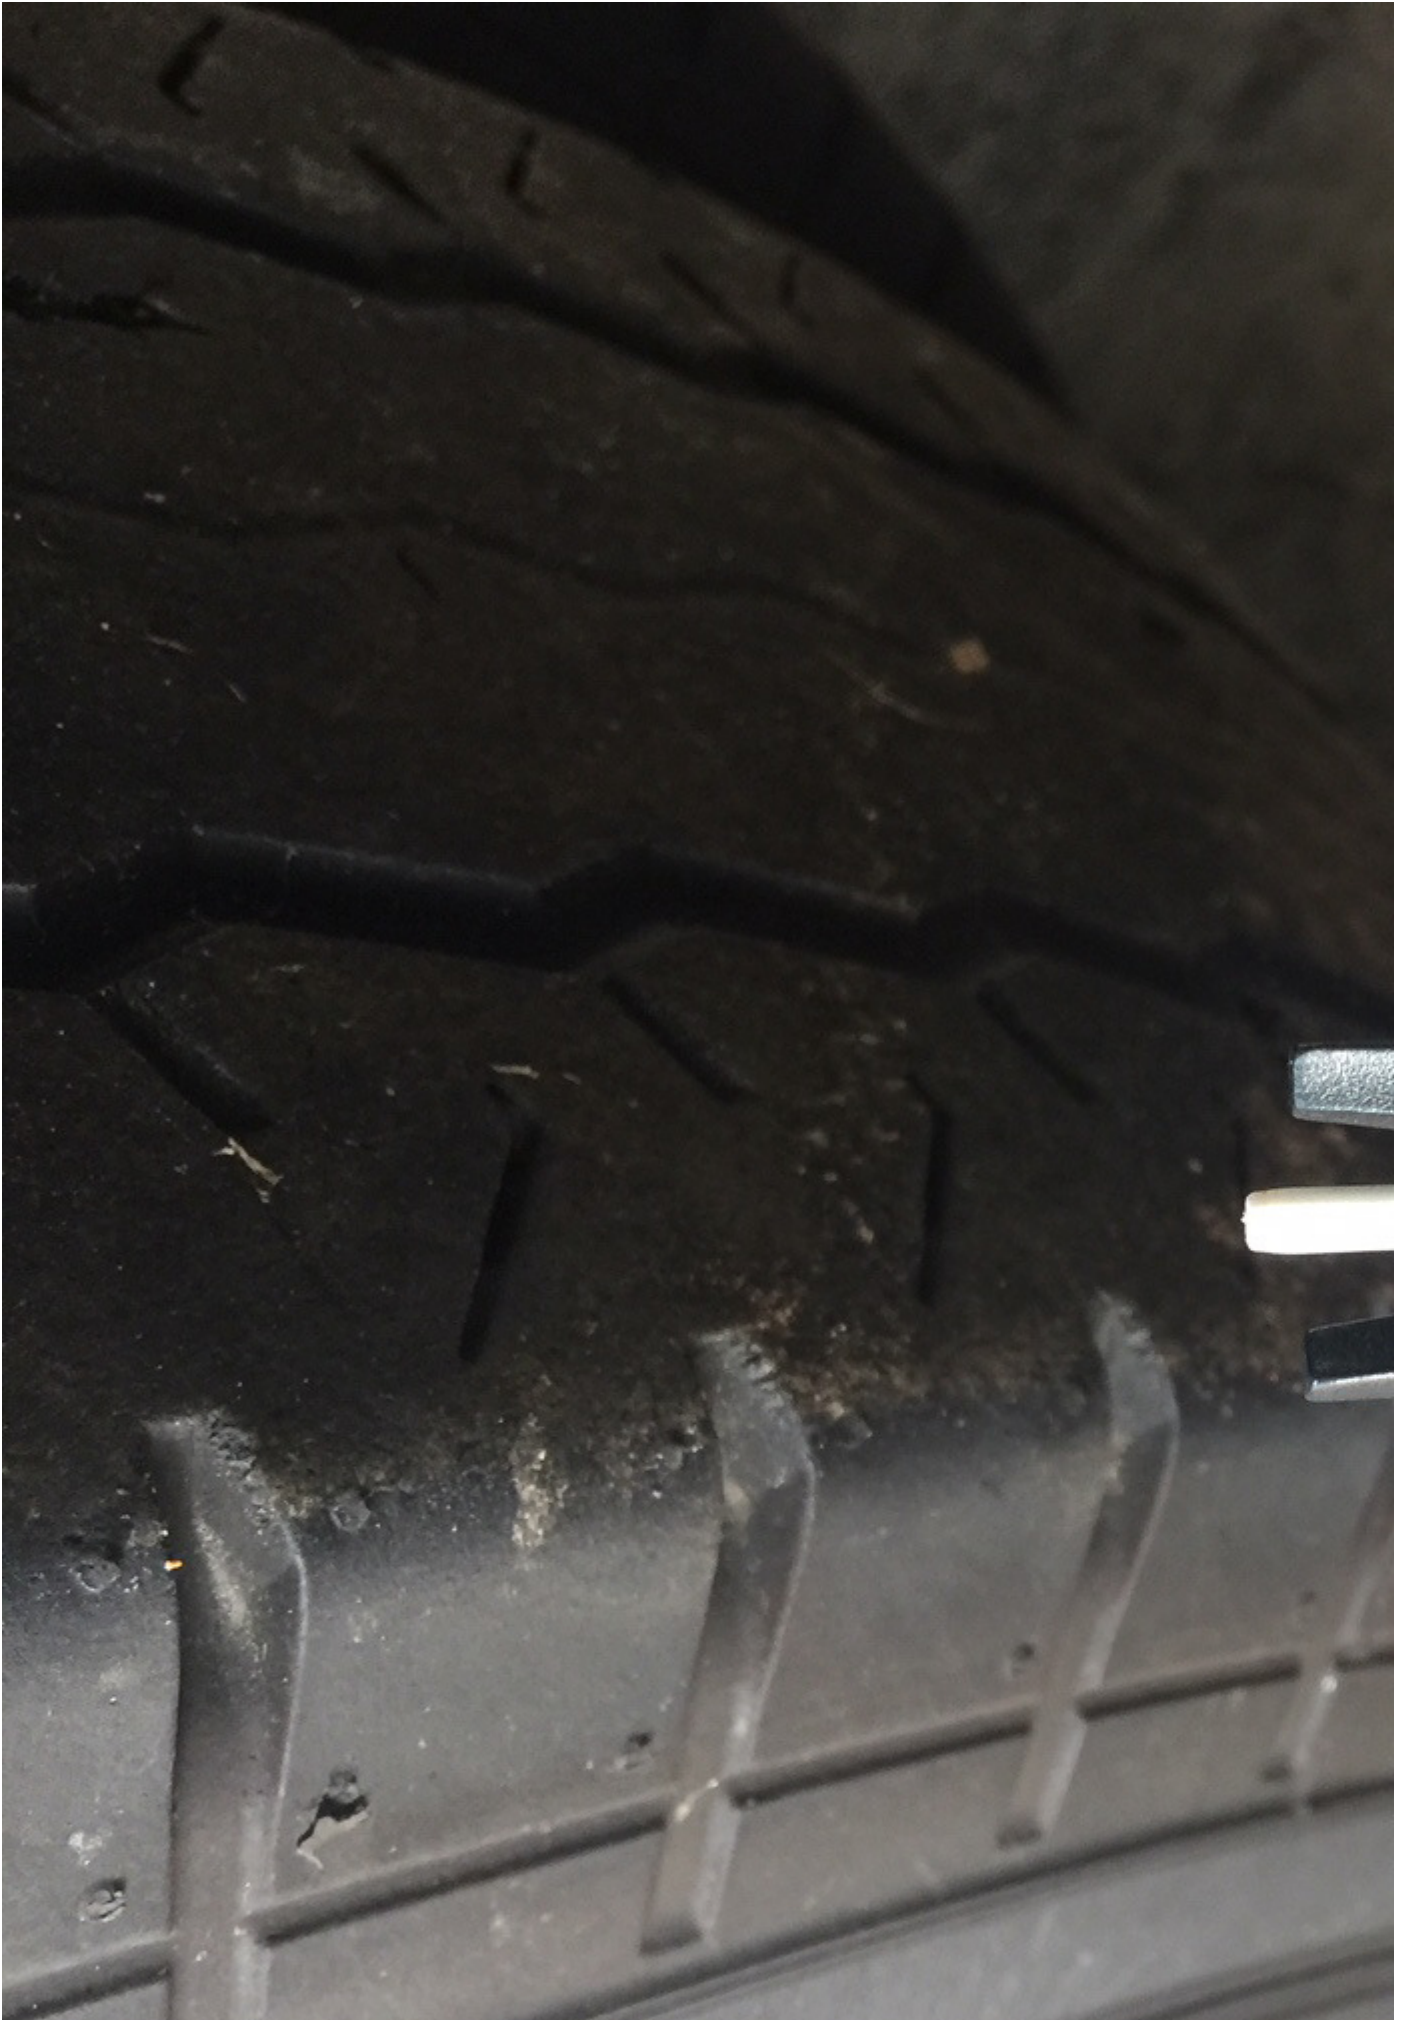
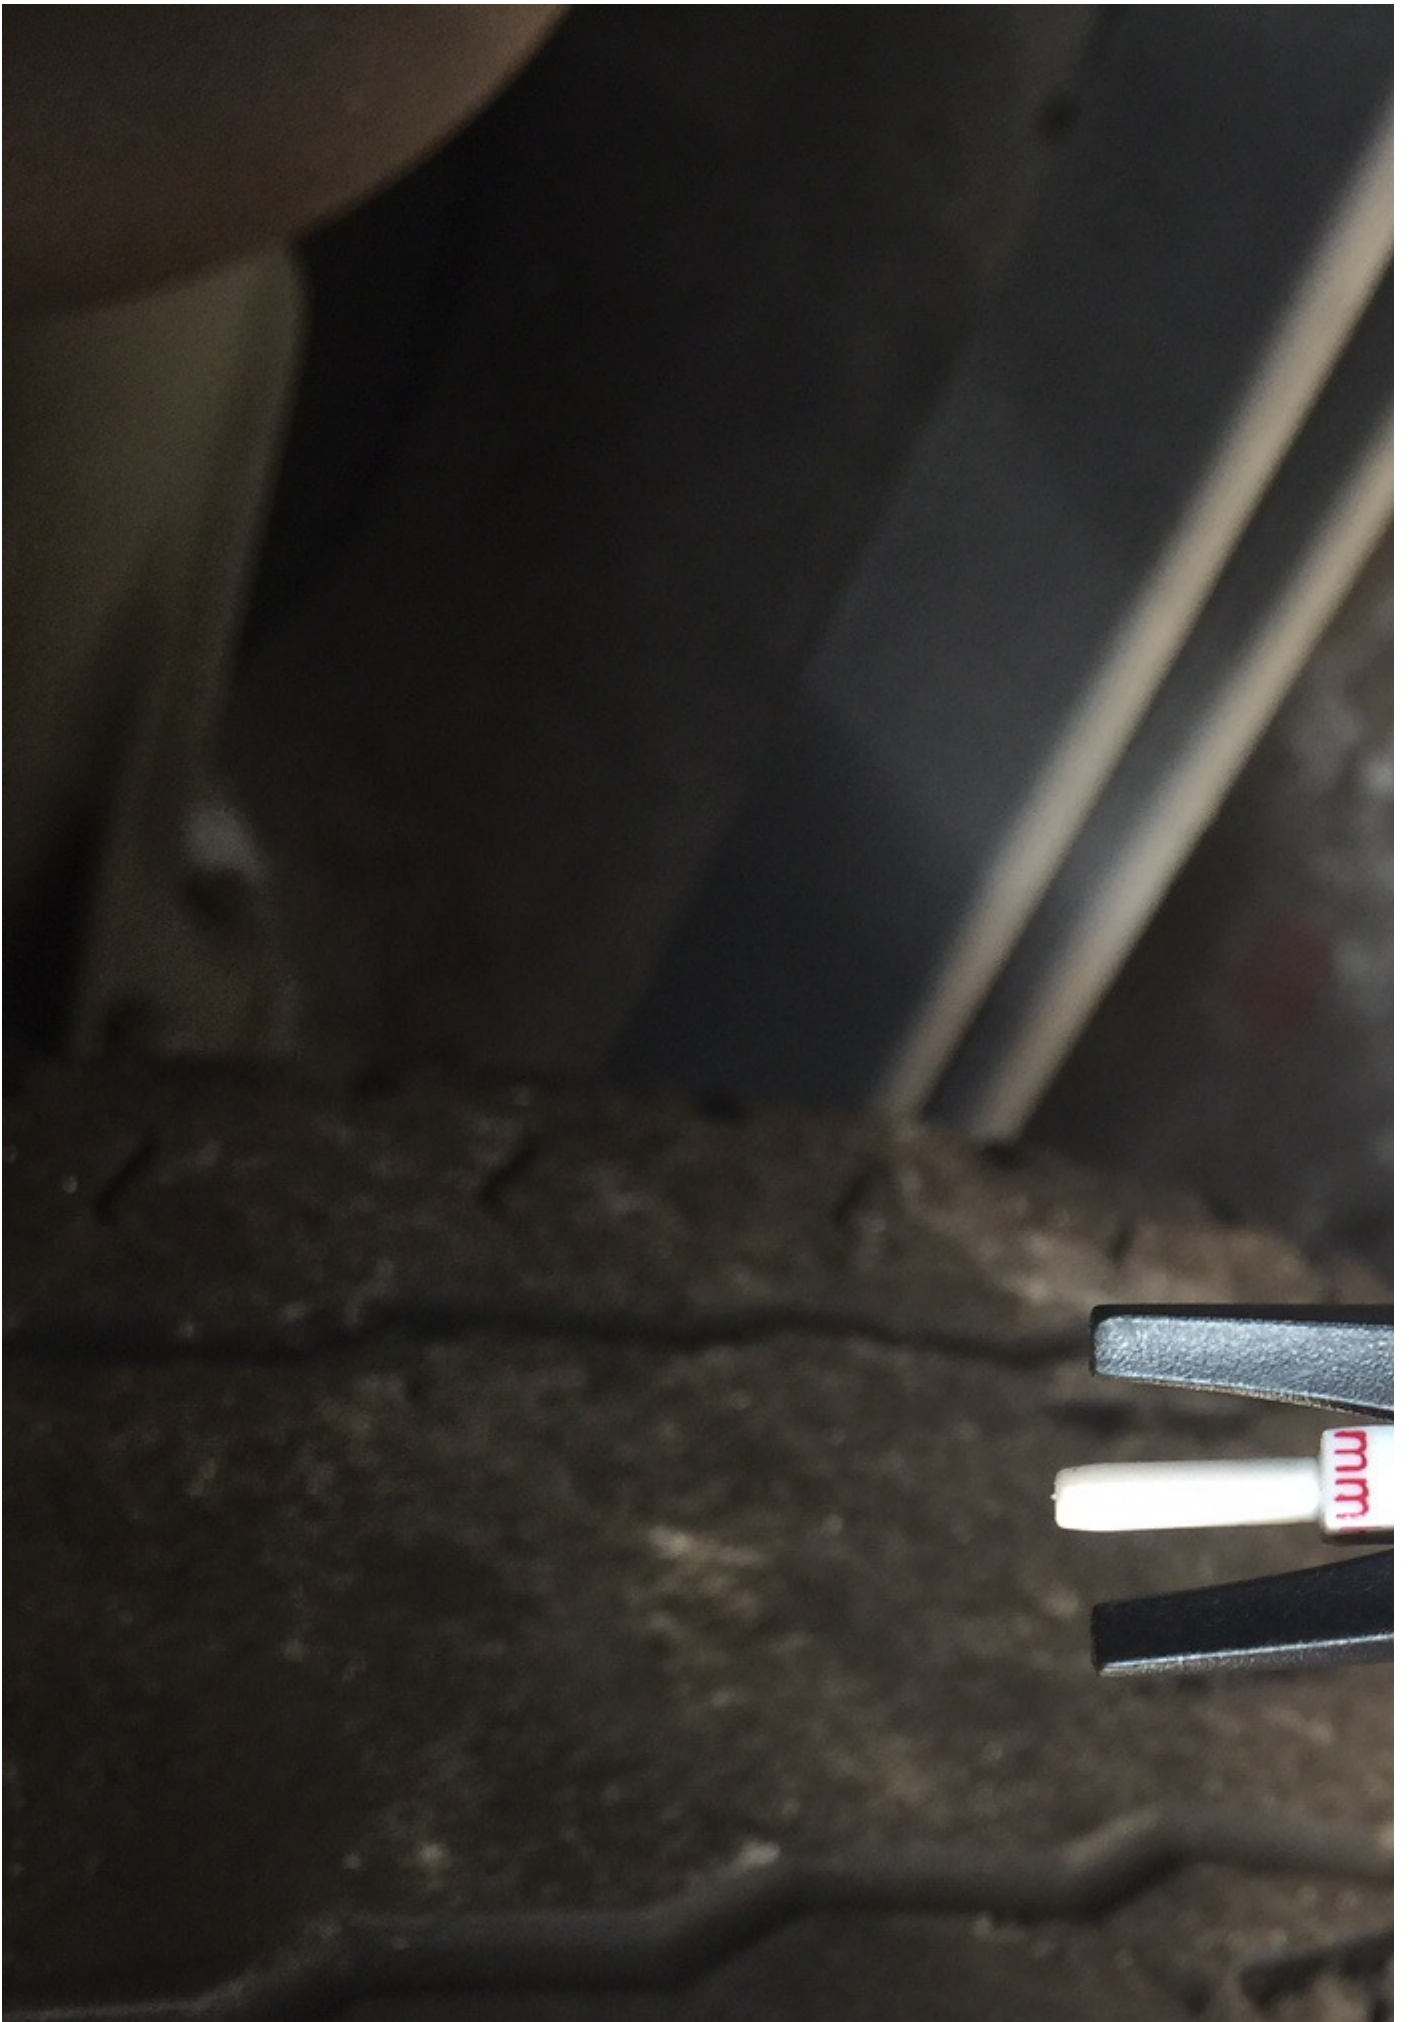
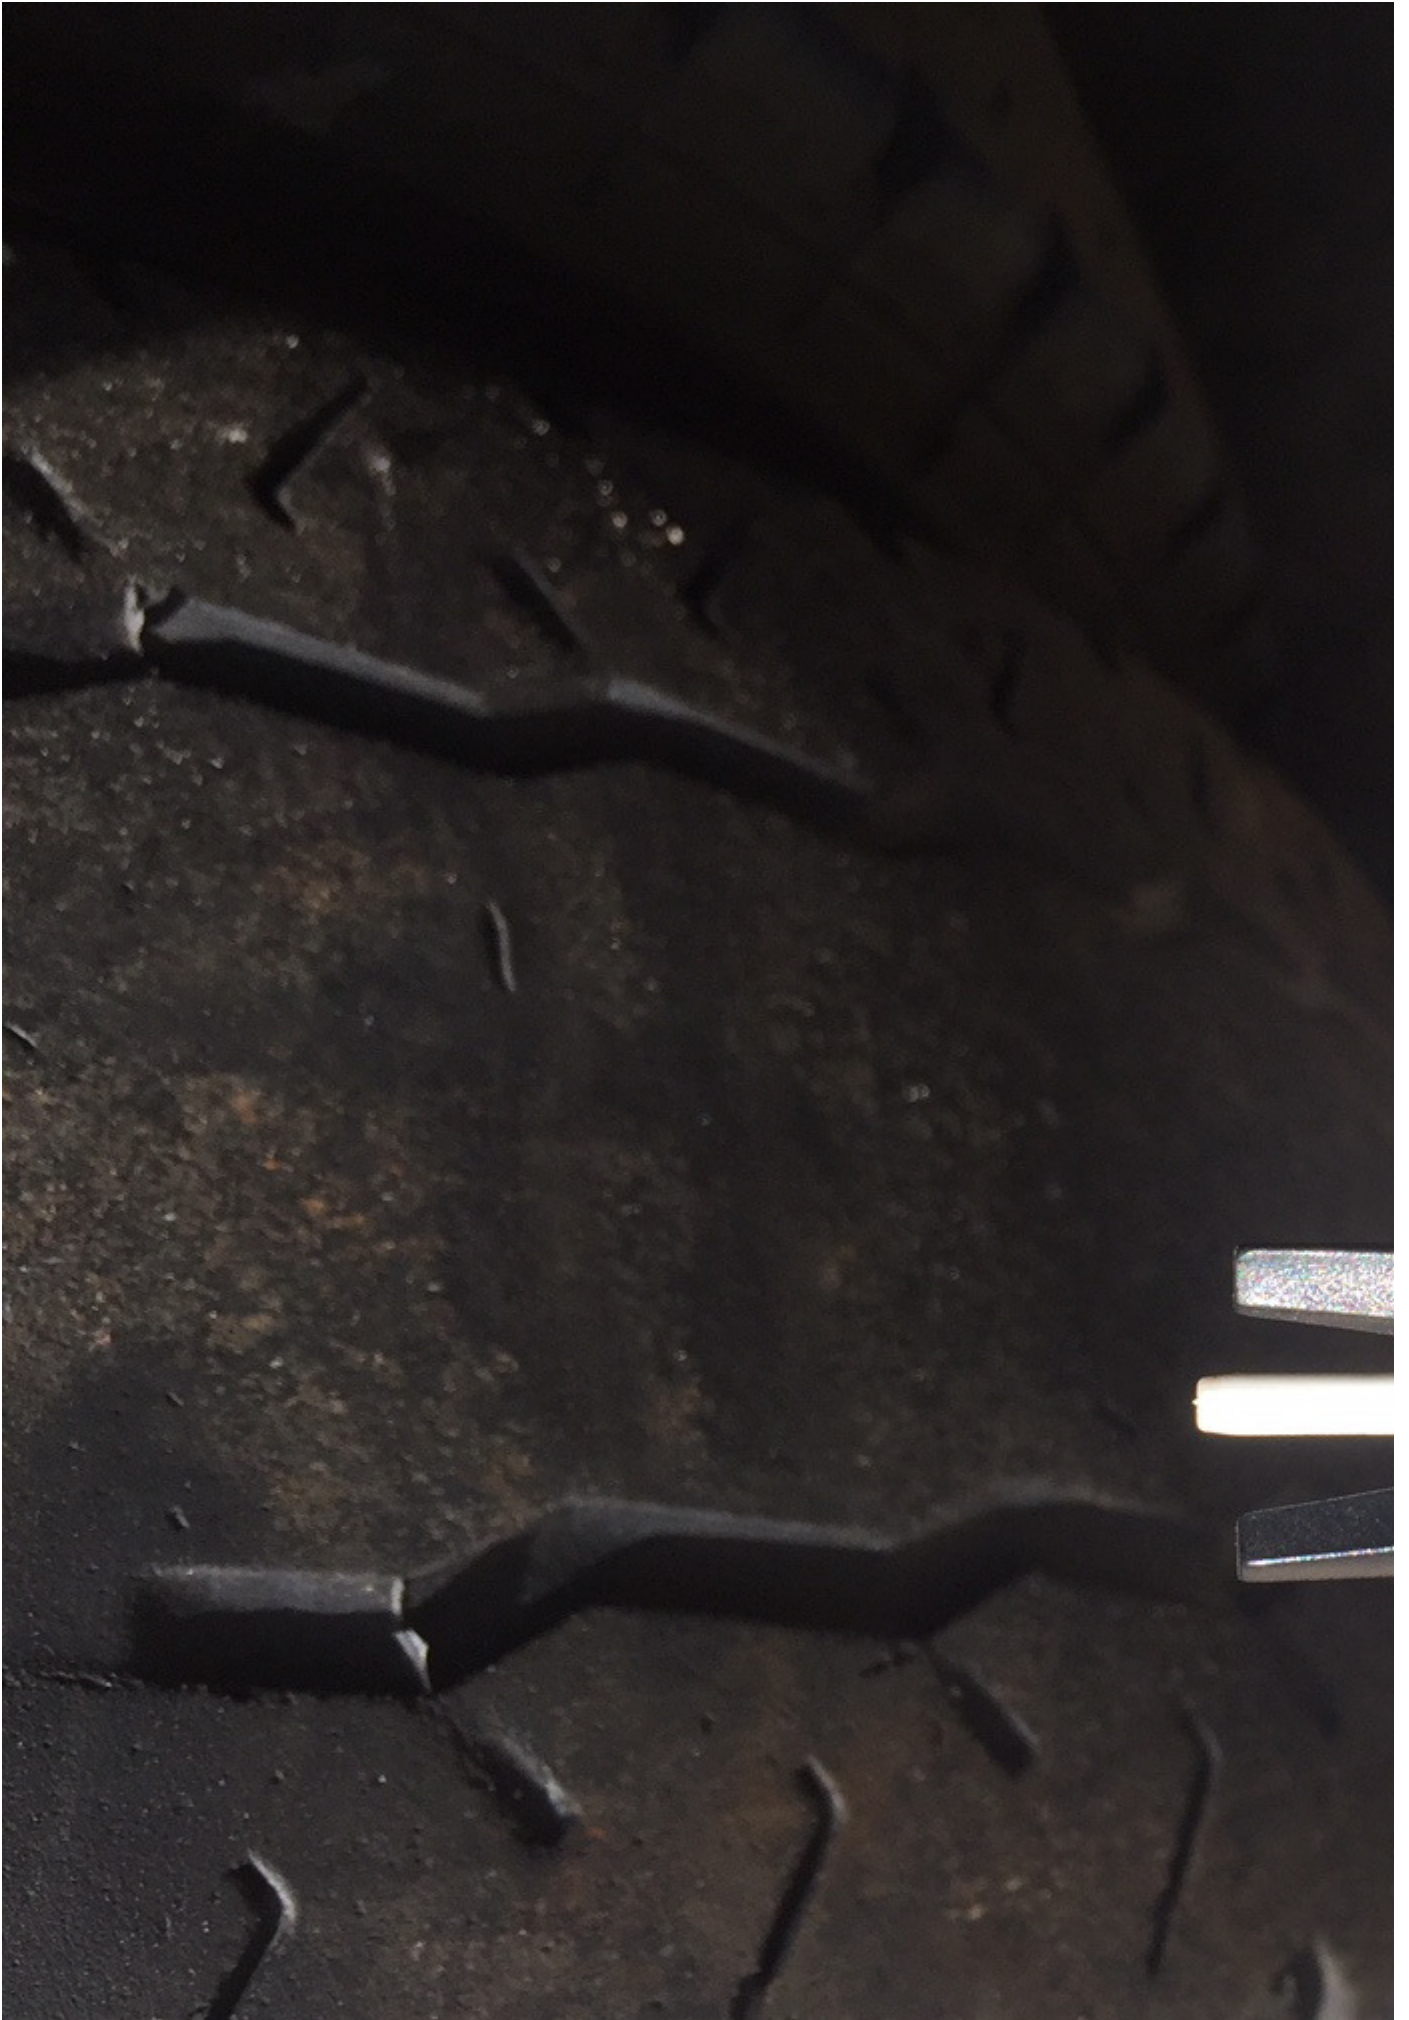
The front 2 tyres were found to be in serviceable condition with remaining tread depth of about 5mm each.

The rear left tyres (inner and outer) were found to be with remaining tread depth of about 1.6mm each. The pattern of the tread for the centre part of both rear left tyres were non-visible at some areas. As the pattern can be seen at some areas, the condition of the rear left tyres may still fall within the legal requirement (borderline case).

The rear right tyres (inner and outer) on the other hand were found to be with remaining tread depth of about 1mm each. The pattern of the tread for the centre part of both rear right tyres were non-visible around the entire circumference of both tyres. Such condition does not comply with the legal requirement :-

Section 109(f) of the **Road Traffic (Motor Vehicles, Construction and Use) Rules** states “where the tyre is fitted to a wheel of a motor vehicle, being a motor cycle whereof the cylinder capacity of the engine does not exceed 50 cubic centimetres, the tread of the tyre does not show throughout at least 75% of the breadth of the tread and round the entire outer circumference of the tyre a pattern the relief of which is clearly visible, or where the tyre is fitted to the wheel of any other motor vehicle or any trailer, the tread pattern (excluding any tie-bar) of the tyre does not have a depth of at least one millimetre throughout at least 75% of the breadth of the tread and round the entire outer circumference of the tyre.”

Attached are the photos taken during the measuring of the tread pattern for all 6 tyres of the insured vehicle.

The accident had occurred when the insured vehicle skidded while braking on a downslope roadway that is wet at the material time. Given the condition of the rear tyres as mentioned above, I am of the opinion that

the condition of the rear tyres could have contributed to the insured vehicle skidding, The centre part of the tyres is the area that contacts the road surface the most. The lack of tread pattern prevents water from being “pushed” away when a tyre is rotating (vehicle moving) hence traction (frictional grip) between the insured vehicle and the wet road surface is reduced, ultimately contributing to the insured vehicle skidding.
