Preliminary Advice

Insured Vehicle No	: SKP7394C	Accident Date	: 01/07/2018
TP Vehicle No	: SJF2465D	Assignment Date	: 03/07/2018
Make	: TOYOTA WISH	Est. Duration of Repair	: 6 days
Date of Inspection	: 03/07/2018		
Inspection At	: Keng Hock Auto BLK 7 SIN MING INDUSTRIAL ESTATE C #01-84 Singapore 575642

VEHICLE DAMAGE INSPECTION REPORT

Our File No: CS/MSG18012025/KSD3N2

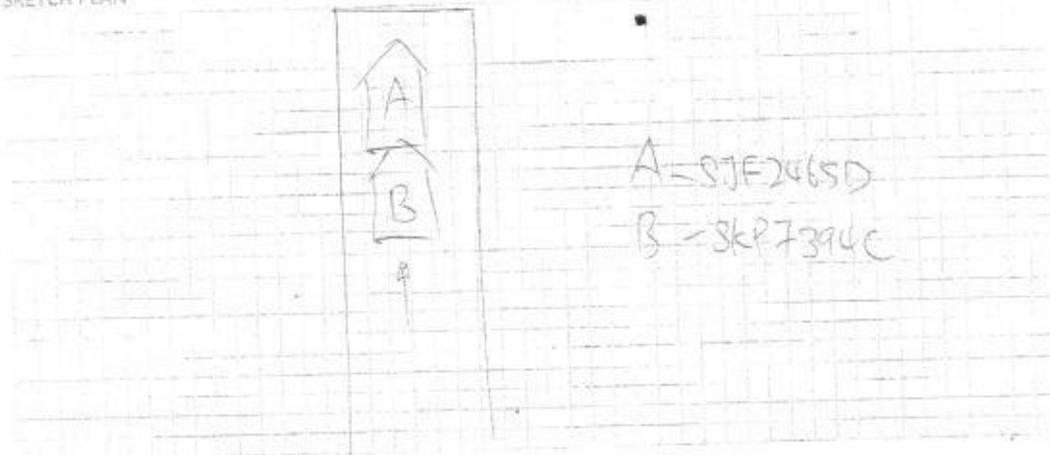
SKETCH PLAN

I am in the car park at Reflection@Keppel to pick up a passenger @ tower ~~33~~ 33. The vis visibility in the car park is very low. I stop to look for the tower 33 and the car behind driven by Shen Yukun car plate SKP 7394C being on my back back.
