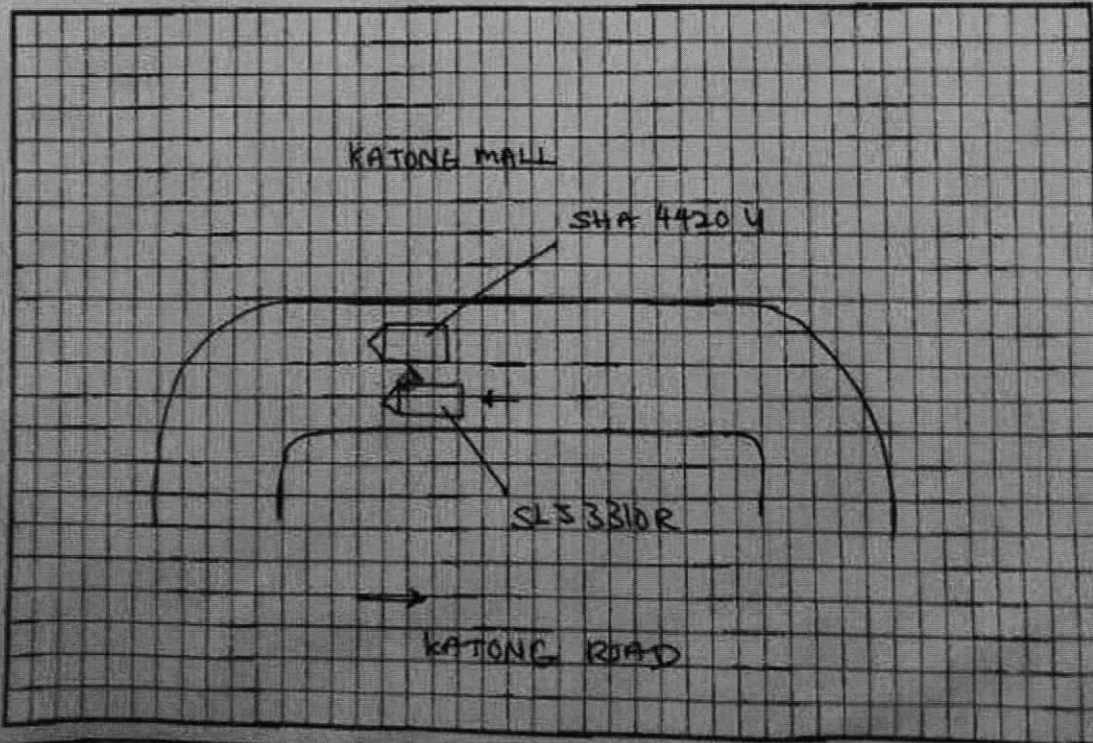
Sketch Plan

I was driving slowly along drive way at 112 KATONG MALL when suddenly a passenger from taxi SHA4420U open the rear left door & hit onto my SLJ3310R right side mirror. No injuries involved.
