REF: CS/CTI 18 01/21/24/RVd36

CHINA TAIPING INSURANCE (S) PTE LTD

Ref : CS/CTI18012124/R1vd3

## VEHICLE DAMAGE INSPECTION REPORT

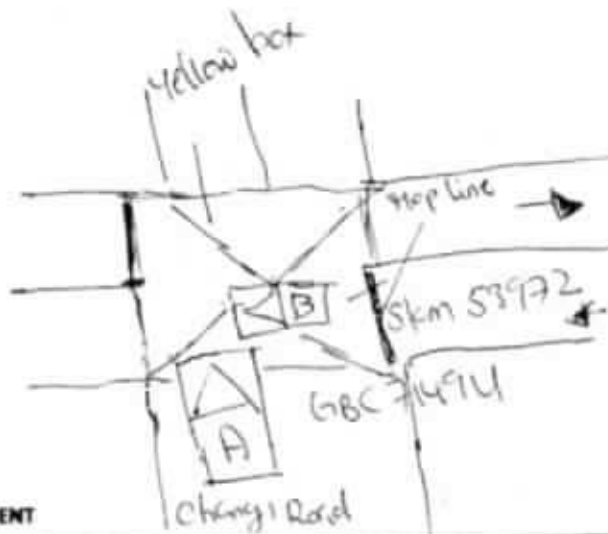
## SKETCH PLAN

On 30/06/2018 @ 1320hrs, I was driving my vehicle GBC 714911 in the Singapore Expo near the exit of Expo hall 2 and 3 heading towards the exit of Expo hall 6 towards TPE. While I was driving near to a cross junction, suddenly the third party vehicle SKM 53572 dash from my right side and hit onto my vehicle right hand side front body causes damage to my vehicle. My vehicle had installed in-car cam and catches the whole incident. The third party fail to stop his vehicle and the stop line and dash forward without checking.
