VEHICLE DAMAGE INSPECTION REPORT

Our File No: CS/CT118012127/KTBN2

Handling Insurer:	China Taiping Insurance (Singapore) Pte. Ltd.	Policy No:	DMPCSN3112361801
Claimant Vehicle No :	SJR6381Y	Insured Vehicle No :	SCN838R
Date of Loss:	21/06/2018	Nature of Claim:	TP
		Claim No:	SNM18D03126C02

Reg No:	SJR6381Y	Engine No:	ZY519959
Make & Model:	MAZDA 2, 1.5 (A)	Chassis No:	JM0DE10Y190130626
Reg. Date:	02/07/2009 (Man. Year: 2008)	Odometer:	213229 km
Colour:	Red		
Engine Capacity:	1498 cc		
Market Value/New Car Price:	N/A		
Sum Insured (S\$):	Market Value/New Car Price

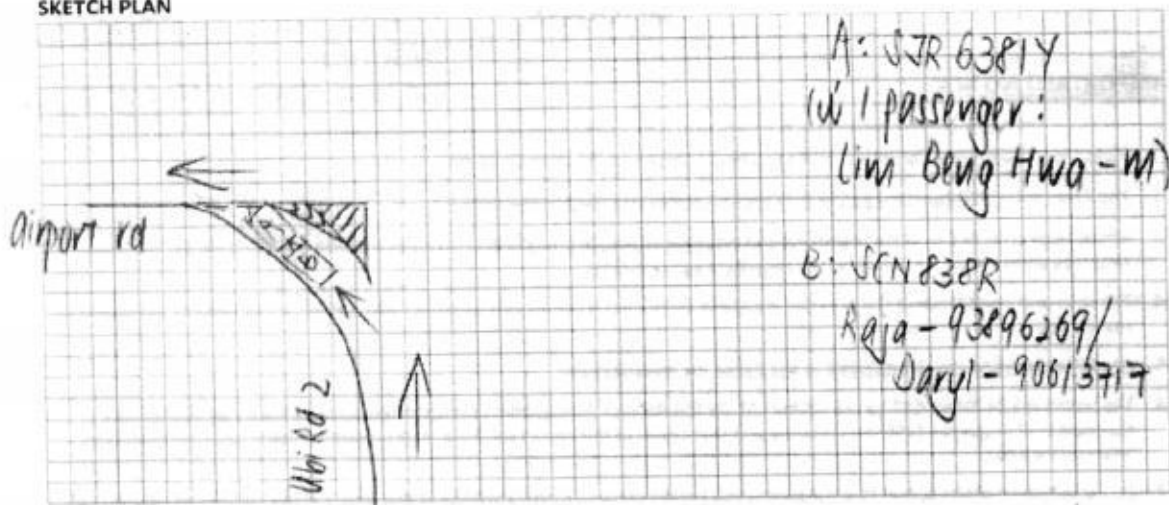
SKETCH PLAN

Vehicle No: SJR6381Y (NTUC)
Date & Time: 21/06/2018 @ 1445 (clear day)

I was giving Driving Tuition to my learner (Alex Tan Kian Hye, S9810385F) on 21/06/2018 at 1445hr and at the slip road from Ubi road 2 towards Airport rd, my learner stopped at the slip road for traffic on the main road to clear. When there were no vehicles on the right and before he could moved out of the slip road, we felt an impact from the back and realised motor car SCN 838R had came from behind and hit onto our vehicle rear portion.
