Veh No: SLP 8803X Yr Regn: 23/4/2014
 Type: M.Car / M.Cycle / Bus / Van / Lorry / Taxi / Prime Mover /
 Truck / Trailer or Car
 Make: Peugeot 2008 c.c. 1560
 Colour: Grey A/C: Insured / Std / NI / NA
 Sp Reading: 105001 T/Radio: Insured / Std / NI / NA
 Eng/No: _____
 C/No: VF 5049 HPSKY 002689
 Gen. Cond: Good / Fair / Poor / Burnt
 Steering: Inorder / Jammed / Leaked / Burnt or
 Brake: Inorder / Jammed / Leaked / Burnt or
 Modi: Nil / S/Rim / **STD A/Rim** or
 Tyre Size: F: 105/155 R16 Yoko
 R: 11 Goodyear
 BS / DUN / EXNOVA / GY / FS / LIZA / MIC / OHTSU / PIR / SUMI /
 TOYO / YOKO or
 Front _____ Rear _____
 R/Bal. 6 mm R/Bal. 6 mm
 L/Bal. 6 mm L/Bal. 6 mm
 D.O.A. 24/3/18 D.O.I. 2/9/15
 Survey held at Handan
 Des. of Damages: Frt / Rear / O/S / N/S / UIC / Rooftop or
 The UIC / Chassis frame / Body Structure affected due to collision.

ACCIDENT INVOLVING SLP 8803 X / SHC 5211 P ON 24th MARCH 2018 ALONG AIRPORT BOULEVARD HIGHWAY

4. Description of Damages			
THE VEHICLE HAD COMPLETED ITS REPAIR WORKS. REPAIR CONDITION SEE DETAILS.			
5. General Information			
Accident Date	24/03/2018	Inspection Date	13/07/2018
Survey held at	HENDON AUTOMOTIVE 280 WOODLANDS IND PARK E5 #01-11 SIN

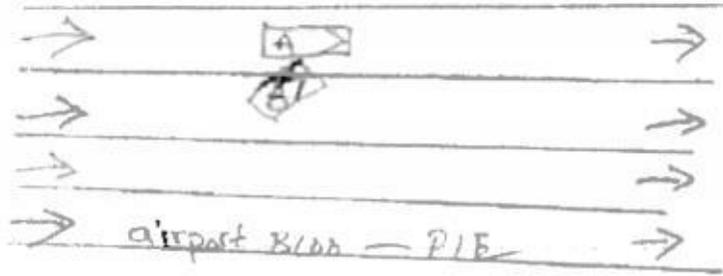
SKETCH PLAN

I was travelling along Airport Blvd highway on 20/3/18 suddenly vehicle B (SHC 5211P) came from my right side and cut into my lane. Thus I realised vehicle B (SHC 5211P) hit onto my vehicle right side portion after the impact, I felt pain on my neck and hand.
