**Preliminary Advice**

| Vehicle No | : WC4764P | Accident Date | : 19/06/2018 |
| Make | : ISUZU CYH52S | Policy No. | : DMCVSN1768971700 |

## VEHICLE DAMAGE INSPECTION REPORT

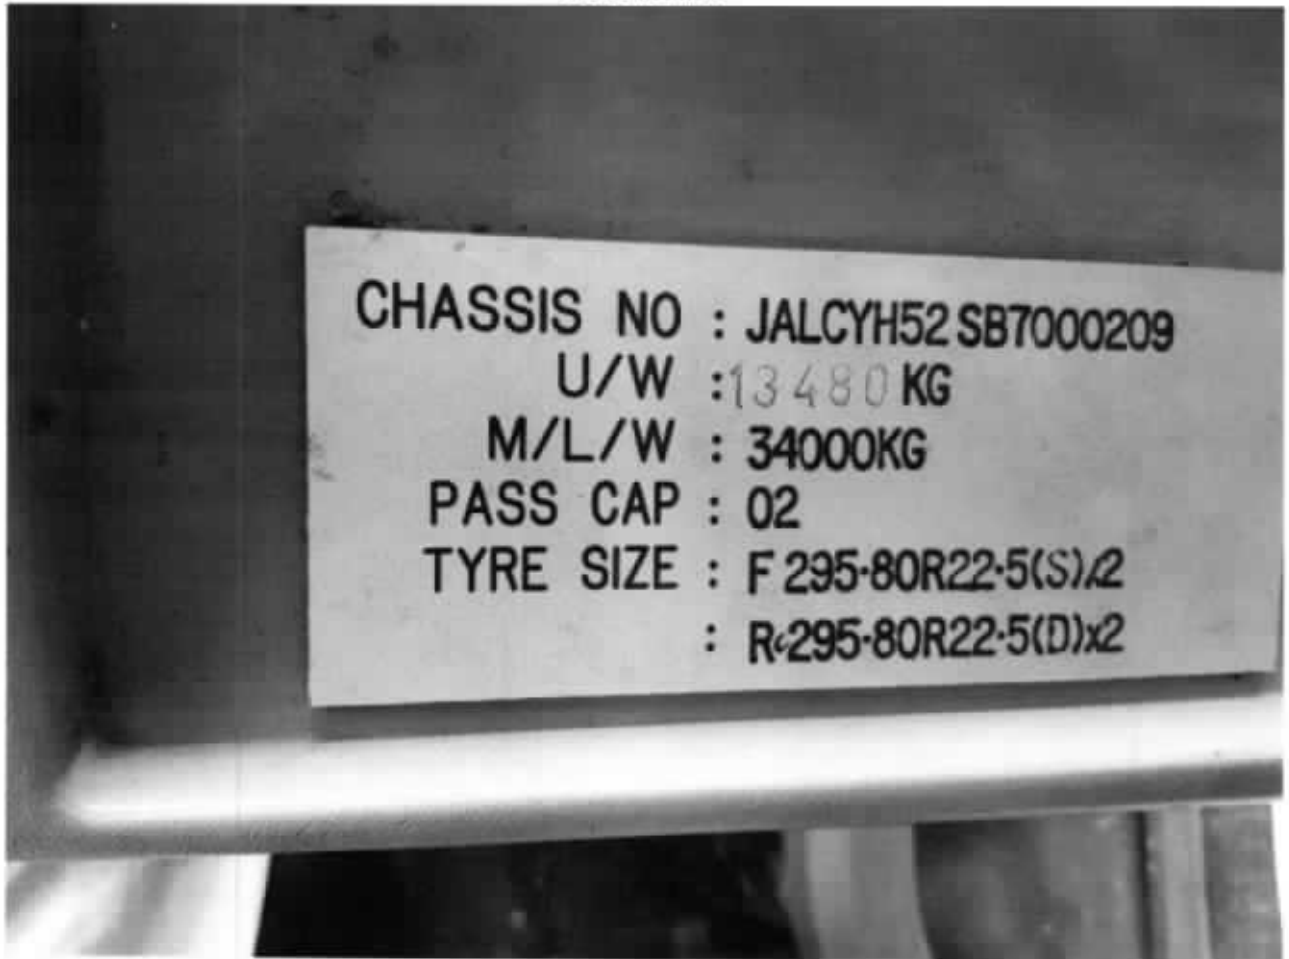
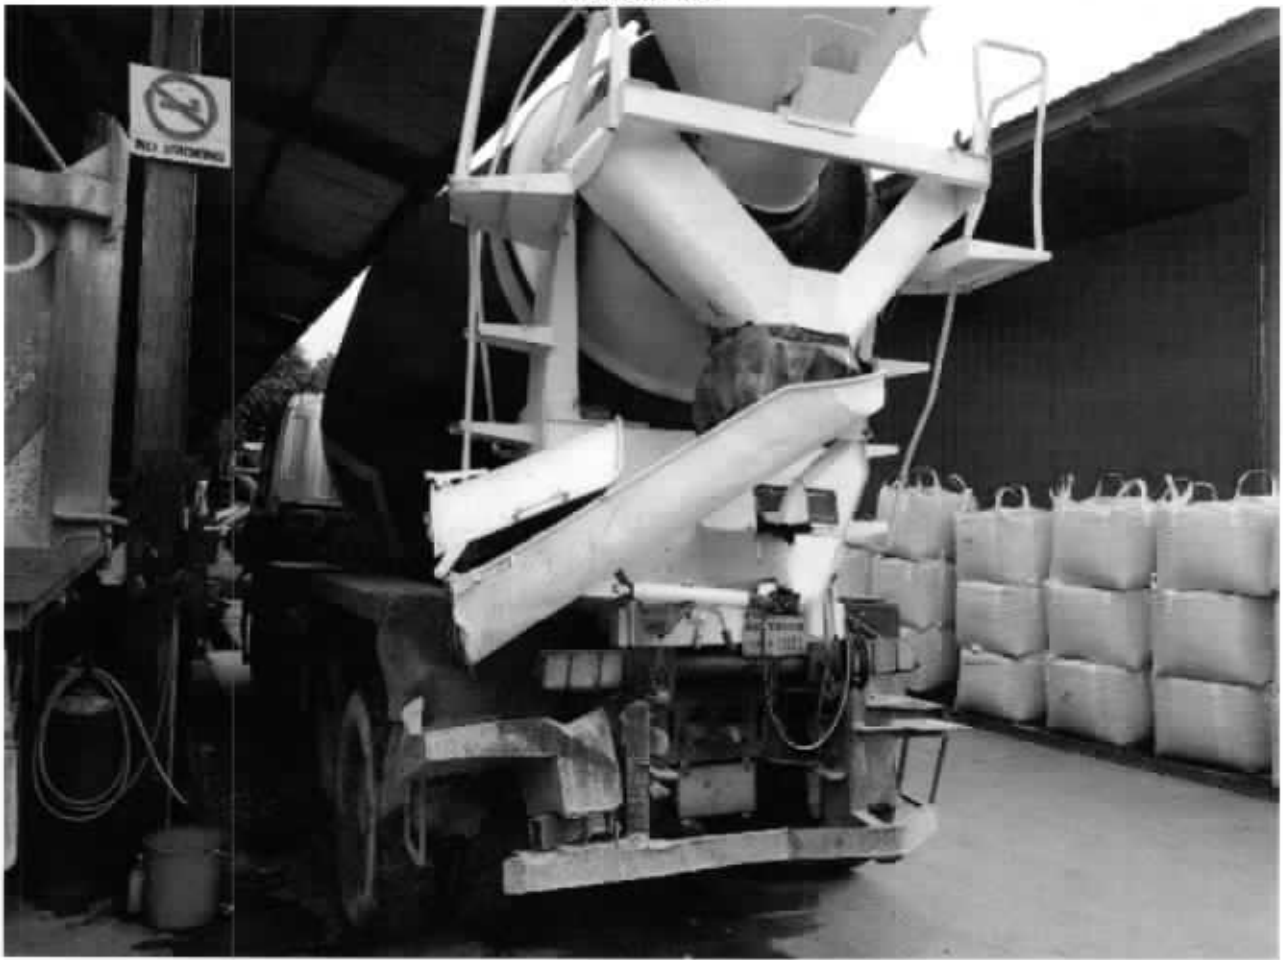
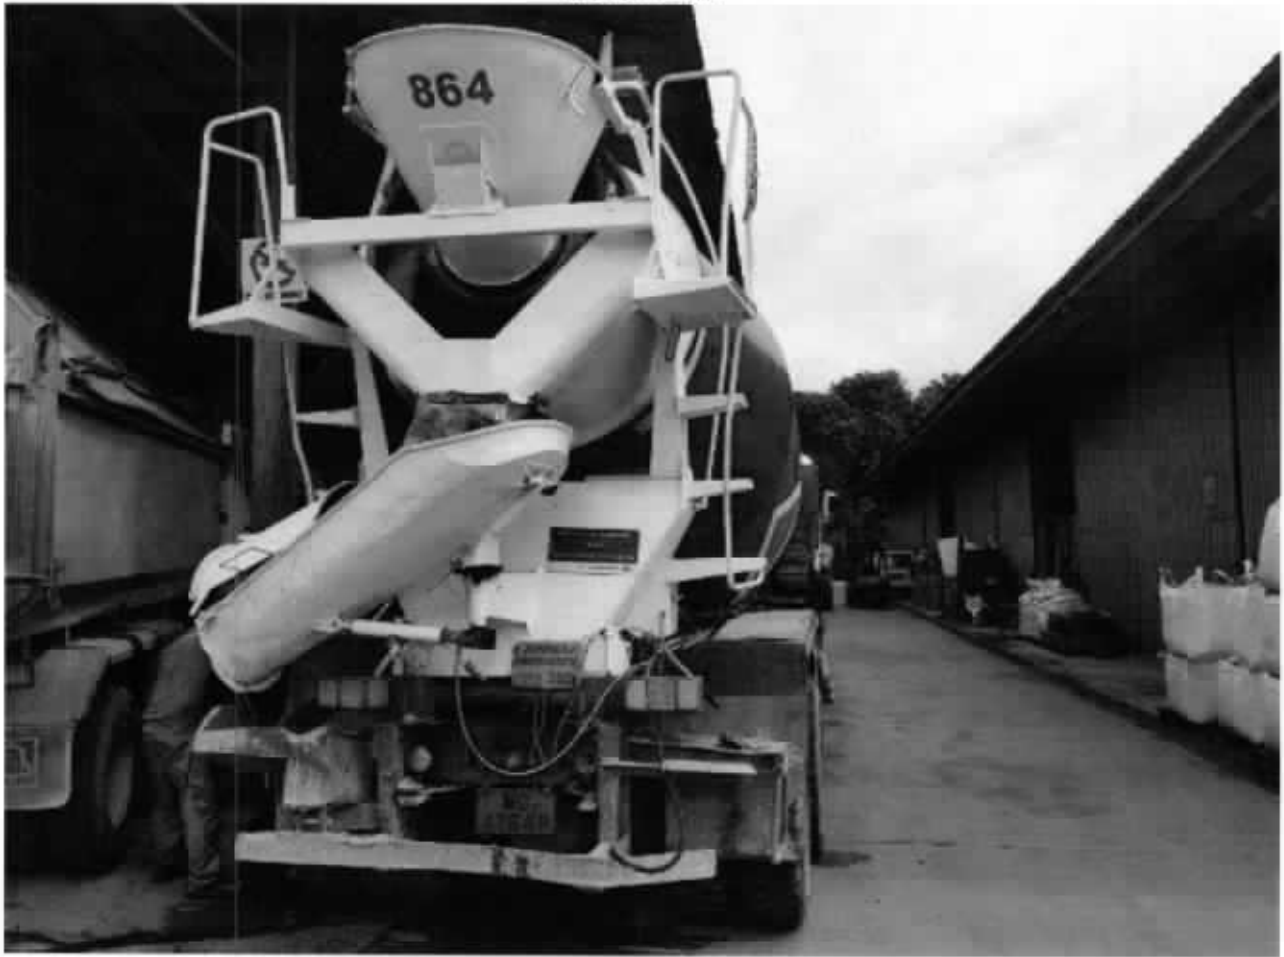
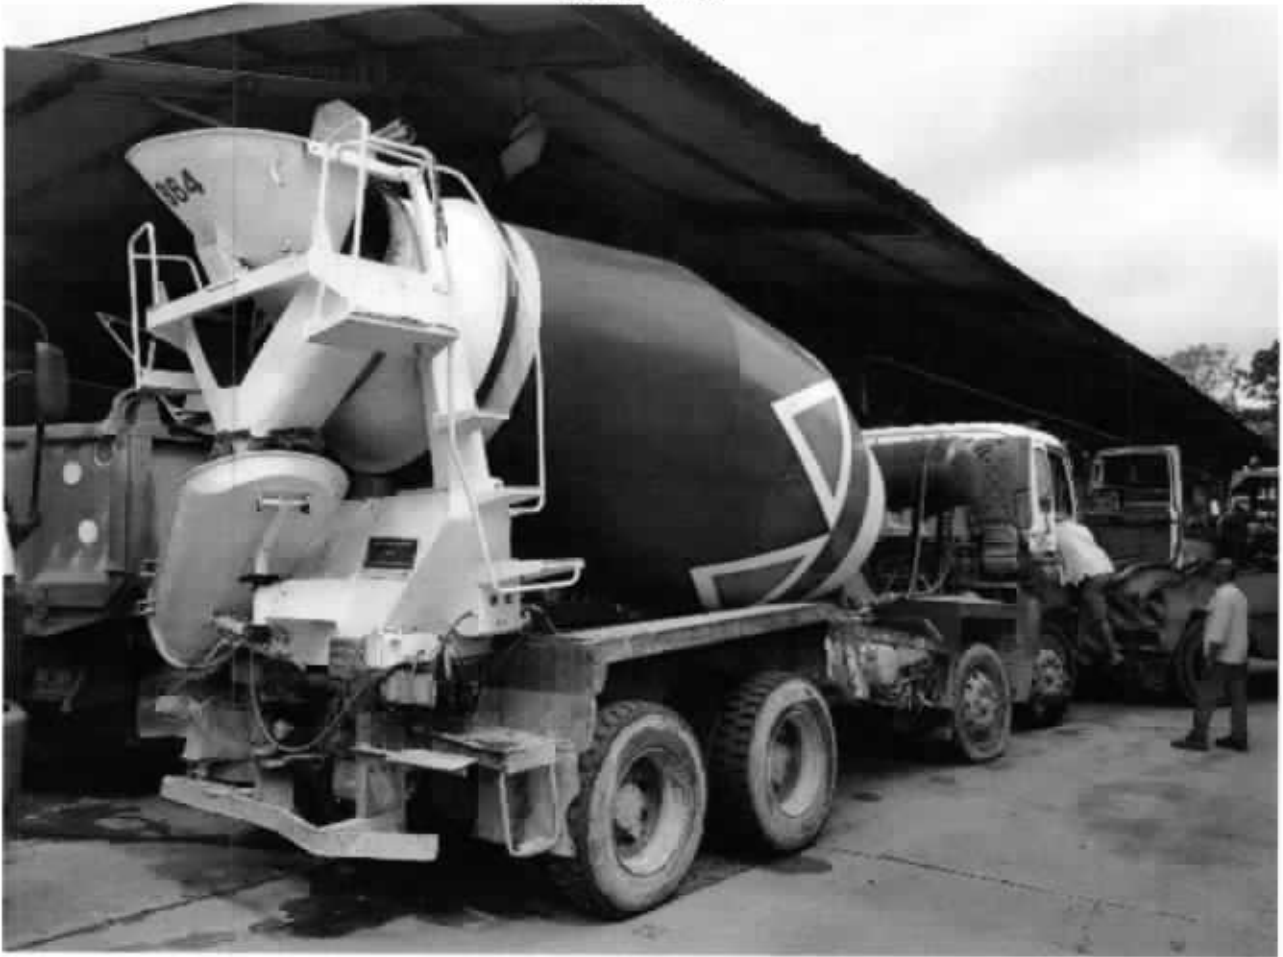
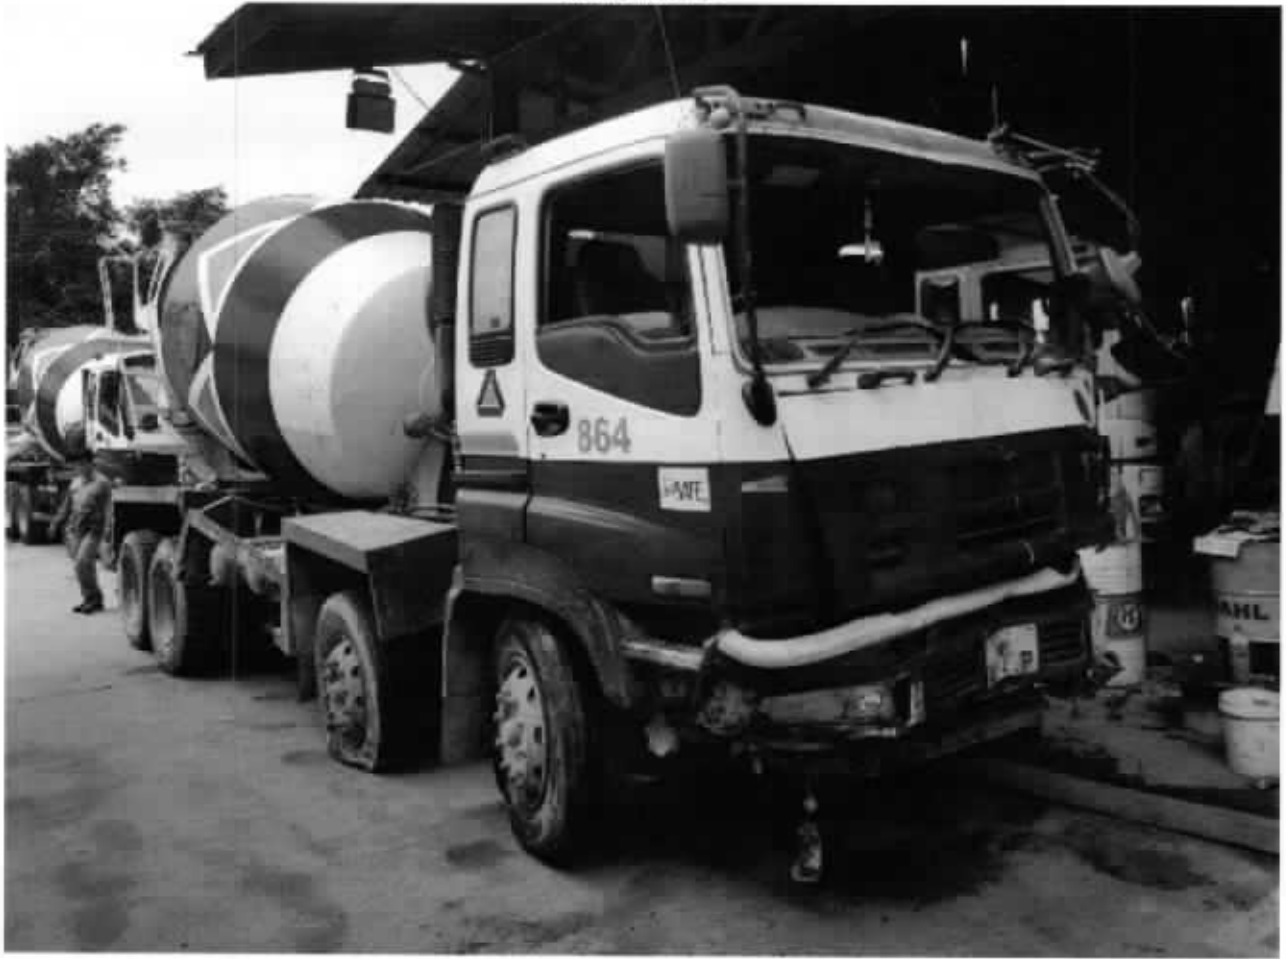
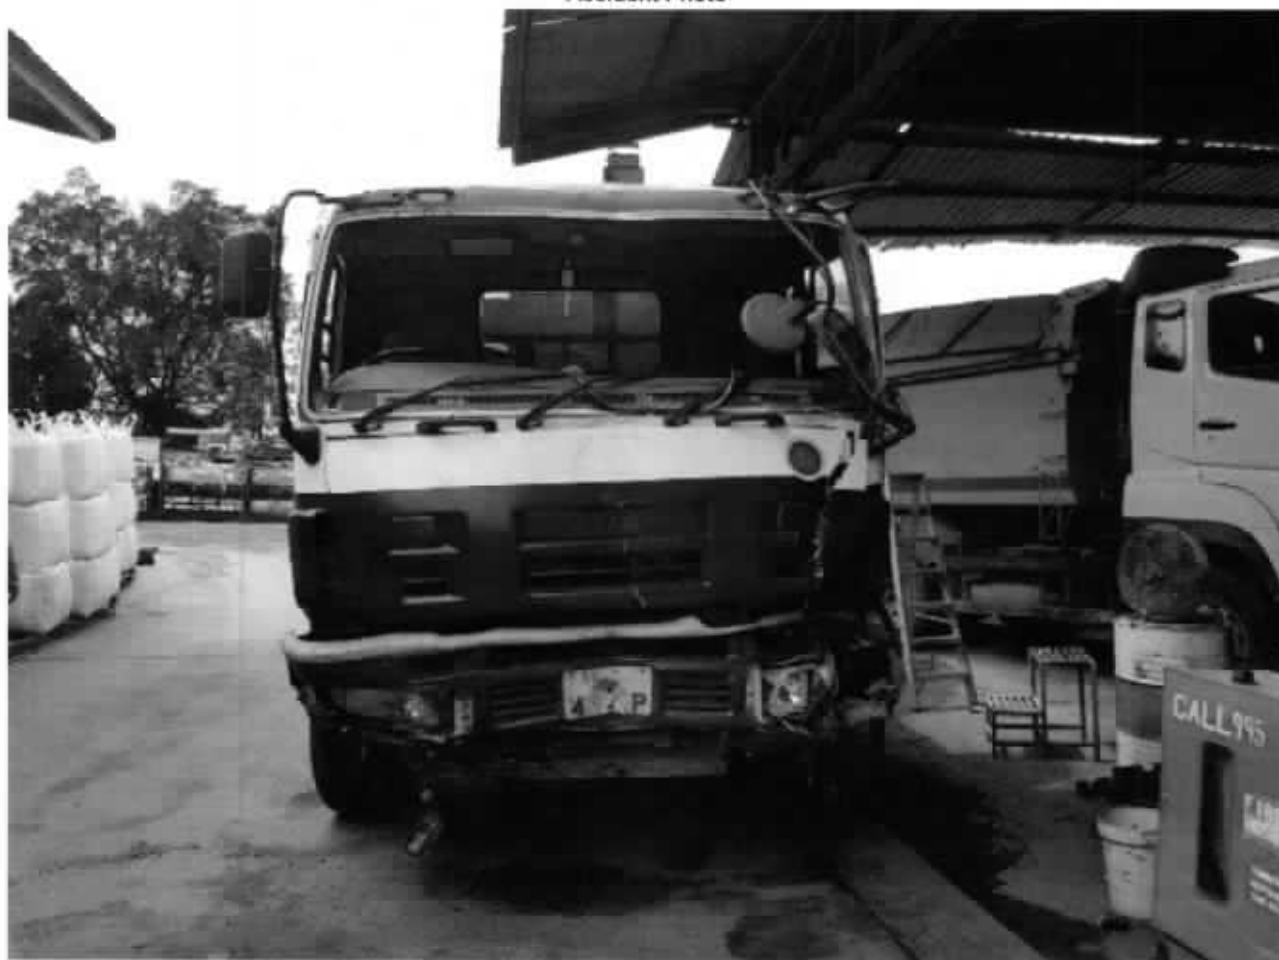
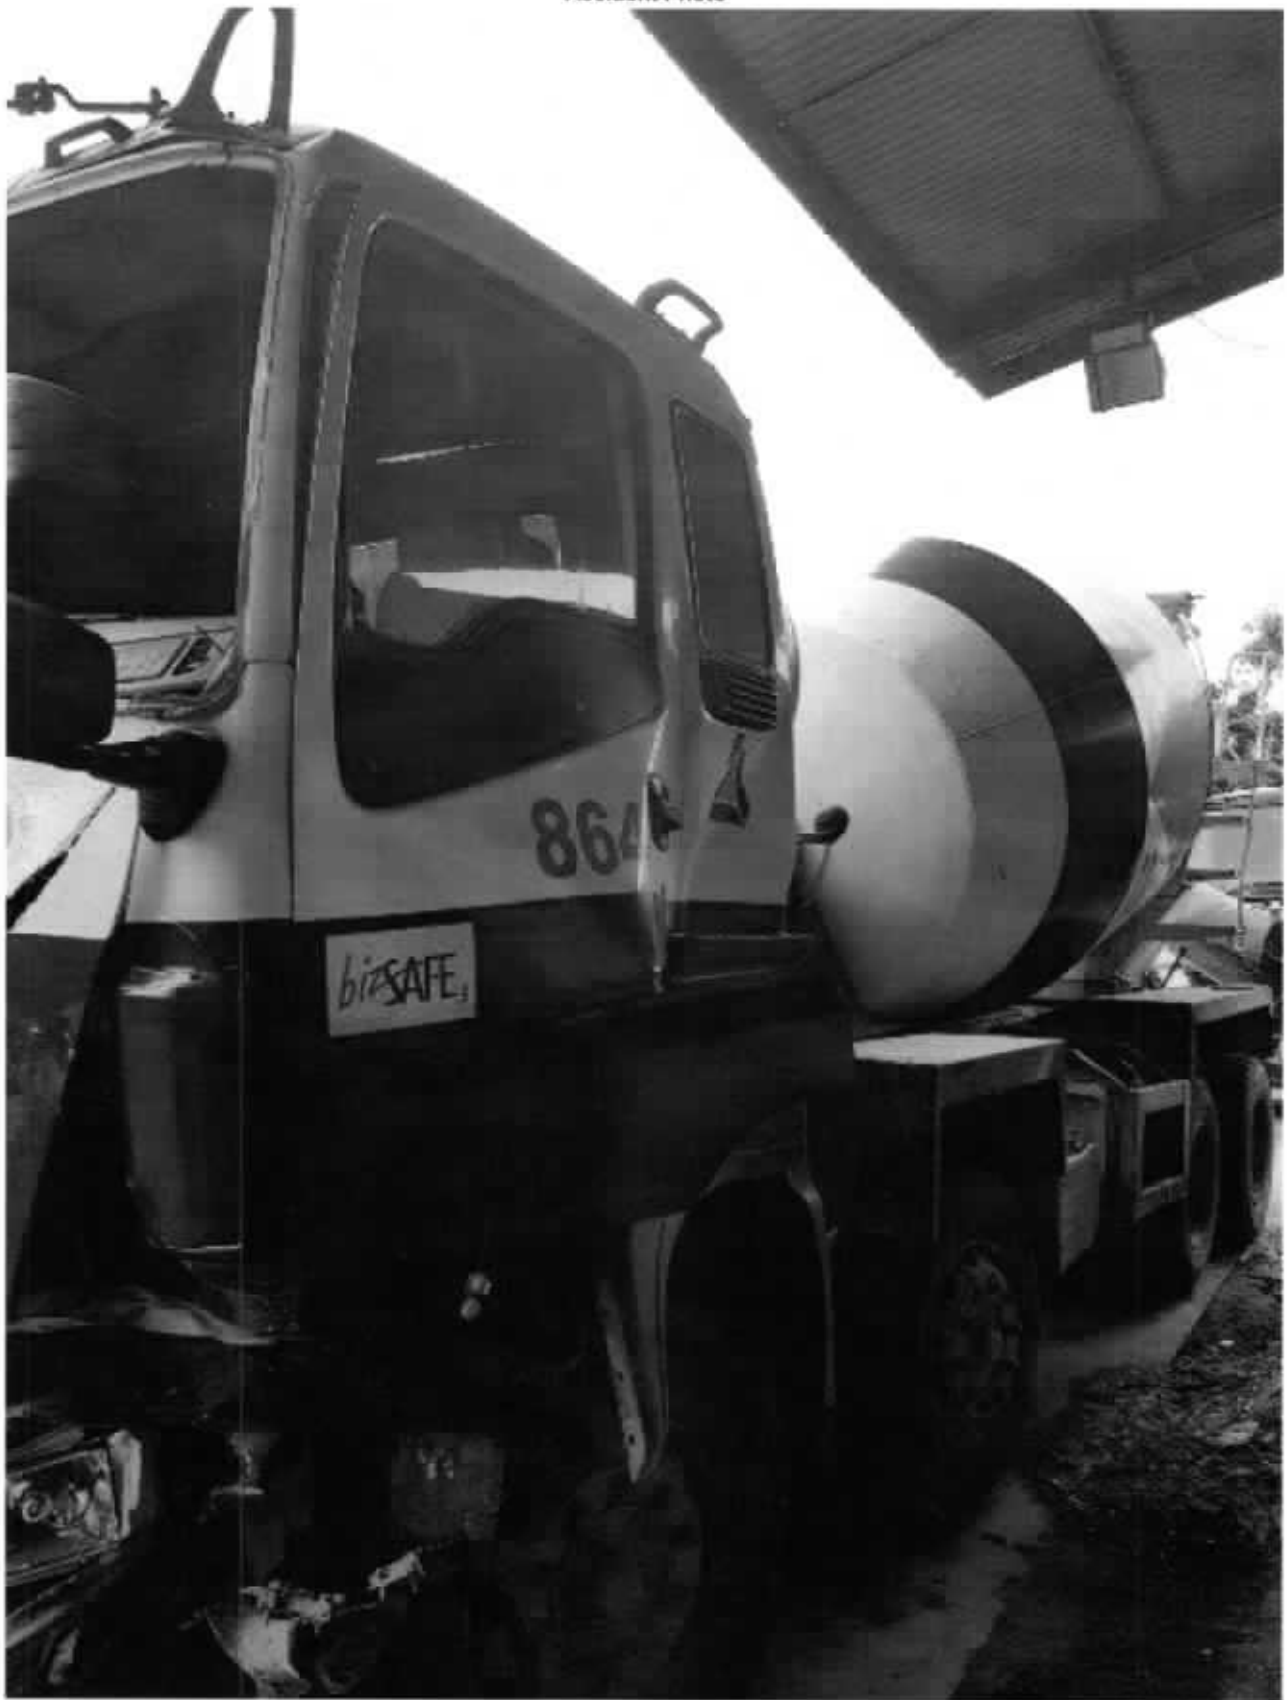
Accident Photo

The U/C / Chassis frame / Body Structure affected due to collision.

The vehicle sustained impact / damages front portion, o/s body, n/s body and parts claimed are consistent to the accident. The undercarriage affected due to collision.

- ( X ) The vehicle is repairable at our adjusted amount. We have also confirmed excess and policy coverage. Kindly let us have your authorisation.
- ( ) The vehicle is uneconomical to be repaired, you are advised to invite tender for the wreck.
- ( X ) Other comments : The vehicle repair on lumpsum basis.
