Preliminary Advice

Insured Vehicle No	: SLR701Z	Accident Date	: 10/07/2018
TP Vehicle No	: SHD1576H	Assignment Date	: 11/07/2018
Make	: HYUNDAI I30 GDH	Est. Duration of Repair	: 4.00
Date of Inspection	: 11/07/2018		
Inspection At	: PREMIER TAXIS PTE LTD - CHANGI (HQ) 23 CHANGI SOUTH AVE 2 #03-02 SINGAPORE 486443

VEHICLE DAMAGE INSPECTION REPORT

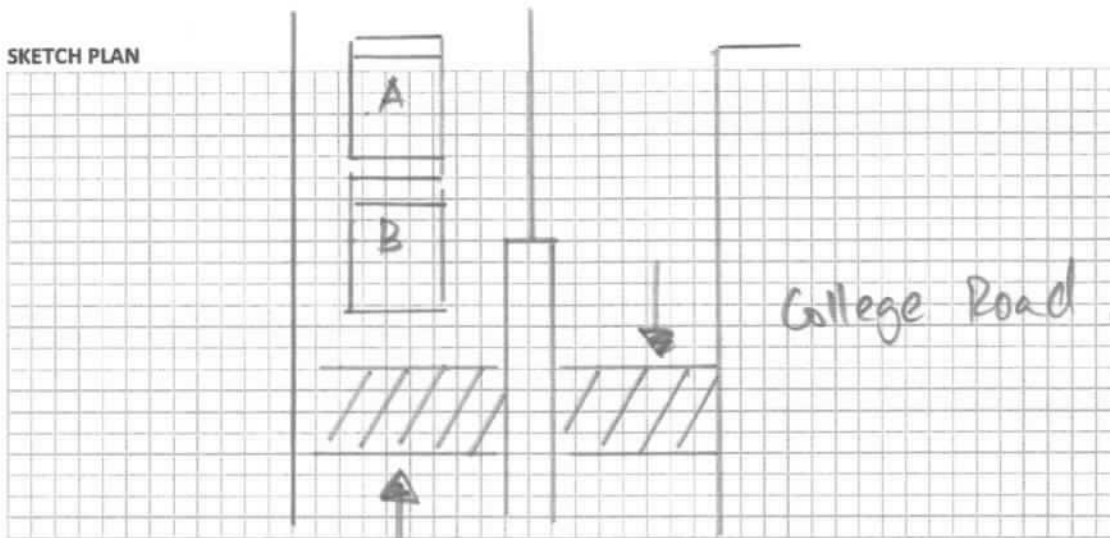
SKETCH PLAN

DESCRIBE CIRCUMSTANCES OF THE ACCIDENT

A: SHD 1576 H

B: SLR 7012

ON 10/07/2018 @ 0725HRS, I WAS DRIVING MY TAXI (SHD 1576 H)
TRAVELLING ALONG COLLEGE ROAD WITH A PASSENGER ONBOARD – ON A
SINGLE LANE OF DUAL CARRIAGE WAY.

I SLOWED DOWN MY TAXI ALMOST TO A STOP AS VEHICLES AHEAD WERE
SLOWING DOWN.

SUDDENLY I FELT AN IMPACT FROM THE REAR.

WHEN INSPECTED, I DISCOVERED THAT VEHICLE B (SLR 701 Z – VOLKS)
WHICH WAS BEHIND ME, HAD COLLIDED ONTO THE REAR OF MY TAXI.

DUE TO THE IMPACT, MY TAXI HAD DAMAGES ON THE REAR PORTION AND VEHICLE
B HAD DAMAGES ON THE FRONT PORTION.

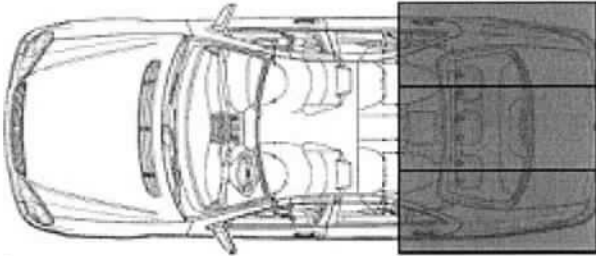
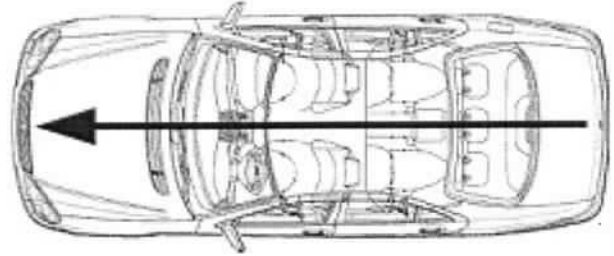
Pre-Accident Condition:	Severity of Impact:	
Steering:	Vehicle Status on Inspection:	
Brakes Pedal Travel:	Date of Inspection:	11/07/2018
Place of Inspection:		
Pre-Accident Damage:		
Tyres Condition:		
Tread Depth LHF:	Tread Depth RHF:	
Tread Depth LHR:	Tread Depth RHR:	
Damage Areas:	Direction of Impact:
