VEHICLE INSPECTION REPORT

Report No.: PAS/TP/0501217

Vehicle Registration No. : SLV57D
Make & Model : Audi A8L 3.0 TFSI QU
Date of Registration : 29/08/2012
Colour : Black

APPRAISEMENT SCHEDULE

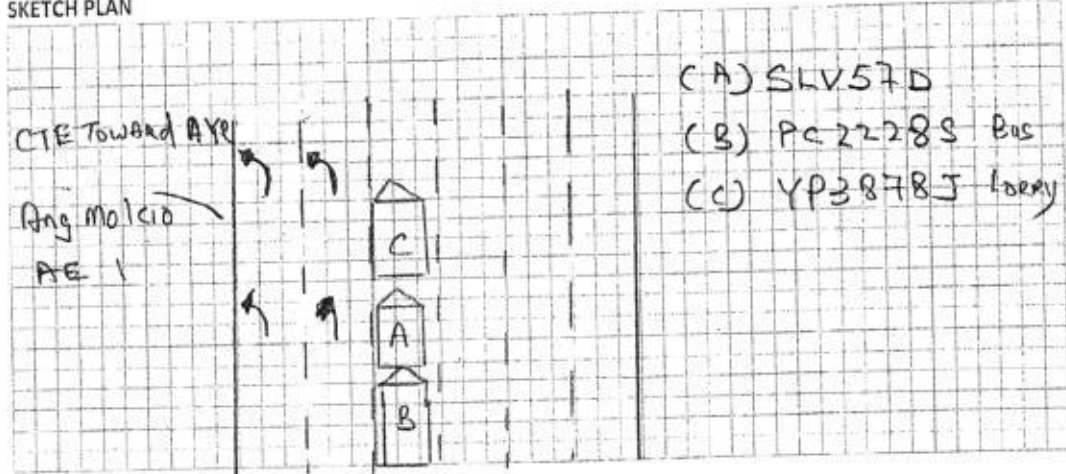
SKETCH PLAN

I was driving along CTE(AYE). I was in the second lane. Suddenly, the lorry in front of me braked to a stop. I was able to stop in time behind it. However, I was hit in the back by a bus. The impact forced my car forward, causing it to hit the lorry in front.

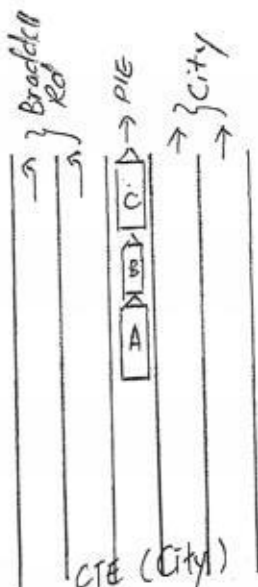
SKETCH PLAN

A: PC33285

B: SLV 57D

On 26/12/2017 @ about 11:40 hrs, my vehicle (A) was travelling along CTE (City) with about 20 passengers on board. While approaching near to Braddell exit, my vehicle was queuing along the lane heading to PIE and all of the vehicles were moving on & off. Suddenly veh C jam brake, and my vehicle (A) ~~was~~ could not stop in time and hit onto veh B rear portion. then veh B surged forward to hit veh C. rear portion. Veh A and B had moderate damage and veh C had minor damage. No injury involved in the accident.

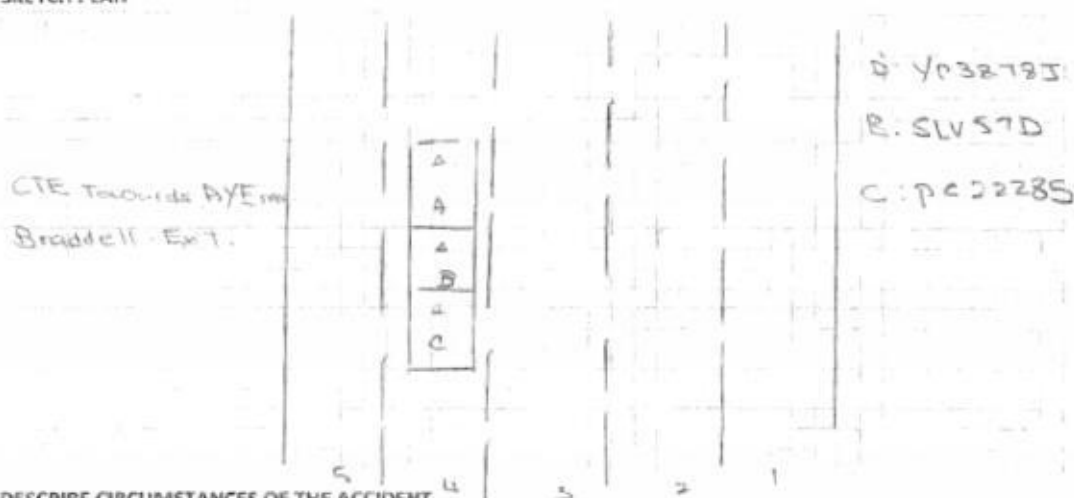
SKETCH PLAN

On 26/12/2017 at about 11:50am I was traveling along CTE Towards AYE near Braddell Exit.
