Preliminary Advice

VEHICLE DAMAGE INSPECTION REPORT

Our File No: CS/MSG18012790/KSD3N2

Handling Insurer:	MSIG Insurance (Singapore) Pte. Ltd.	Policy No:	B28884730QMY
Claimant Vehicle No :	SJG5003D	Insured Vehicle No :	SLK7578D
Date of Loss:	06/07/2018	Nature of Claim:	TP
		Claim No:	564507

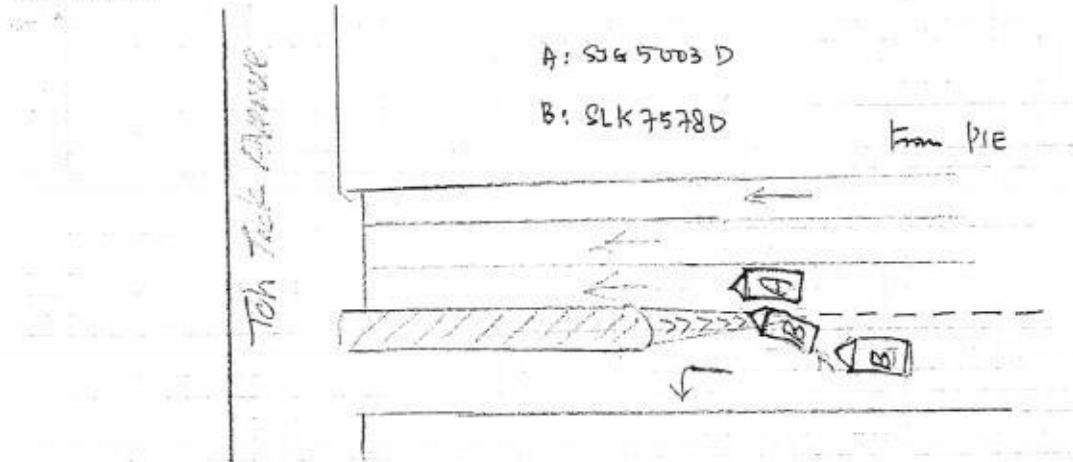
SKETCH PLAN

I was driving slowly from PIE after lane towards Toh Tuck Ave. Vehicle B towards the end of the chevron cut into my lane and hit my vehicle. There was a witness standing there because of his car breakdown and he took the photos immediately of accident happen.
