VEHICLE DAMAGE INSPECTION REPORT

Our File No: CS/CTI18012820/USD3N2
Date: 30/07/2018

Handling Insurer:	China Taiping Insurance (Singapore) Pte. Ltd.	Policy No:	DMCVSN3047641700
Claimant Vehicle No :	SJN1543B	Insured Vehicle No :	GBC5069E
Date of Loss:	13/07/2018	Nature of Claim:	TP
		Claim No:	SNM18D03452C02

Reg No:	SJN1543B	Engine No:	R18A13800779
Make & Model:	HONDA STREAM, 1.8 L RSZ (A)	Chassis No:	JHMRN68809S200769
Reg. Date:	05/02/2009 (Man. Year: 2008)	Odometer:	176414 km
Colour:	Brown		
Engine Capacity:	1799 cc		
Market Value/New Car Price:	N/A		
Sum Insured (\$\$):	Market Value/New Car Price

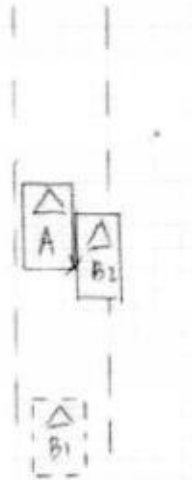
SKETCH PLAN

Vehicle A: SN1543B

Vehicle B: GBL5069E

PIE (Change), before Centre Ave Exit

On the stated date & time, I vehicle A, SN1543B, was travelling along the stated route I slowed down and came to a complete stop. Suddenly, vehicle B, GBL5069E, tried to overtake me, and grazed into my vehicle's rear right portion.
