Affiliated to Federation Internationale Des Experts En Automobile			
AIG ASIA PACIFIC INSURANCE PTE LTD		Ref : CC6/AIG18012833/Ajb3	
78 SHENTON WAY #08-16 CHARTIS BUILDING SINGAPORE 079120		Date : 16-07-2018	 
		Code : AIG

Estimated repair cost for vehicle no: SLK7583M NISSAN QASHQAI 1.2 A '17

RE: ACCIDENT INVOLVING SLK7583M & SJY4451E AT MAXWELL X WALlich ST ON 12.07.2018, 21:30HRS

VEHICLE DAMAGE INSPECTION REPORT

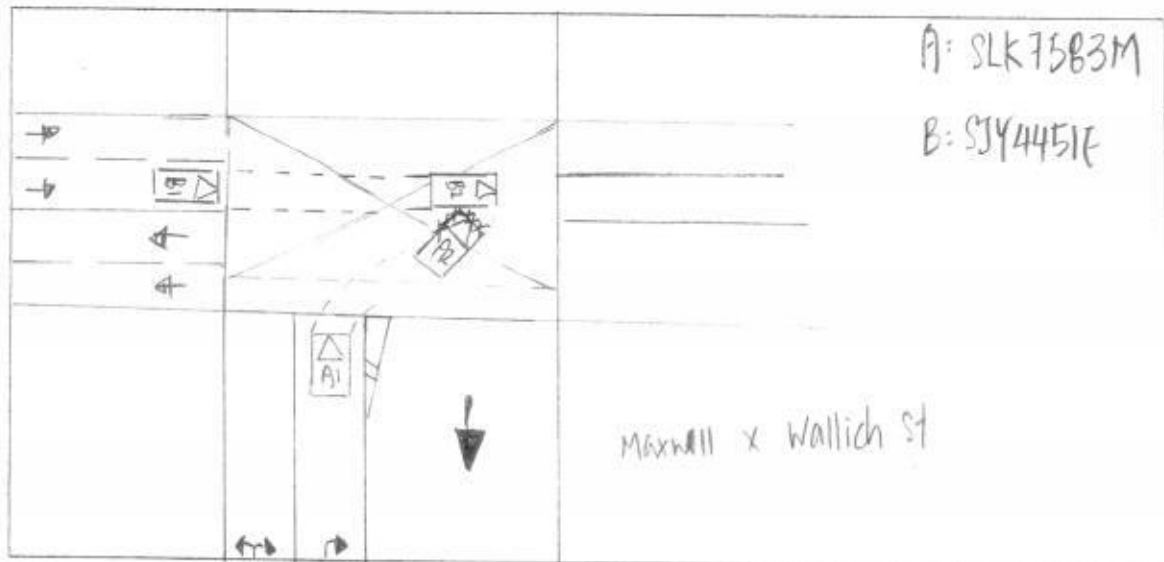
SKETCH PLAN

I was driving along maxwell x wallich st at extreme RH lane of 2 lanes.

After traffic light turned green in my favor, I proceed turned RH. Suddenly, vch "B" from my left beat the traffic light and ^{the} collided into front & front LH side of my vehicle.
