GBF 7430R

Nissan Cabstar.

Re: Accident involving motor vehicle Nos. GBF 7430R and GBH 1982T
along Woodlands Avenue 12 towards Gambas (After Woodlands Ave 5) on 17/07/2018

VEHICLE DAMAGE INSPECTION REPORT

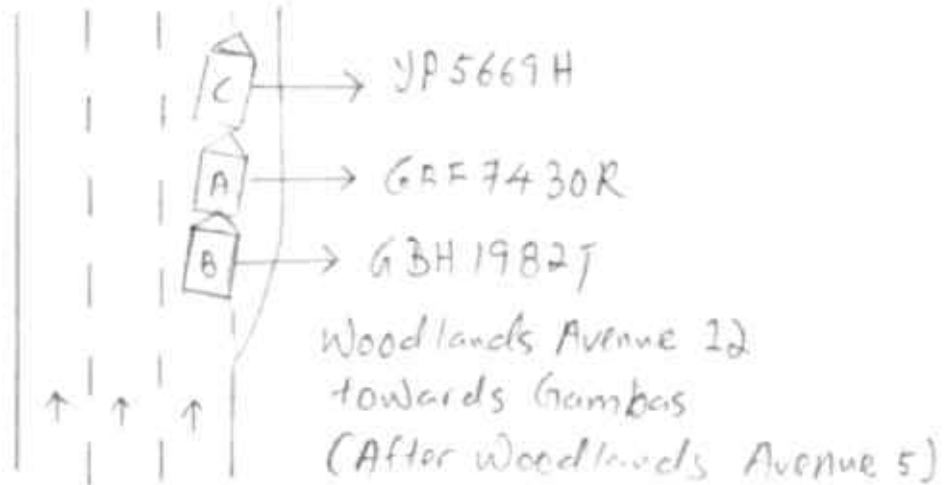
SKETCH PLAN

On 17.07.18 at about 16:20 hours at Woodlands Avenue 12 towards Gambas (After woodlands Avenue 5). While I was travelling on the right lane, traffic was slow moving.

Suddenly I heard a loud bang from behind and the impact forced my vehicle (A) to move forward, I tried to avoid hitting onto the vehicle (C) and immediately turned my steering to right, but unfortunately the great impact caused my vehicle (A) front left portion hit onto rear right portion of vehicle (C). When I alighted I realise it was vehicle (B) hit onto my rear portion causing damages on my vehicle (A) front left hand side and rear portion.

It was a chain collision of total 3 vehicles involved and I have one passenger inside my vehicle (A).
