ASSIGNMENT (Office)

To Inspect Vehicle No:

SKX 5610A

## VEHICLE DAMAGE INSPECTION REPORT

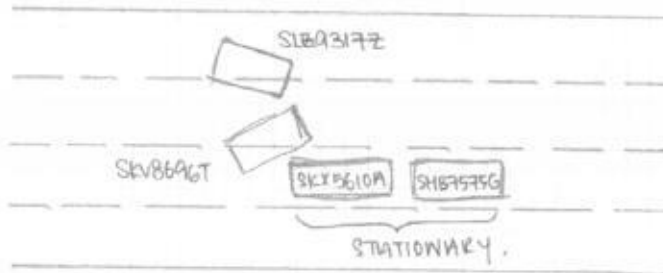
### SKETCH PLAN

| <p>I was waiting at the traffic light when suddenly SKV8696T hit my vehicle from the side. SKV8696T was pushed by SLB9317Z into my lane and caused damage on my vehicle as well as the taxi in front of me. There was no injury. Please refer to my in car camera footage.</p> | |
