Affiliated to Federation Internationale Des Experts En Automobile				
LONPAC INSURANCE BHD 300 BEACH ROAD #17-04/07 THE CONCOURSE SINGAPORE 199555			Ref: CC4/LPC18013411/Krs3q2	
			Date: 11/03/2021	
			Code: LPC2

ADJUSTMENT ON REPAIR COST FOR VEHICLE NO. SLF 2707H

PHOTOGRAPHS FOR VEHICLE NO. SLF 2707H

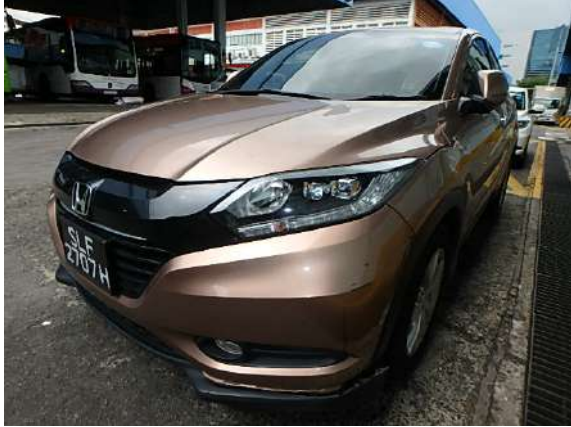
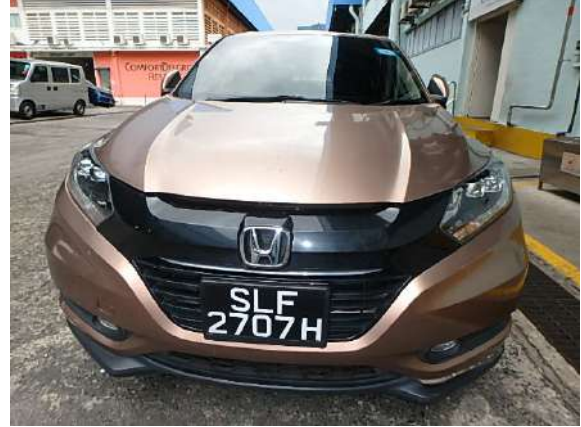
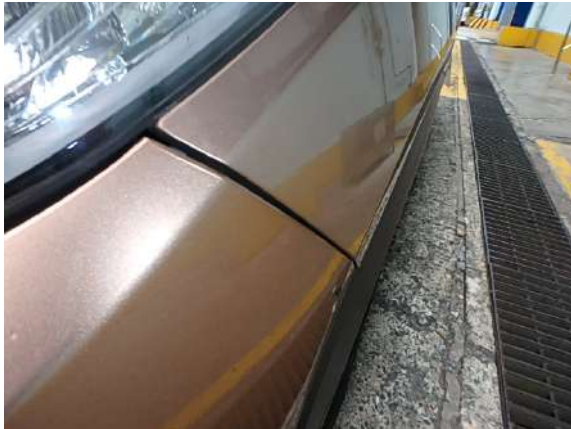
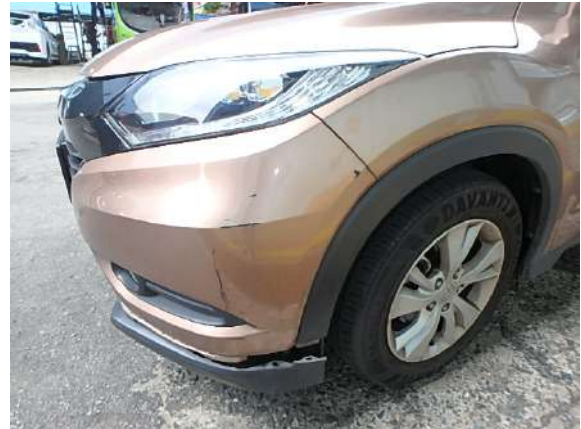
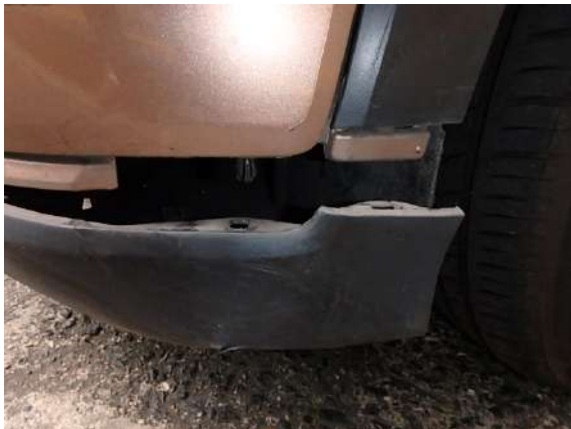
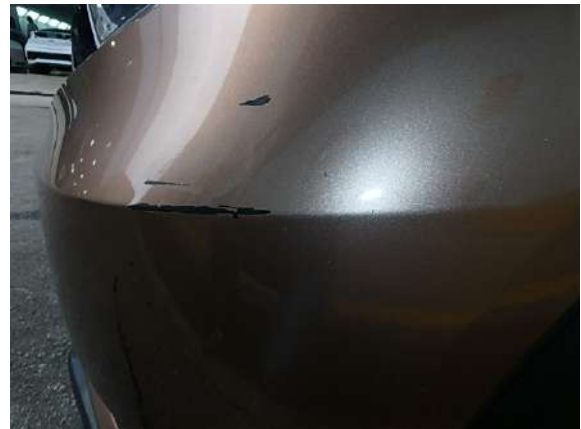
4. Description of Damages				
THE VEHICLE SUSTAINED DAMAGES AT THE N/S FRONT PORTION. DAMAGES SEE DETAILS.				
5. General Information				
Accident Date	05/07/2018	Inspection Date	25/07/2018	
Survey held at	COMFORTDELGRO ENGINEERING PTE LTD 205 BRADDELL ROAD Blk C, 3rd Floor SINGAPORE 579701.			
5a. Remarks
