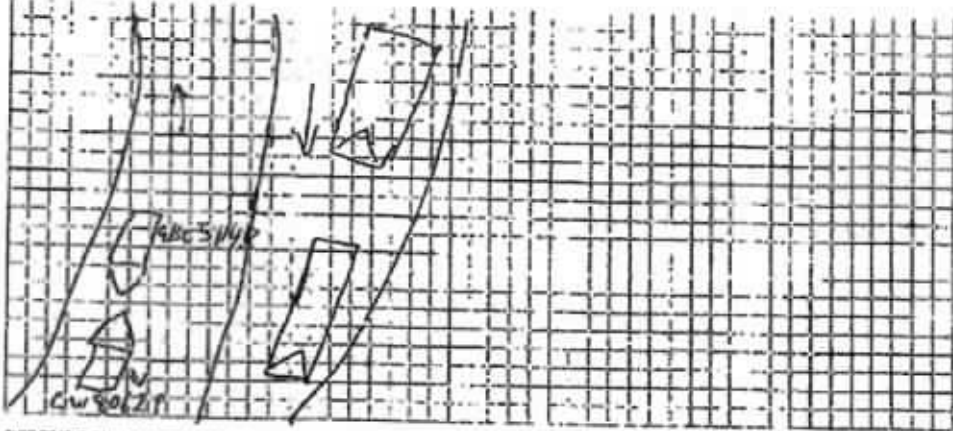
SKETCH PLAN

When going up the ramp, I took a left sharp turn. Then the van was going down the ramp very fast on my lane. When I saw him I stop and he hit my vehicle head on the left.

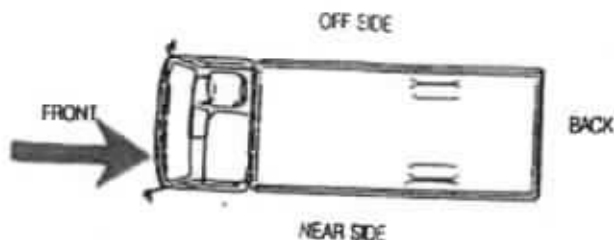
Direction of Impact (→)

Damages sustained were consistent with the subject vehicle being involved in a collision with another vehicle and the impact was delivered onto the front n/s portion of the vehicle.

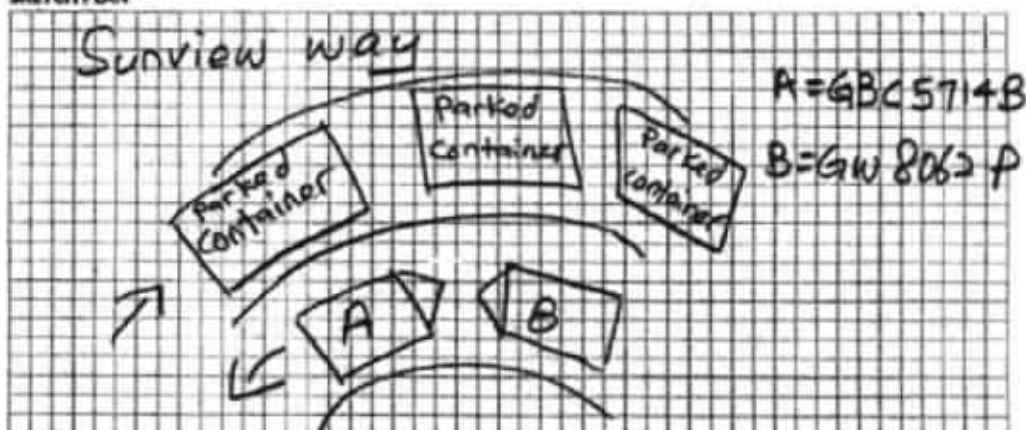
SKETCH PLAN

At the date 28/05/2018 at about 1543 hrs along sunview way. I was driving my vehicle A (GBC 5714 B). At the sunview way, there have many parked container within my lane. I have no choice to choose the right lane. when I slowly to drive, there are vehicle B (GW 8062 P) coming forward. I accidentally collided the front of the vehicle B (GW 8062 P).
