PRE-REPAIR INSPECTION REPORT				
ERGO INSURANCE PTE LTD		Ref: CS3/EGI18013702/T1z4d3e2		
5 TEMASEK BOULEVARD #04-01 SUNTEC TOWER		Date: 03-08-2018		
FIVE SINGAPORE 038985

1. Policy Particulars :- (THIRD PARTY CLAIM)				
Insured Veh.	YN 5405M	Veh. Inspected	YN 3089E	
Policy No.		Coverage (\$)	0.00	
Claim No.	DSMCH1801176	Excess (\$)	0.00	
Assign From	YEE PEI LI	Assign Date	27/07/2018

2. Vehicle Particulars & Condition				
Make & Model	MITSUBISHI CANTER		c.c	2977
Engine No.	HIDDEN		Year of Reg.	2012
Chassis No.	FE83BEA20870		Colour	WHITE
Odometer	-		Steering	IN ORDER
Brakes	IN ORDER		Modification	NIL
General	GOOD

4. Description of Damages				
THE VEHICLE SUSTAINED DAMAGES AT THE FRONT AND REAR PORTION.

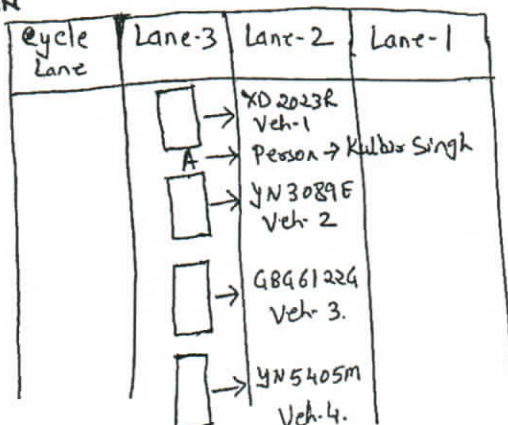
SKETCH PLAN

Vehicle 1 broke down at 6:25 pm on 20th June 2018 and came to a stationary position at Tanah Merah Coast Road Lamp post 506A Leftmost lane beside the designated cycling lane. Drivers of Vehicle 1 and 2 went to vehicle 1 to give assistance for repairs. Vehicle 2 was park stationary at the distance of 2 meter from Vehicle 1, Vehicle 3 was park stationary at the distance of 1.5 meters from vehicle-2. Behind Vehicle 3, we had placed 3 safety cones at the distance of 4 meters from Vehicle-3 and breakdown sign was placed after the traffic safety cones at another 2 meters distance apart for further safety measures. Our Company driver, Mr Kulbir Singh (A), who was driving XD 7413R, passed by the vehicle breakdown location.
