Affiliated to Federation Internationale Des Experts En Automobile			
INDIA INTERNATIONAL INSURANCE PL		Ref : CS/III18013780/Gtd3	
64 CECIL STREET #05-02 IOB BUILDING SINGAPORE 049711		Date : 30-07-2018	 
		Code : III2

1. Policy Particulars :- THIRD PARTY CLAIM			
Insured Veh.	SH 7153D	Veh. Inspected	FY 7340U
Policy No.		Coverage (\$)	0.00
Claim No.		Excess (\$)	0.00
Assign From	GABRIEL WEE	Assign Date	30/07/2018

VEHICLE DAMAGE INSPECTION REPORT

Date of Assignment: 30/07/2018
 Date Inspected: 30/07/2018 Inspected At: Gng Motor Trading (HQ)
 BLK 6 DEFU LANE 10 #01-564
 Singapore 539187
 Estimated Period of Repair: 2.0 days

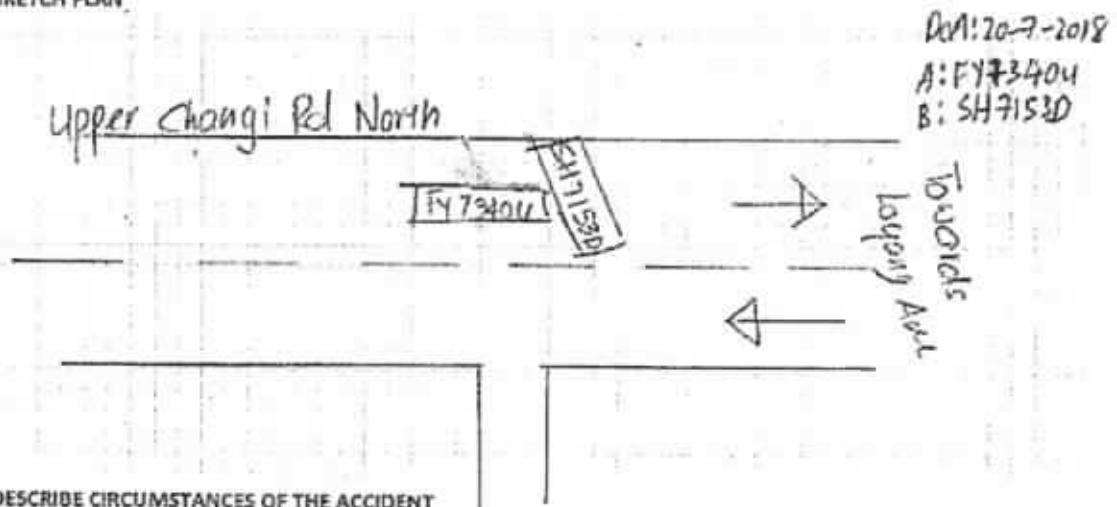
SKETCH PLAN

Please refer to Police Report No. T/20180720/2210.

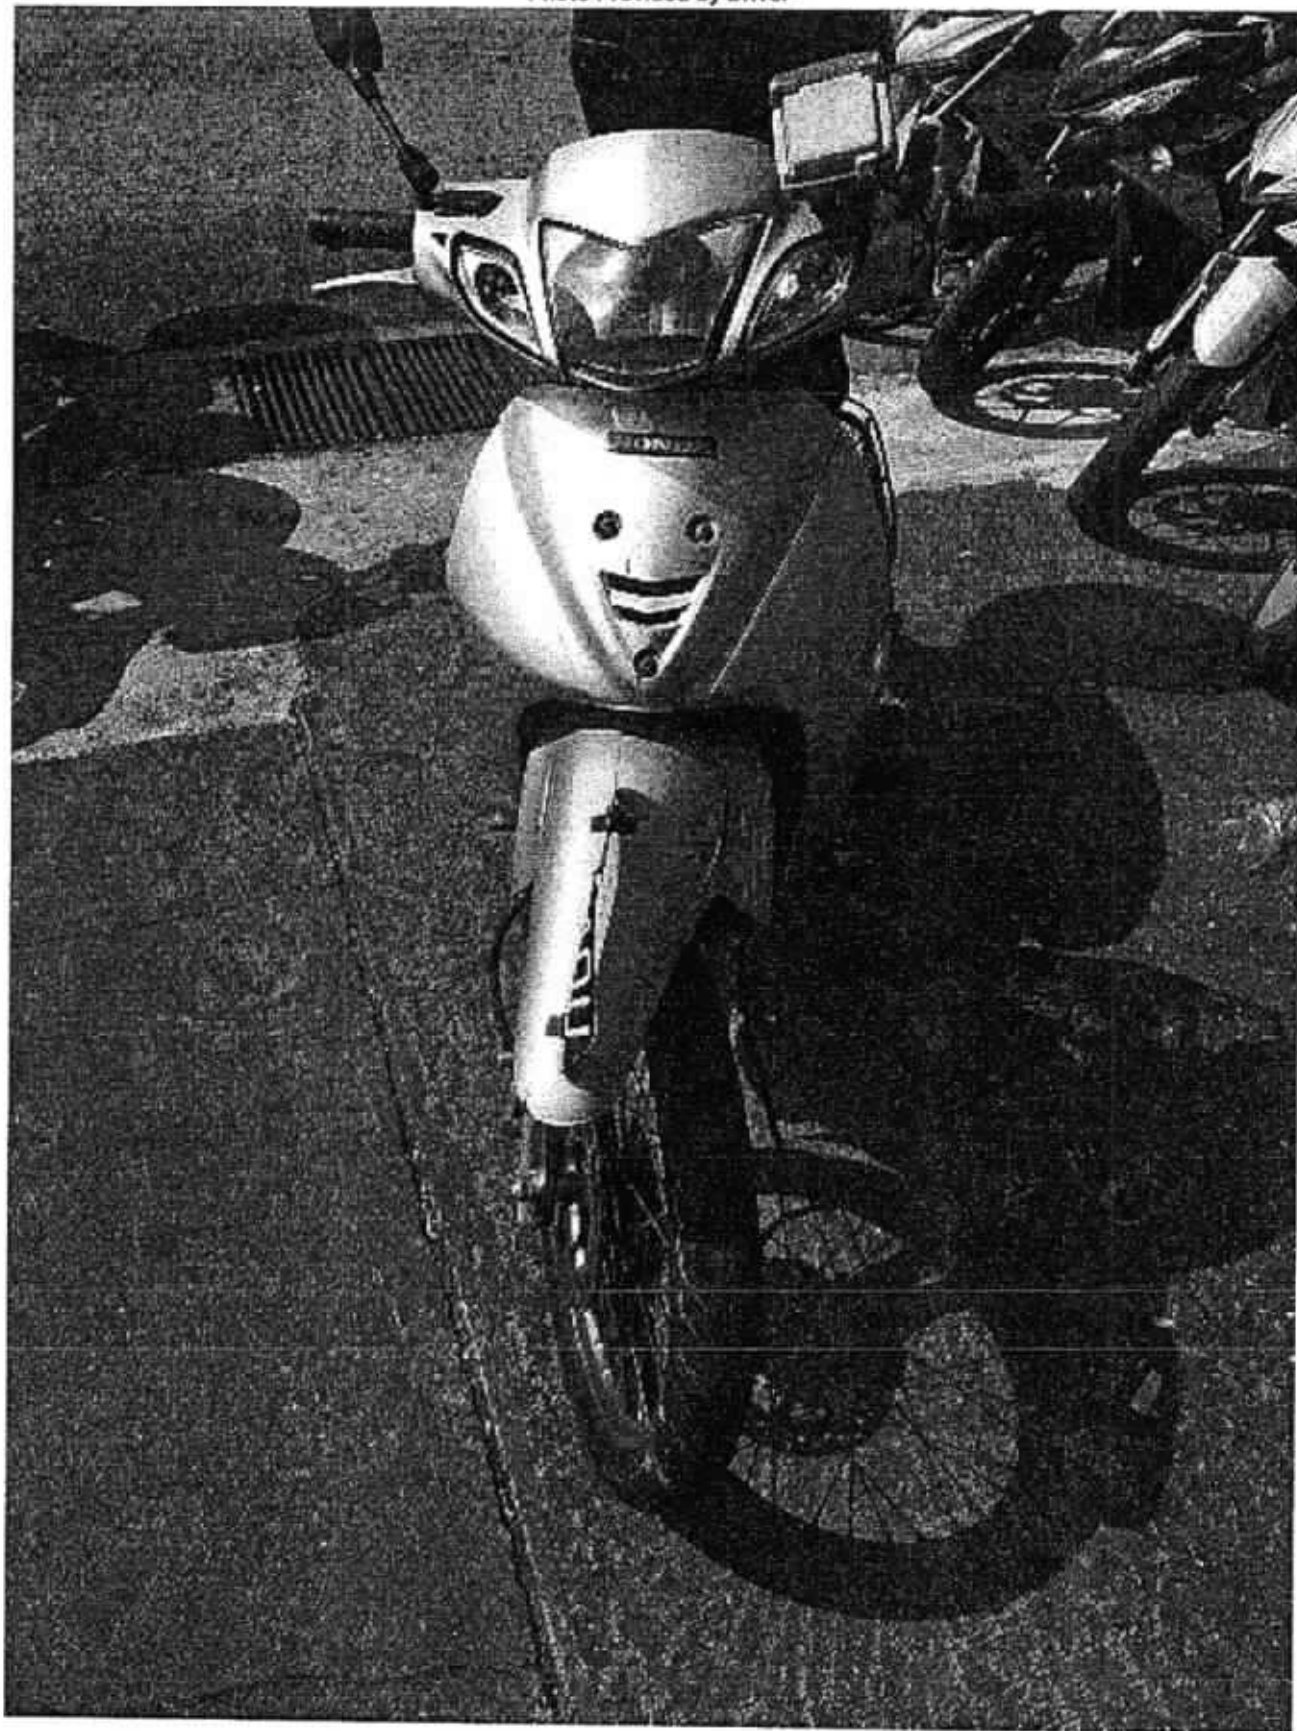
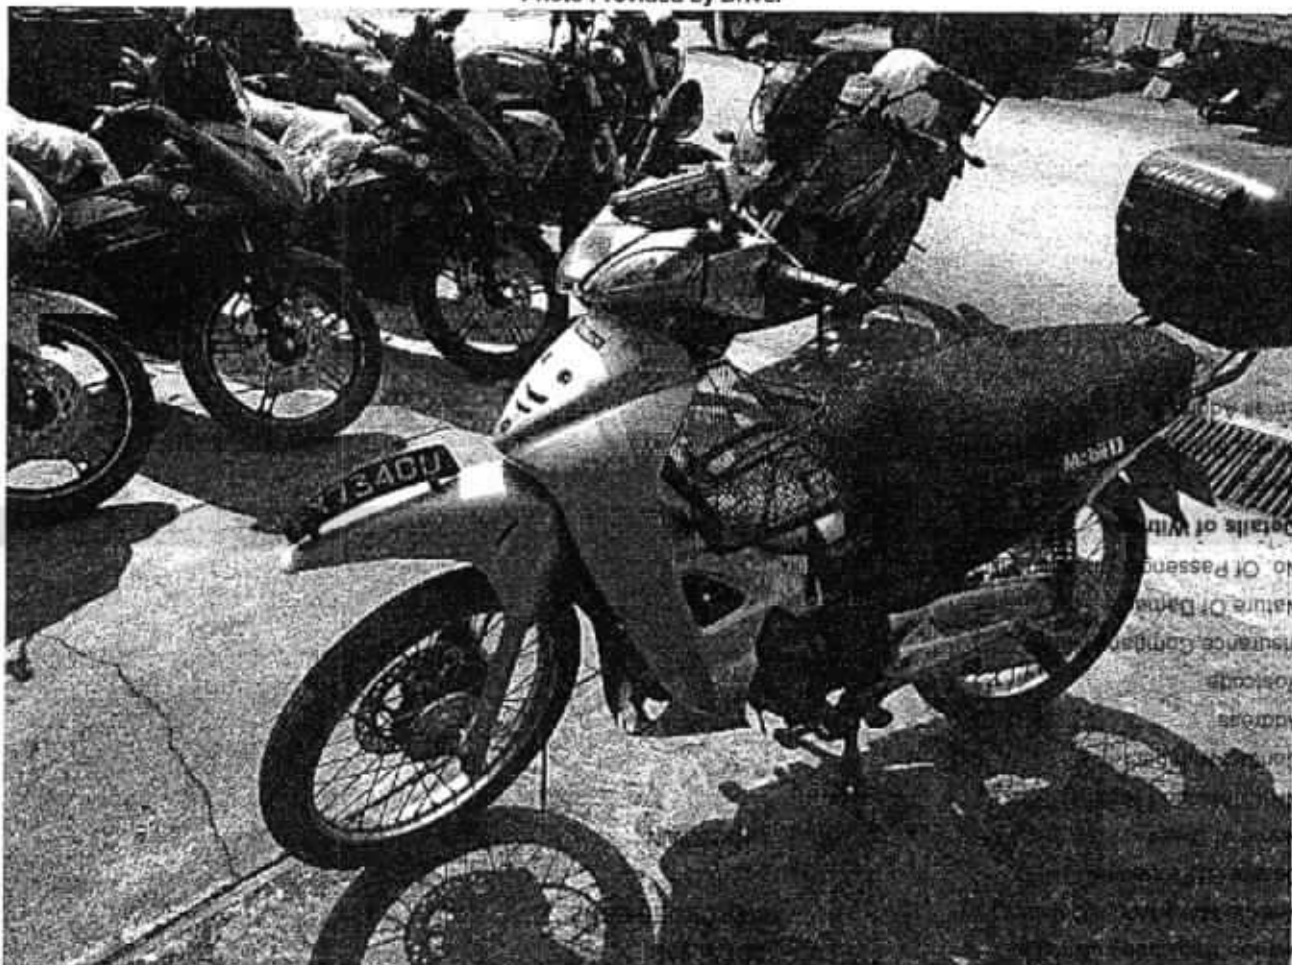
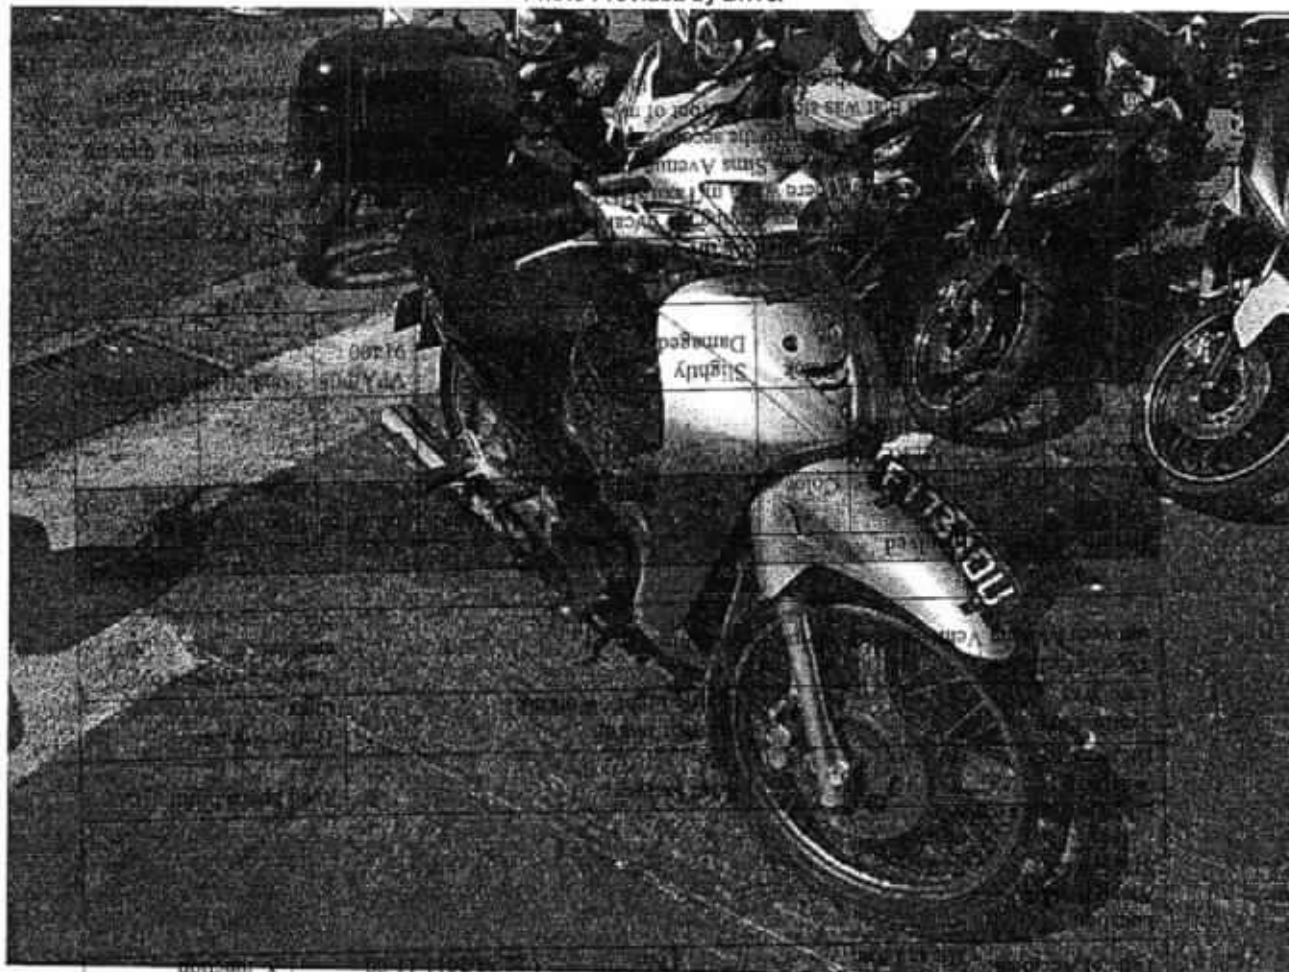
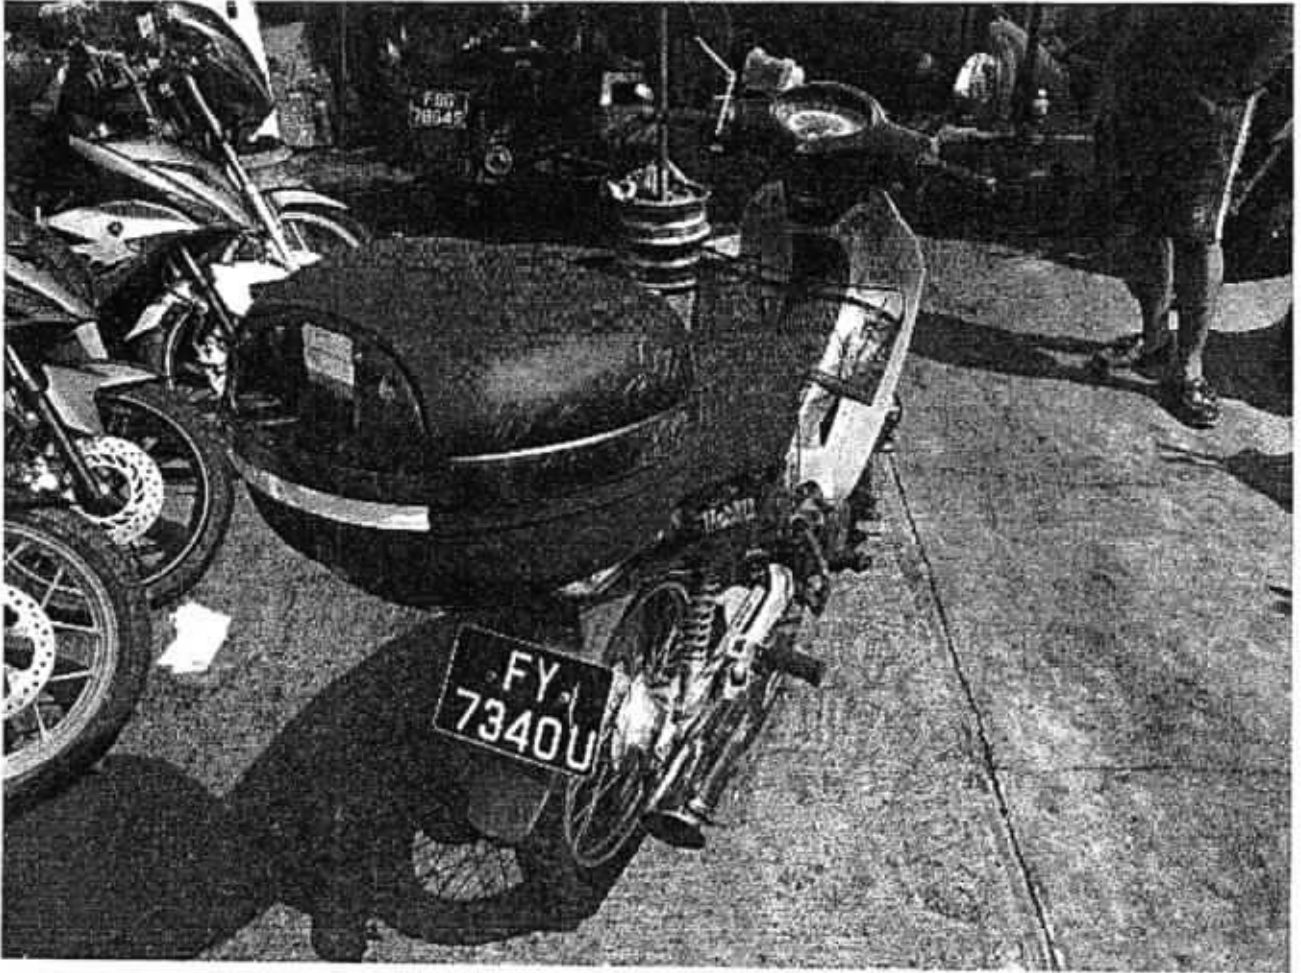
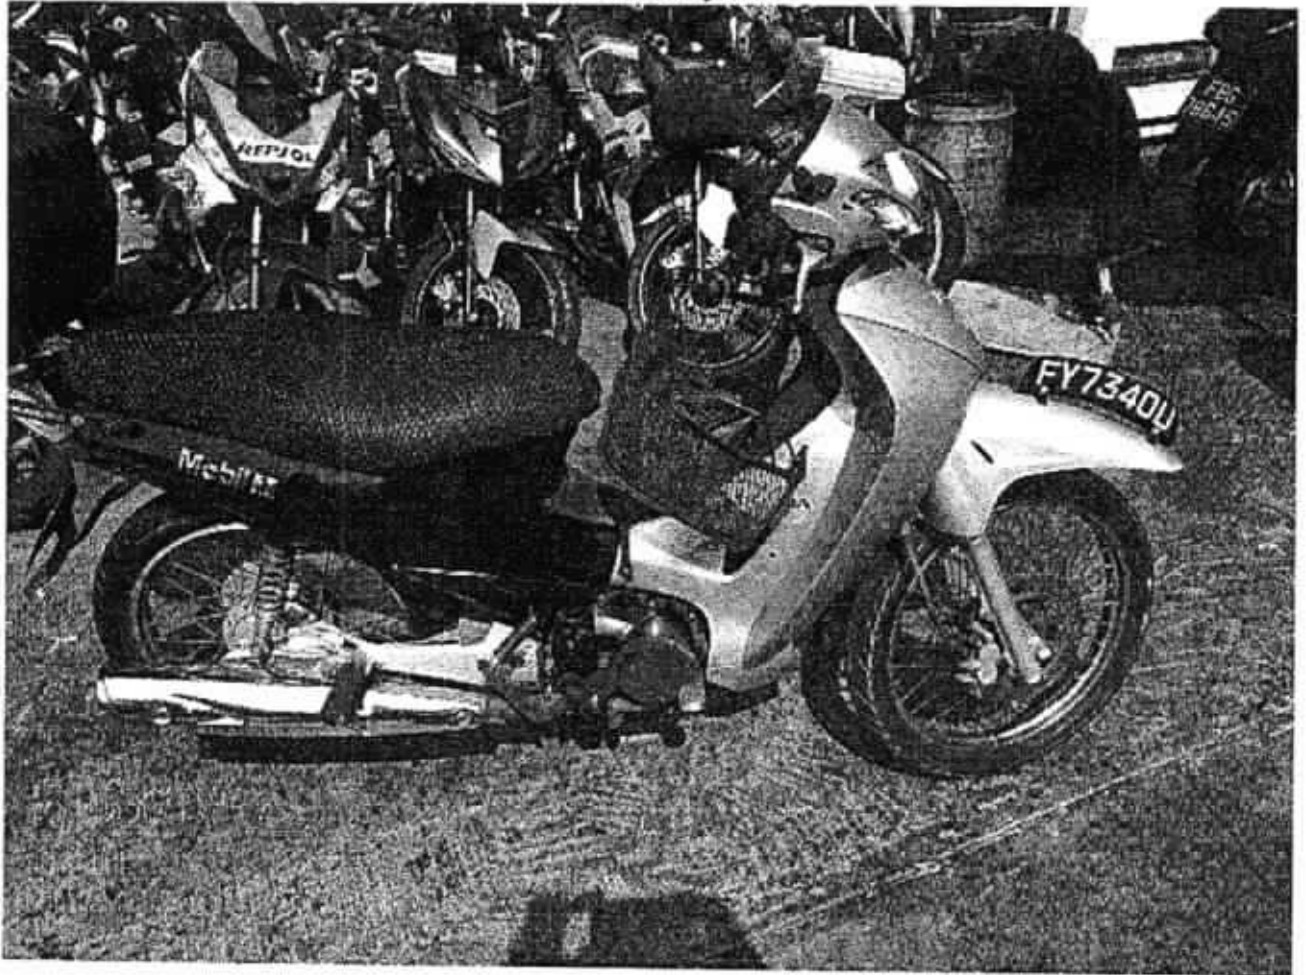
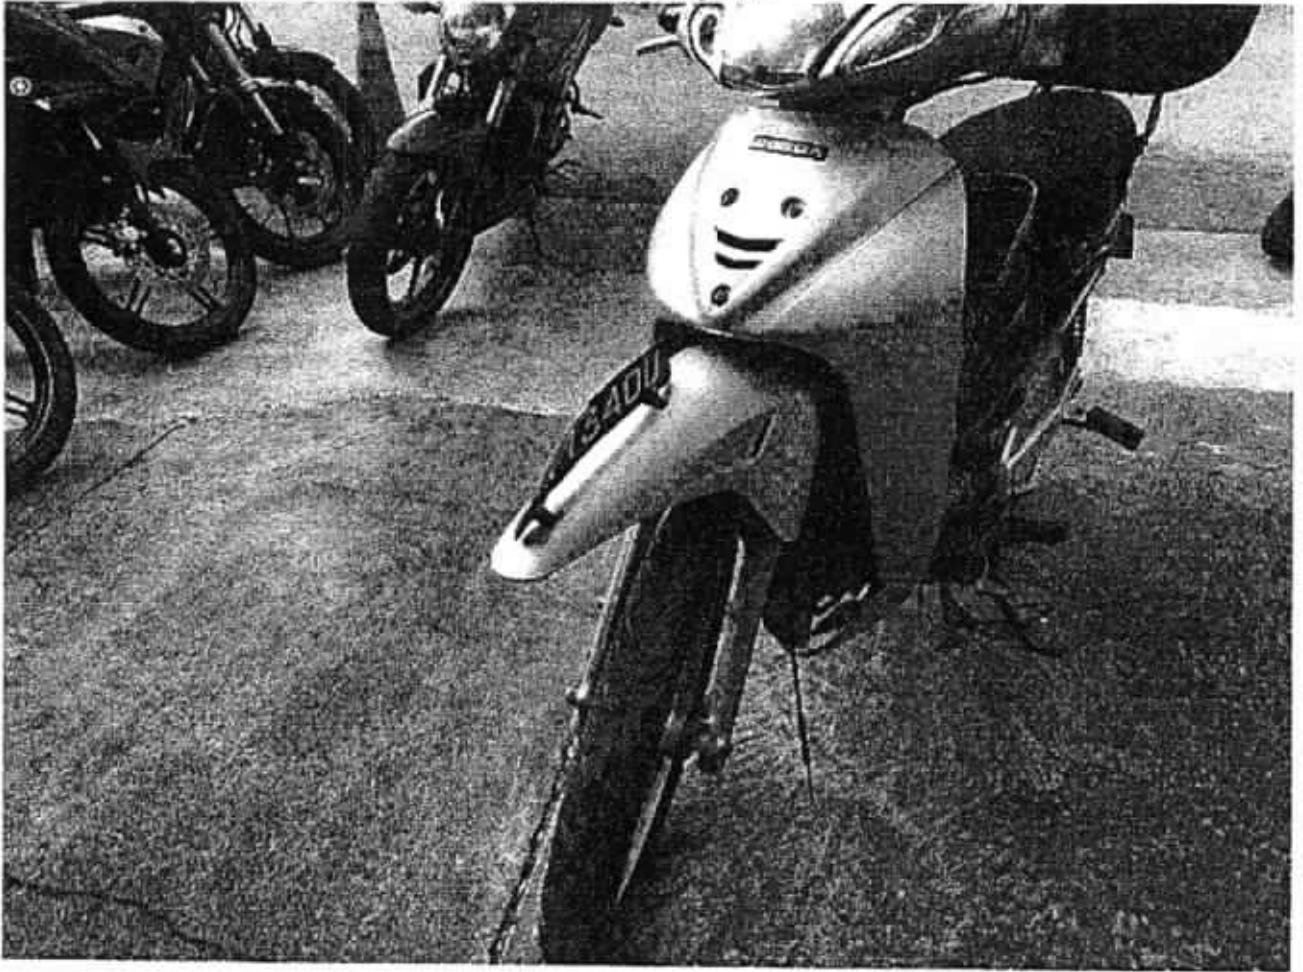
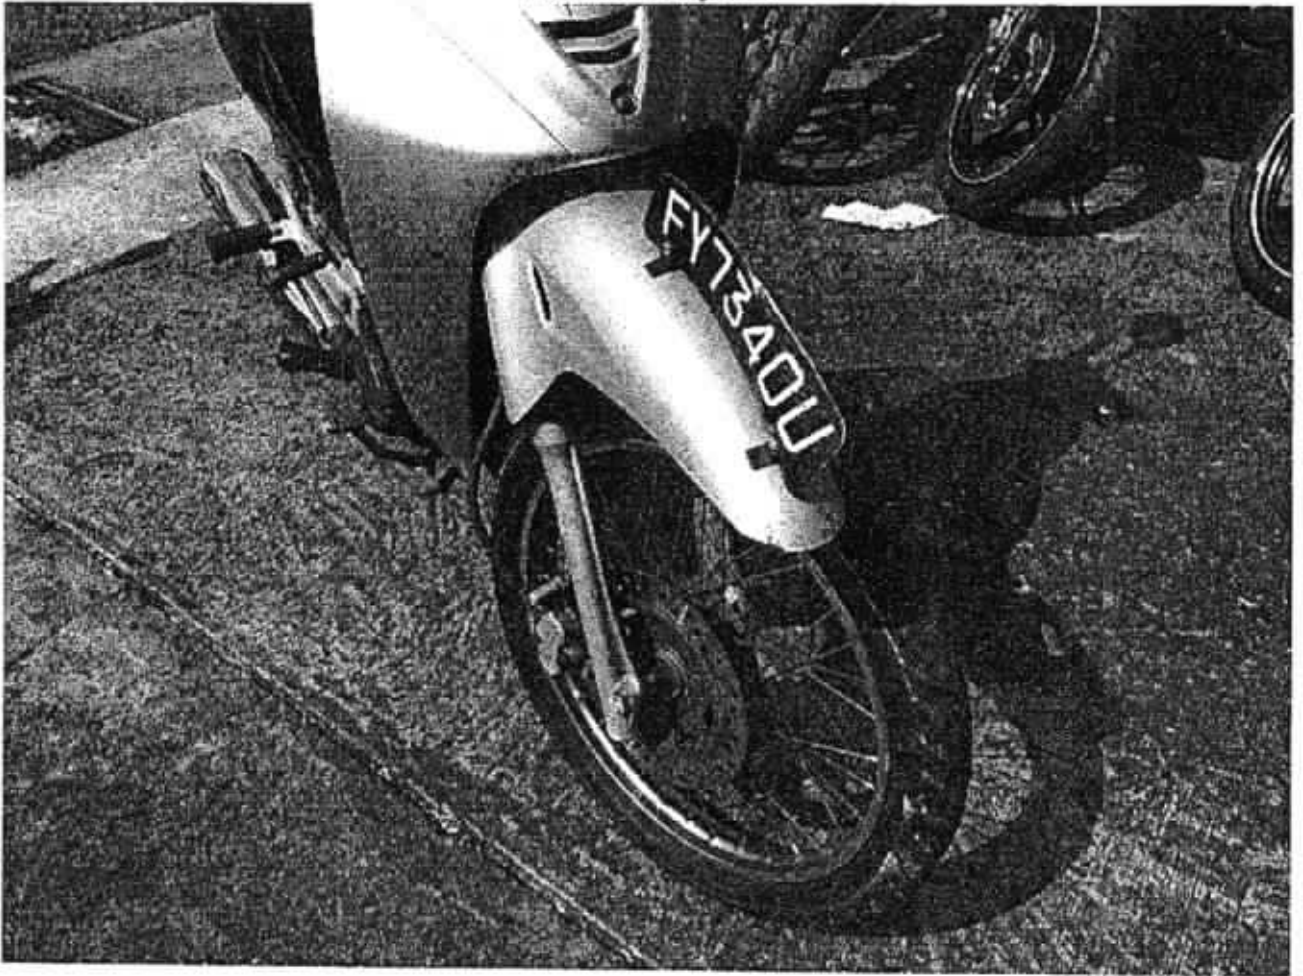
Photo Provided by Driver

Details of Vehicle Involved						
Vehicle No.	Type	Make	Model	Color	Condition	No of Passenger
FY7340U	Motorcycle	HONDA	WAVE 125R A	Silver	Slightly Damaged	0

My motorcycle was damaged in this accident. The front part of my motorcycle was damage, by my assessment. However, I was not able to made a check as I was injured.

- 1pc. HEADLIGHT COWLING - \$45 / Cut
- 1SG. HEADLIGHT UNIT - \$55 X NV
- 1pc. L.H. UNIT - \$155. So NEXT / Cut
- 1pc. HANDLE BAR - \$48 / BT
- 1pc. HANDLE BRACKET - \$45 X NV
- 1SG. HANDLE BARANCHER - \$35 / Cut
- 1SG. MIRROR - \$30 / Cut
- 1pc. BRAKE LEVER - \$20 / BR
- 1pc. FRONT ^{RH} ~~LEFT~~ SIGNAL - \$25 / CRAFT
- 1pc. BASKET - \$25 X Repair.
- 1pc. FRONT HORN COVER - \$35 / Cut
- 1pc. FRONT MUDGUARD - \$55 / Cut
- 1pc. REAR MUDGUARD - \$35 / el
- 1pc. RIGHT OUTER COWLING - \$55 / Cut
- 1pc. RIGHT INNER COWLING - \$45 / Cut
- 1pc. FOOTREST BRACKET - \$45 / BT
- 1SG. FOOTREST RUBBER - \$20 / TN

No.	Qty	Part No.	Particulars	Condition	Repairer's	Amount
1	1		*REAR BRAKE PEDAL	Not Necessary	47.00 F	*- FL
2	1		*SPEEDOMETER CABLE	Not Necessary	20.00 F	*- FL
3	1		*SPEEDOMETER GAUGE	Not Necessary	38.00 F	*- FL
4	1		*FRONT FORK ASSY	Bent	240.00 F	*240.00 FL
5	1		*FRONT FORK UNDER BRACKET	Bent	95.00 F	*95.00 FL
6	1		*FRONT WHEEL	Not Necessary	150.00 F	*- FL
7	1		*FRONT BRAKE DISC	Bent	85.00 F	*85.00 FL
8	1		*FRONT NO.PLATE	Cut	10.00 F	*10.00 FL
9	1		*FRONT BRAKE CALIPER ASSY	Cut	125.00 F	*125.00 FL
10	1		*FRONT WHEEL SHAFT & BOLT	Cut	25.00 F	*25.00 FL
11	1		*REAR BOX	Cut	125.00 F	*125.00 FL
12	1		*STEERING CONE	Necessary	85.00 F	*85.00 FL
