To Inspect Vehicle No: SBU 8219A Insured: SGS 2457U

## AUTOMAX SURVEY

THIRD PARTY SURVEY  
ACCIDENT OCCURED ON 20 July 2016

## ADJUSTMENT ON REPAIR COST FOR VEHICLE NO. SBU 8219A

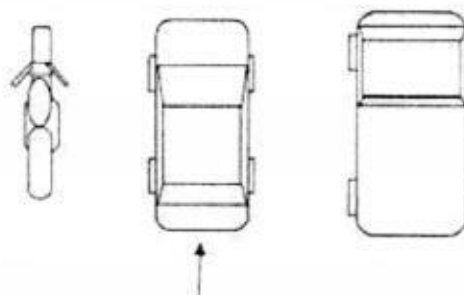
## 4. DESCRIPTION OF DAMAGE

At the time of inspection, this vehicle sustained damages to the **Rear** portion. Please see attached scheduled for details.

Market Value : -  
Salvage Value : -  
Repair Limit (Nett Loss) : -  
Repairer's estimate : **Not Provided**  
Nett Saving : -  
Excess : -  
Sum Insured : -  
Our adjusted amount : \$ 3,500.00  
Estimated Repair Days : 05 days
