To Inspect Vehicle No: GBD 2586T.

Claim No: CMTD1802777/GPL

**From:** Gnoh, Pau Loong <PauLoong.Gnoh@sompo.com.sg>  
**Sent:** Monday, 30 July 2018 4:00 PM  
**To:** Bryan Ang (LKKAuto); Veron Chen (LKKAuto)  
**Cc:** SUR; Ong, Lay Gim; KKLau; Ngo, Sau Wei Shawn; Han, Bernard  
**Subject:** Pls expedite final report ( by 01.08.18 ); RE: Urgent : Pls assist to conduct rear tyre inspection for our vehicle GBD2586T ; RE: CMTD1802777/GPL - SUV(LKK)/GBD2586T & XB7128A ACC ON 26.06.18

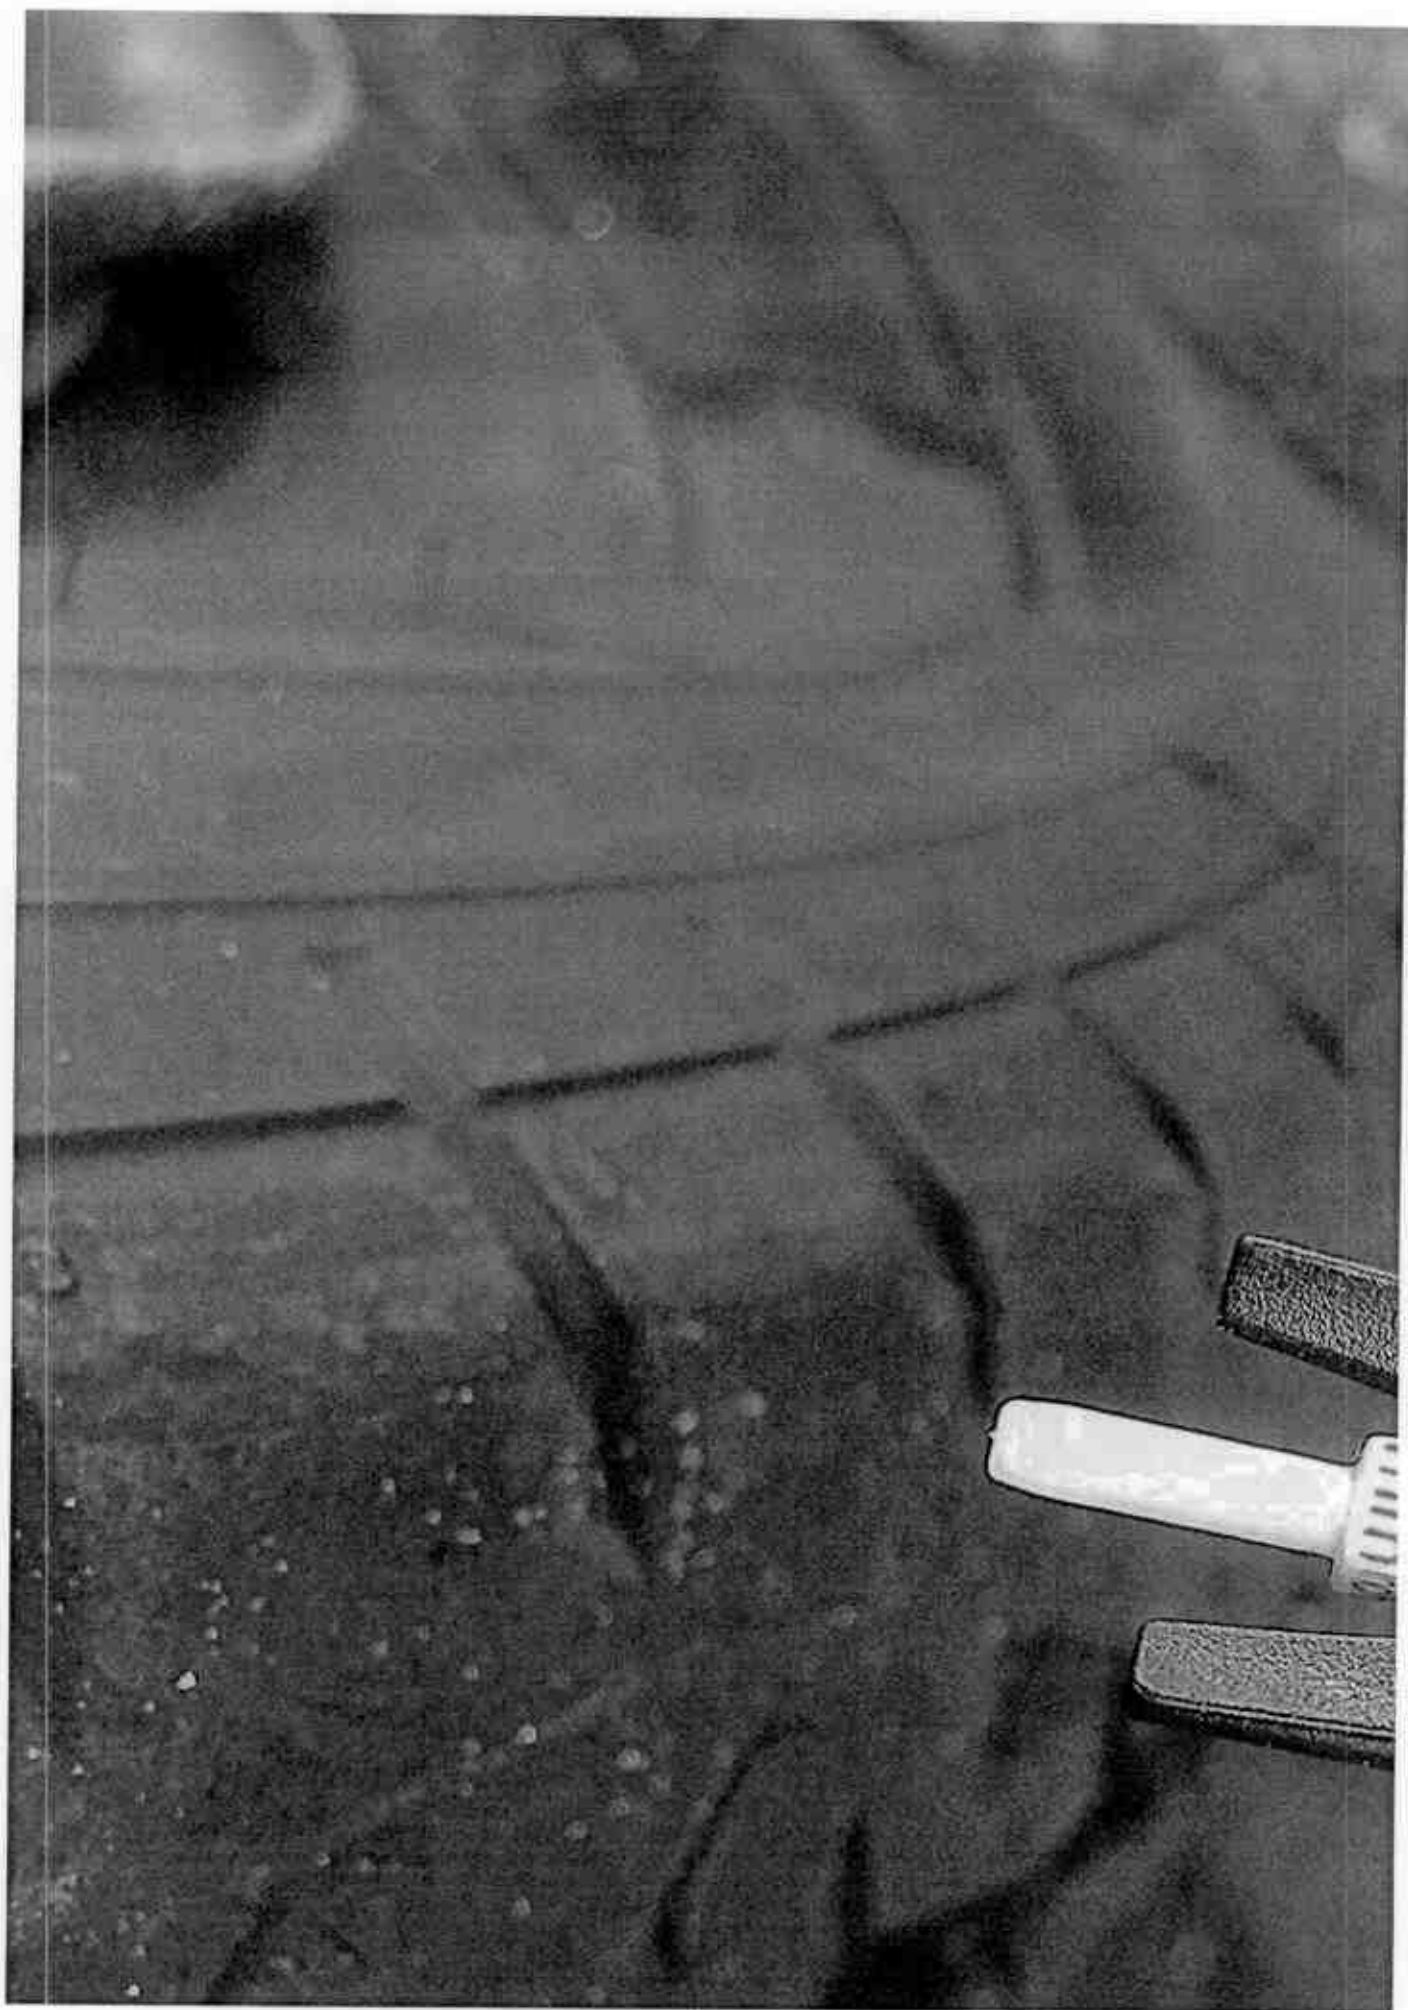
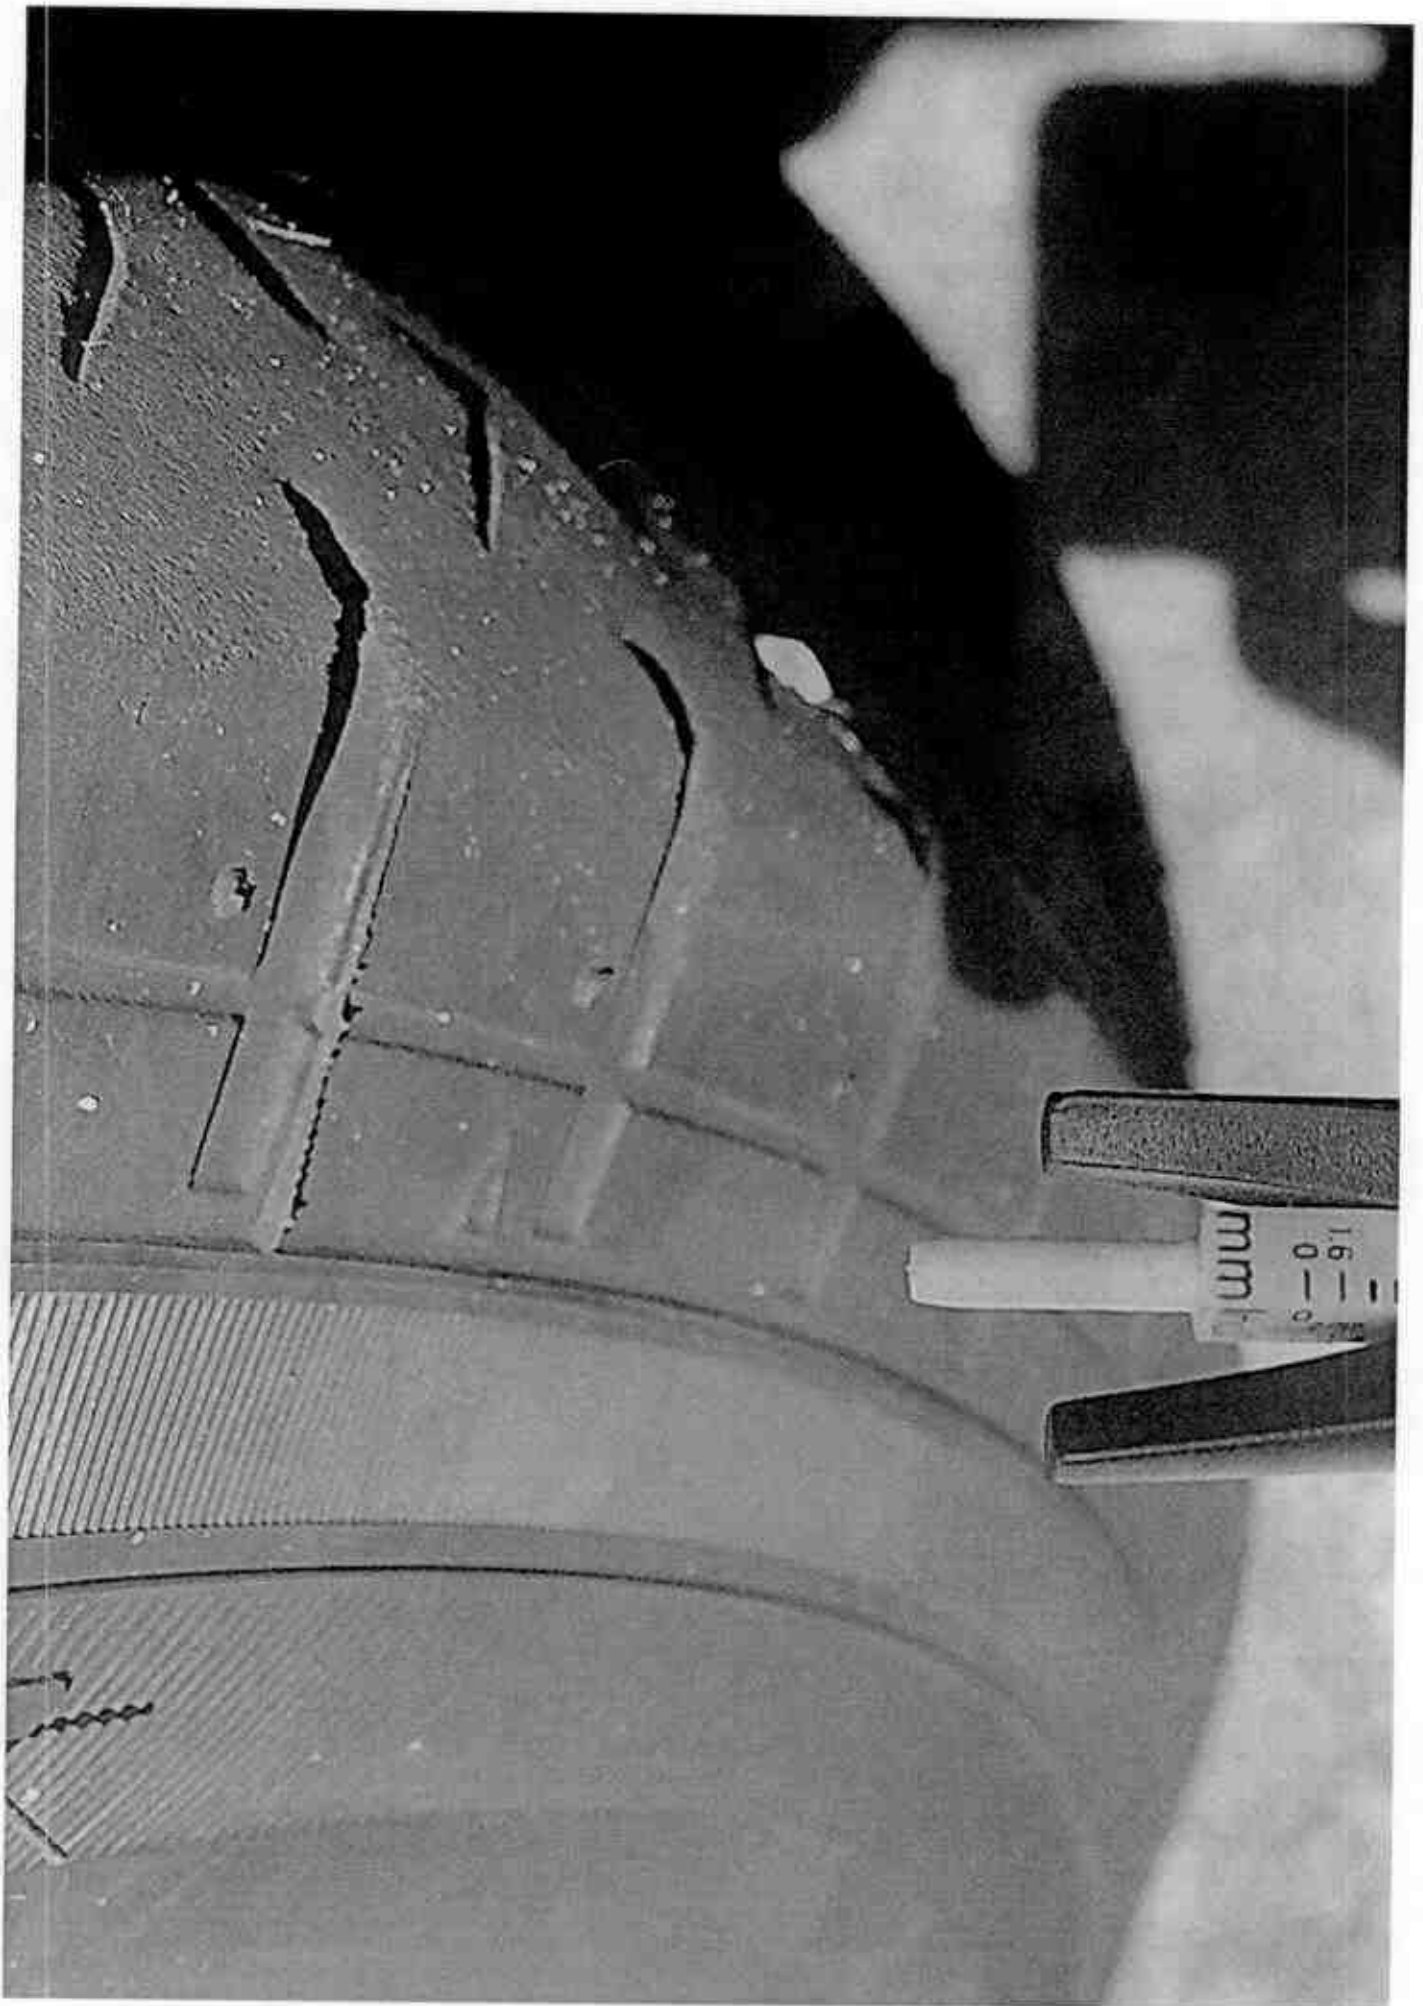
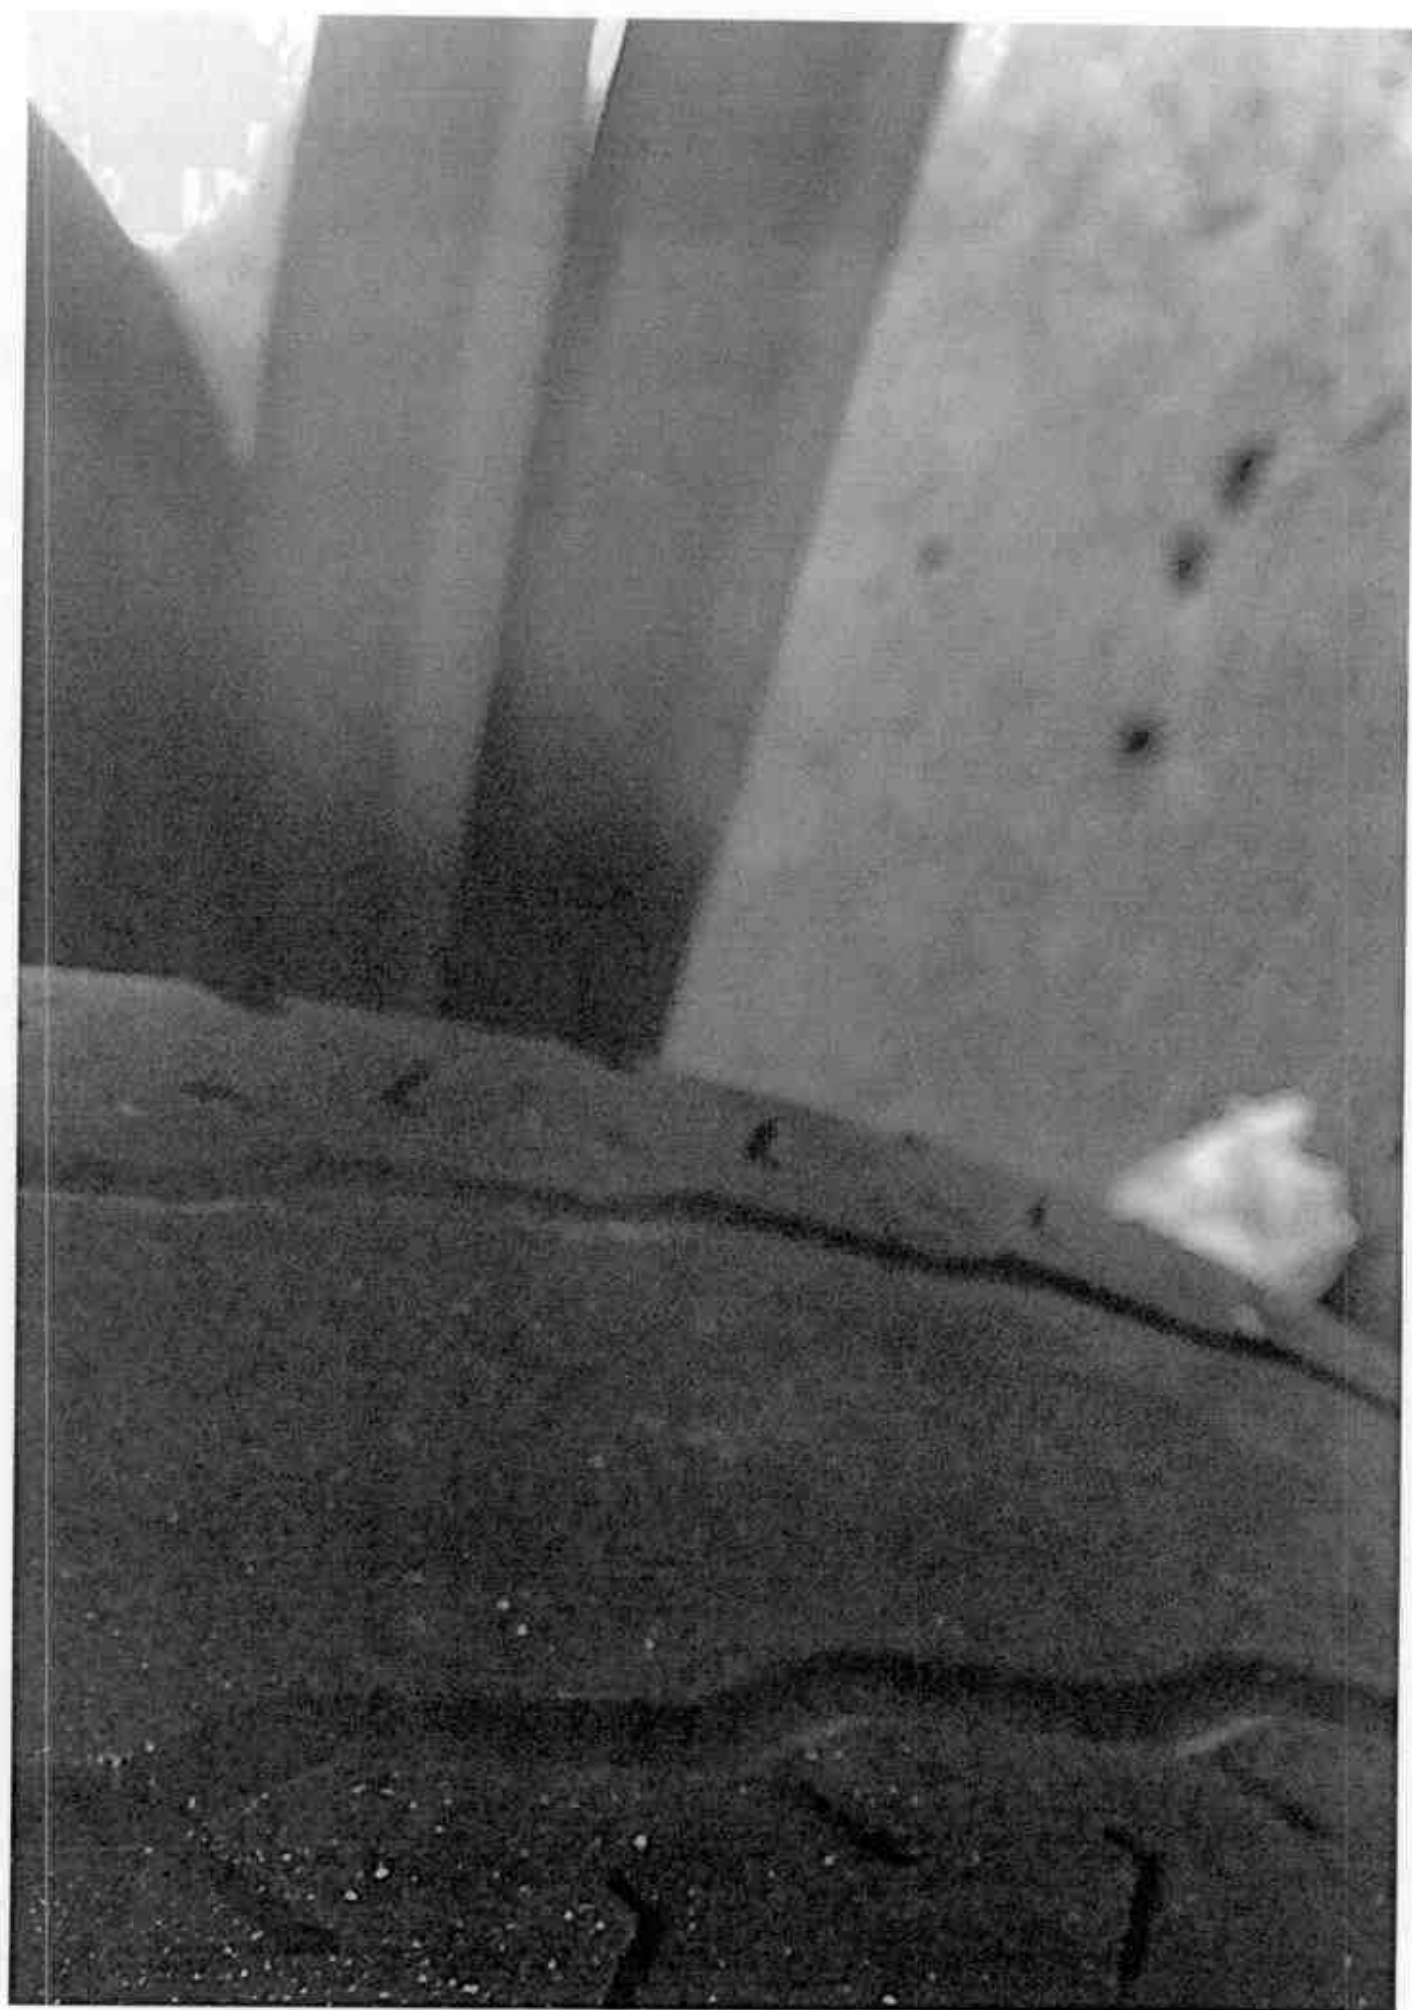
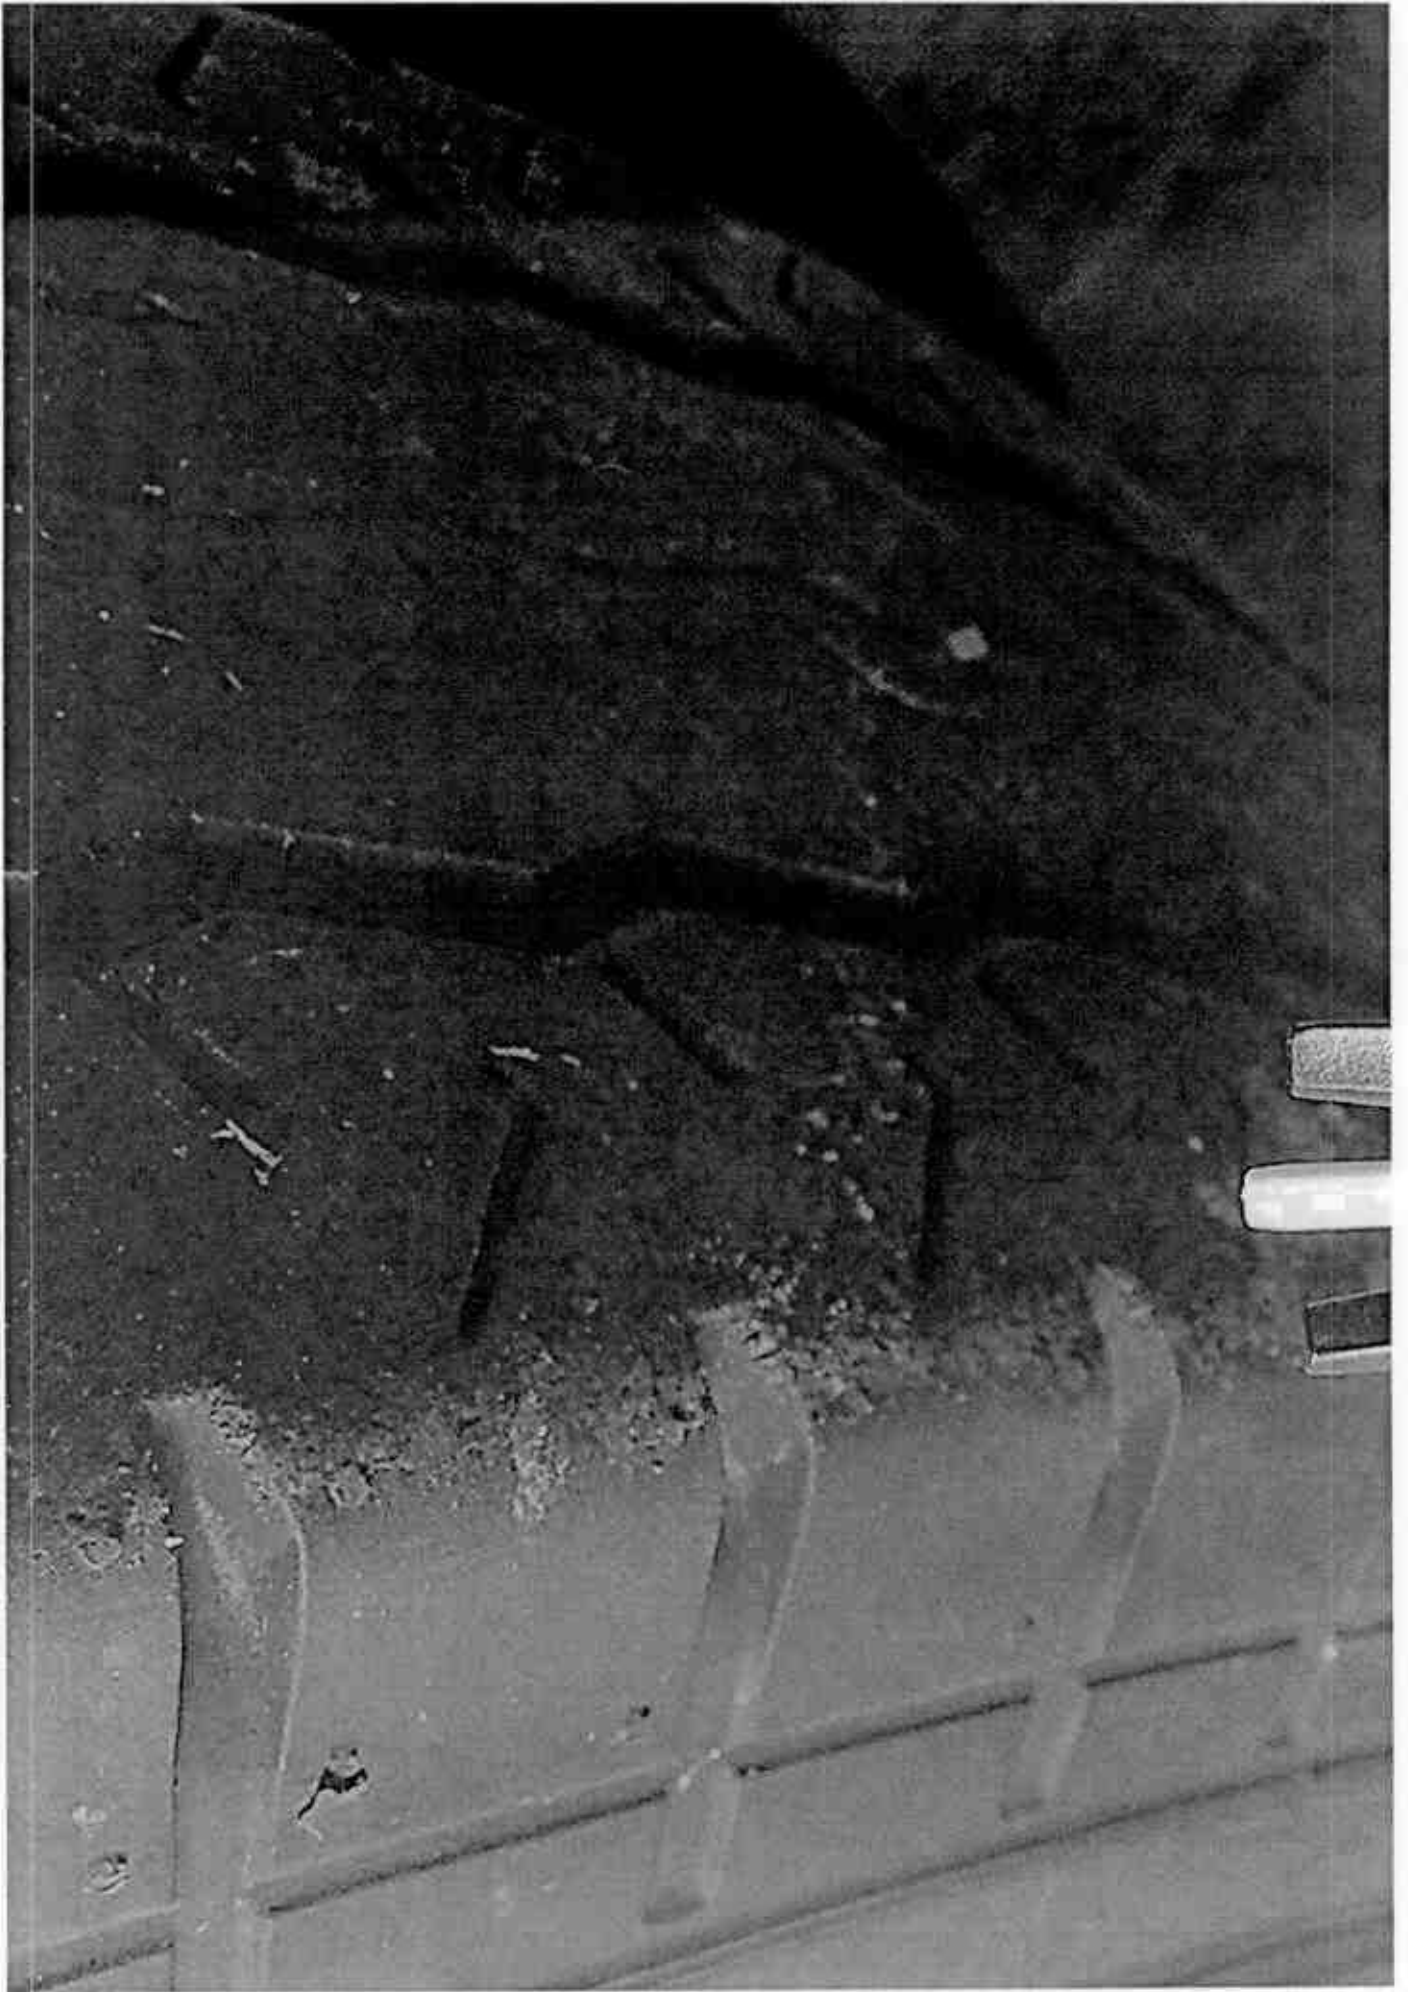
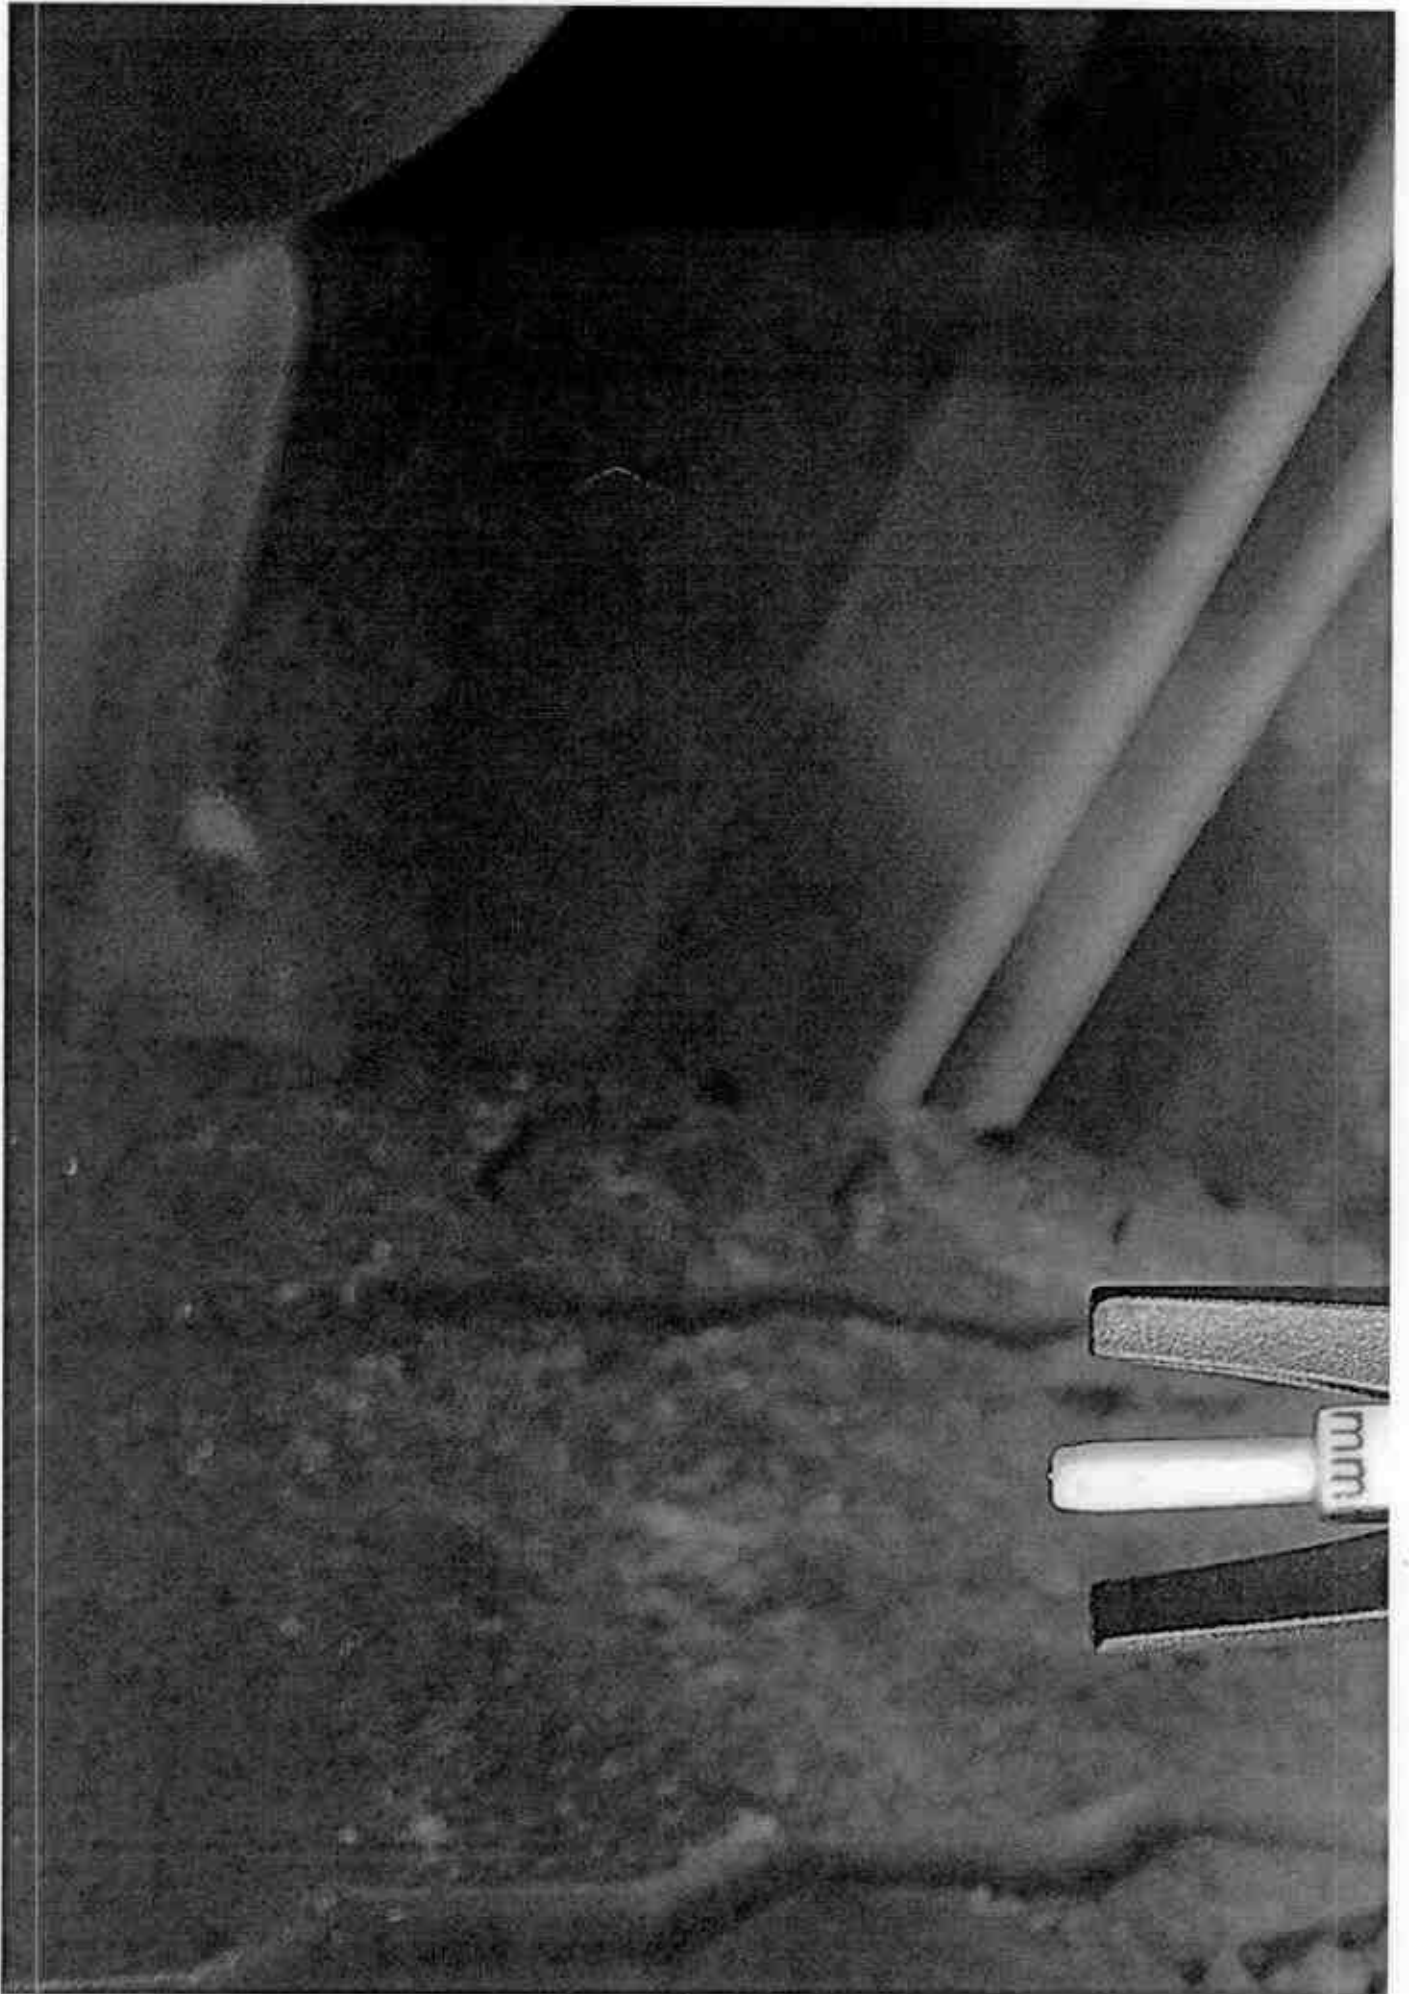
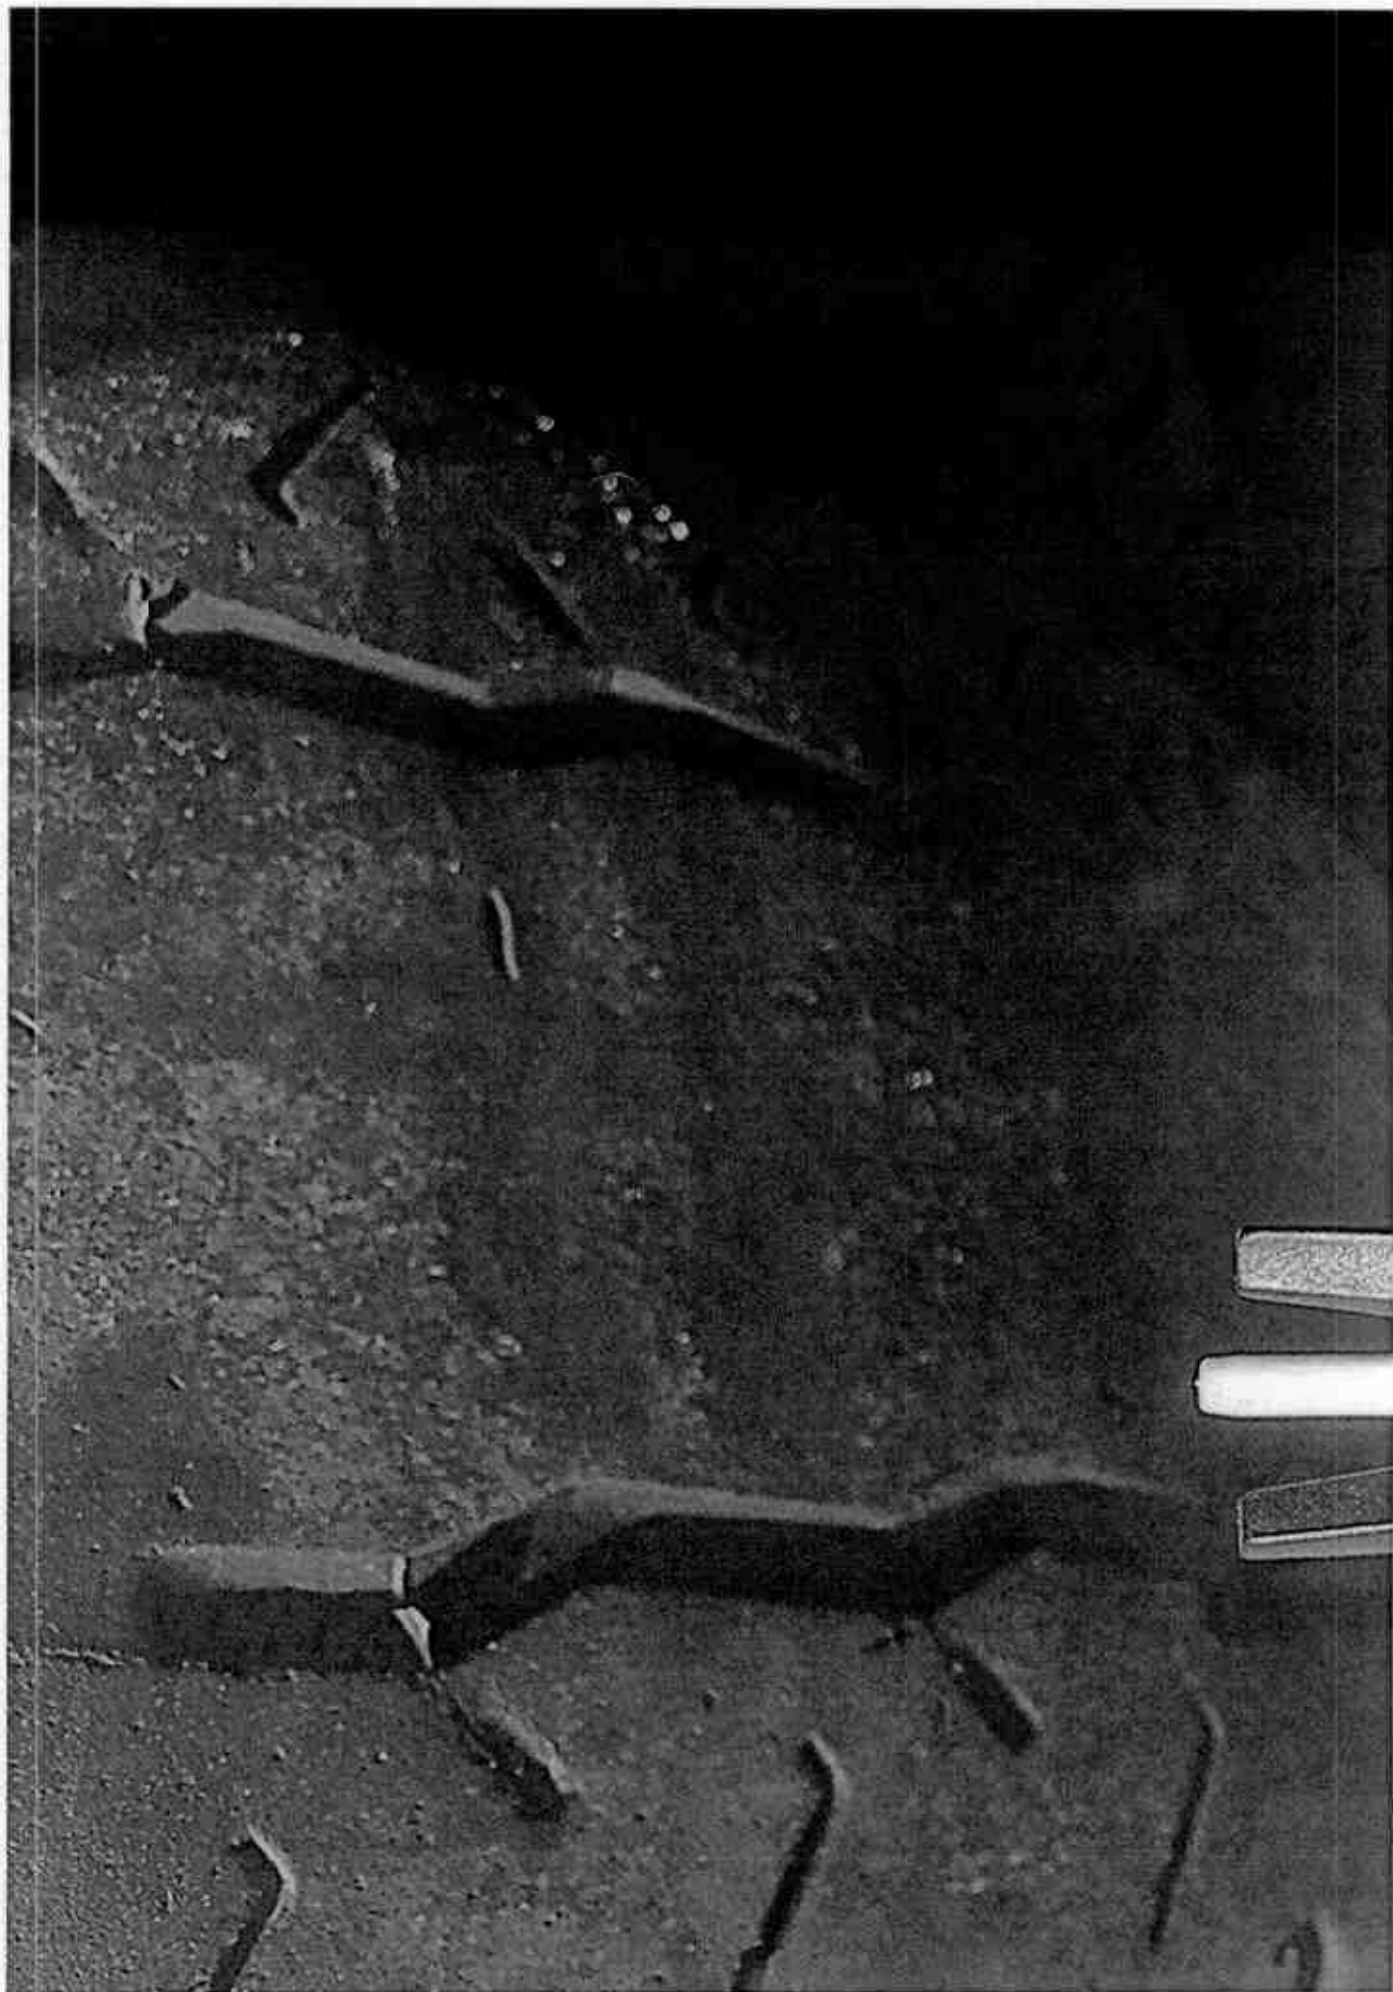
The front 2 tyres were found to be in serviceable condition with remaining tread depth of about 5mm each.

The rear left tyres (inner and outer) were found to be with remaining tread depth of about 1.6mm each. The pattern of the tread for the centre part of both rear left tyres were non-visible at some areas. As the pattern can be seen at some areas, the condition of the rear left tyres may still fall within the legal requirement (borderline case).

The rear right tyres (inner and outer) on the other hand were found to be with remaining tread depth of about 1mm each. The pattern of the tread for the centre part of both rear right tyres were non-visible around the entire circumference of both tyres. Such condition does not comply with the legal requirement :-

**Section 109(f) of the Road Traffic (Motor Vehicles, Construction and Use) Rules states** "where the tyre is fitted to a wheel of a motor vehicle, being a motor cycle whereof the cylinder capacity of the engine does not exceed 50 cubic centimetres, the tread of the tyre does not show throughout at least 75% of the breadth of the tread and round the entire outer circumference of the tyre a pattern the relief of which is clearly visible, or where the tyre is fitted to the wheel of any other motor vehicle or any trailer, the tread pattern (excluding any tie-bar) of the tyre does not have a depth of at least one millimetre throughout at least 75% of the breadth of the tread and round the entire outer circumference of the tyre."

Attached are the photos taken during the measuring of the tread pattern for all 6 tyres of the insured vehicle.

The accident had occurred when the insured vehicle skidded while braking on a downslope roadway that is wet at the material time. Given the condition of the rear tyres as mentioned above, I am of the opinion that the condition of the rear tyres could have contributed to the insured vehicle skidding. The centre part of the tyres is the area that contacts the road surface the most. The lack of tread pattern prevents water from being "pushed" away when a tyre is rotating (vehicle moving) hence traction (frictional grip) between the insured vehicle and the wet road surface is reduced, ultimately contributing to the insured vehicle skidding.
