CS/GAI/8014288/R190302

PRELIMINARY ADVICE OF VEHICLE NO. SLM 9996G

ESTIMATE COST OF REPAIRS TO SLM9996G

ADJUSTMENT ON REPAIR COST FOR VEHICLE NO. SLM 9996G

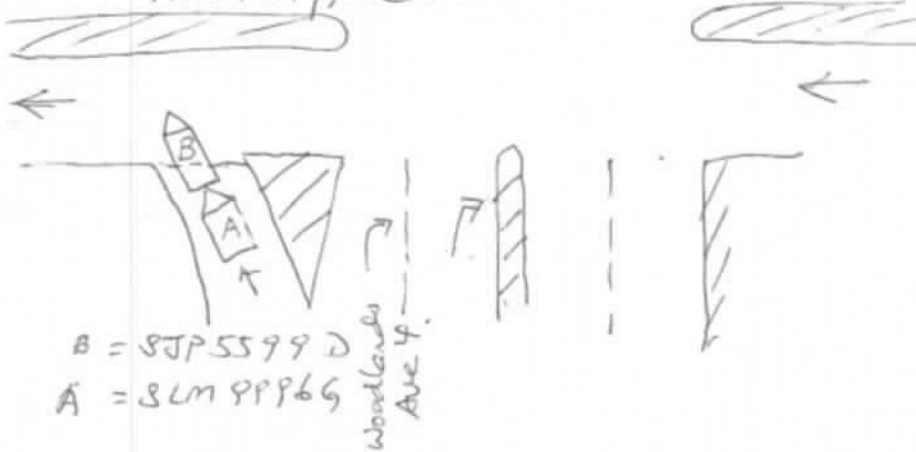
Sketch Plan #2

Admiralty Road West

On 30/7/18 I was travelling along Woodlands Ave 4 towards Admiralty Rd west. The front vehicle after passing half way out of the slip road then junc on the bike. I also quickly put junc but still could not make it in time to avoid the accident.
