Your Ref: Honda Engine
(number B16A5404030)
Our Ref : CI/TP18014299/D

06 August 2018

INSPECTION REPORT OF A HONDA ENGINE WITH NUMBER B16A5404030

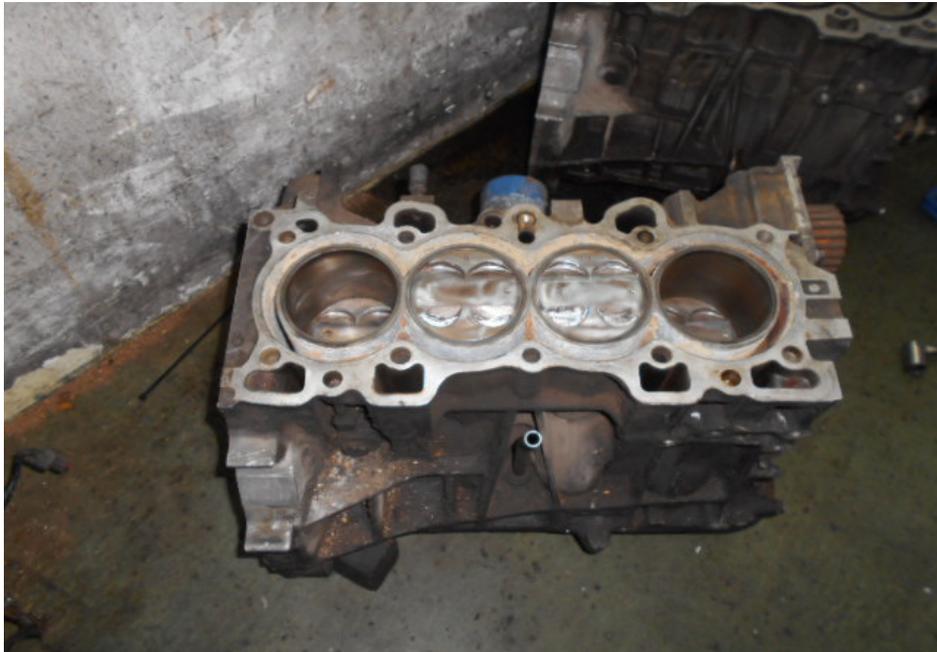
Photo 1 shows a general view of the Honda engine that I had inspected. The Honda engine was observed to be a used engine and was not fitted on any motor car. The top block of the Honda engine was separated from its bottom block. This was to enable me to carry out measurements of its cylinders, in particular the bore and stroke measurements of each cylinder, which typically can be used to determine the engine displacement or more commonly referred to as engine cc.

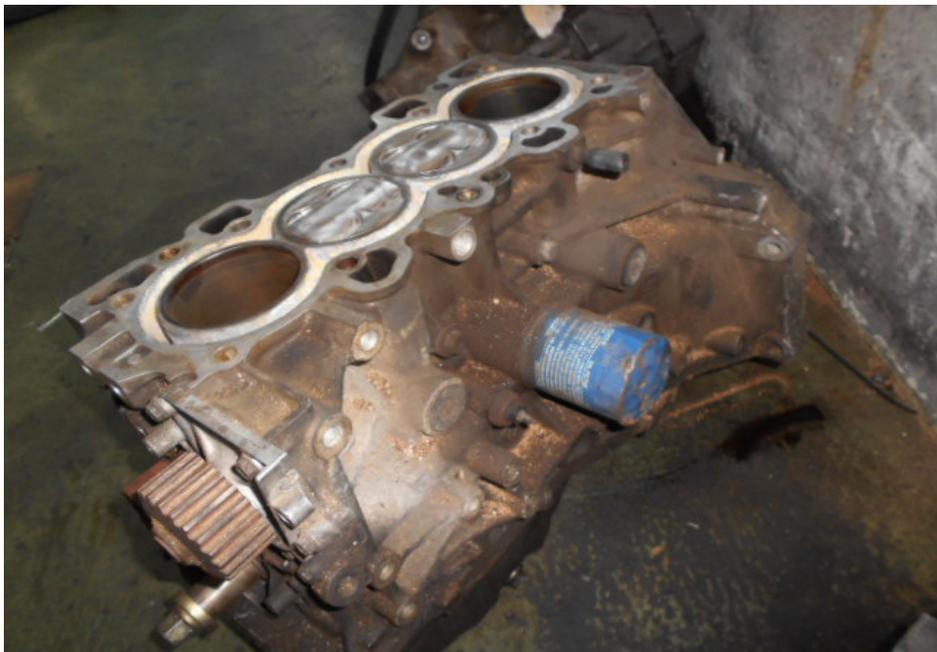
Photo 2 shows a general view of the Honda engine that I had inspected. My visual examination of the engine housing revealed the housing to be of serviceable/satisfactory condition. There was no crack and/or hole observed on the engine housing.

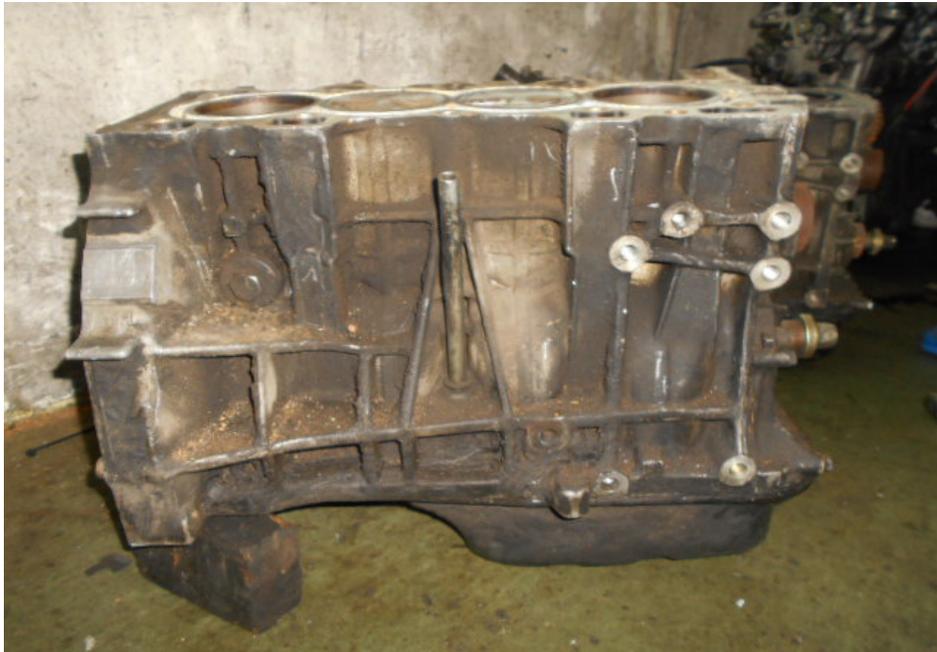
Photo 3 shows a general view of the Honda engine that I had inspected. My visual examination of the engine housing revealed the housing to be of serviceable/satisfactory condition. There was no crack and/or hole observed on the engine housing.

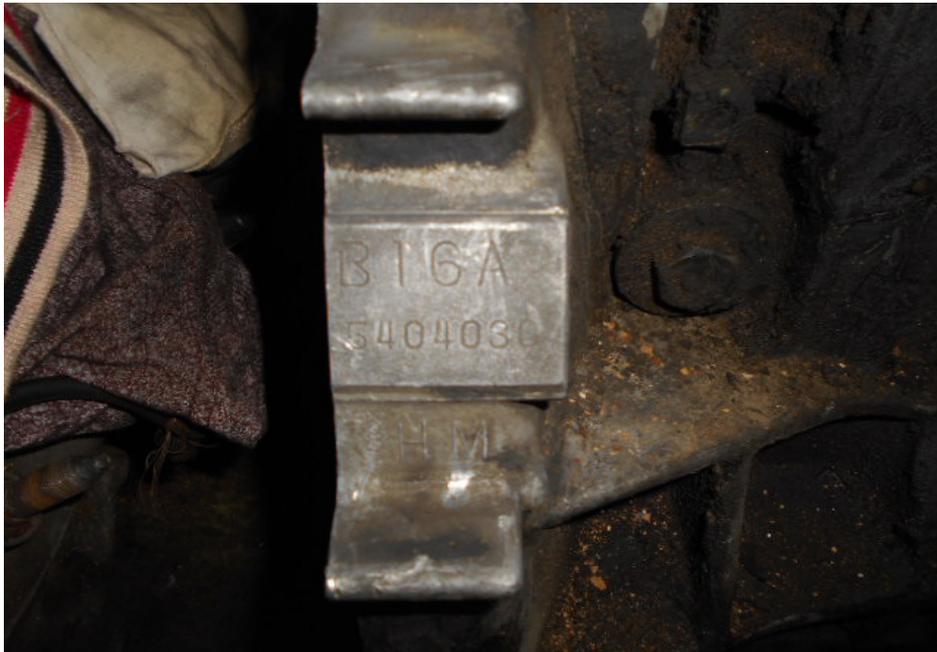
Photo 4 shows the engine number engraved on the housing of the Honda engine that I had inspected. The engine number was B16A5404030.

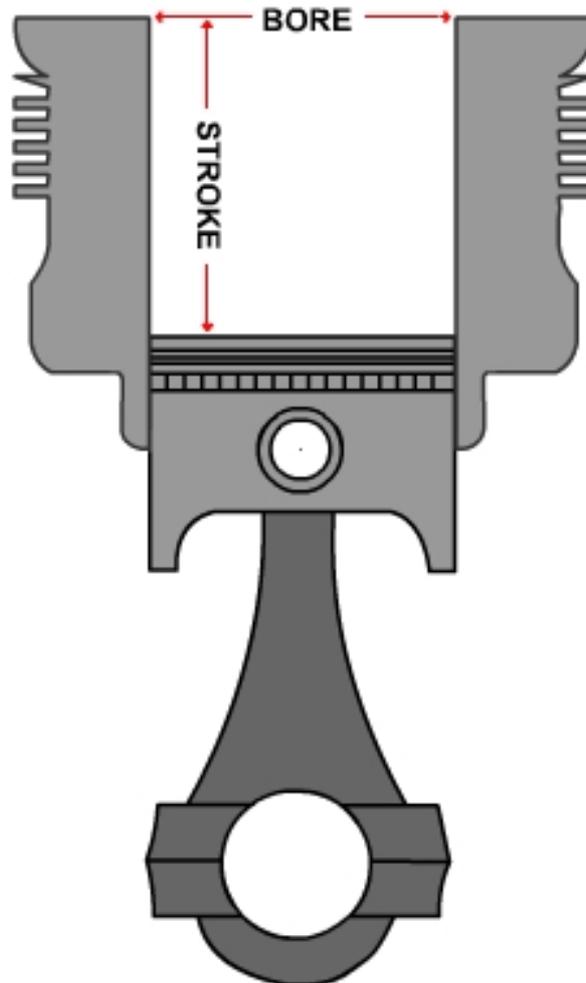
9. The bore of an engine refers to the measurement of the inside diameter of the cylinder while the stroke refers to the distance the piston moves in one direction of upward or downward movement in the cylinder. See diagram below for illustration purposes.

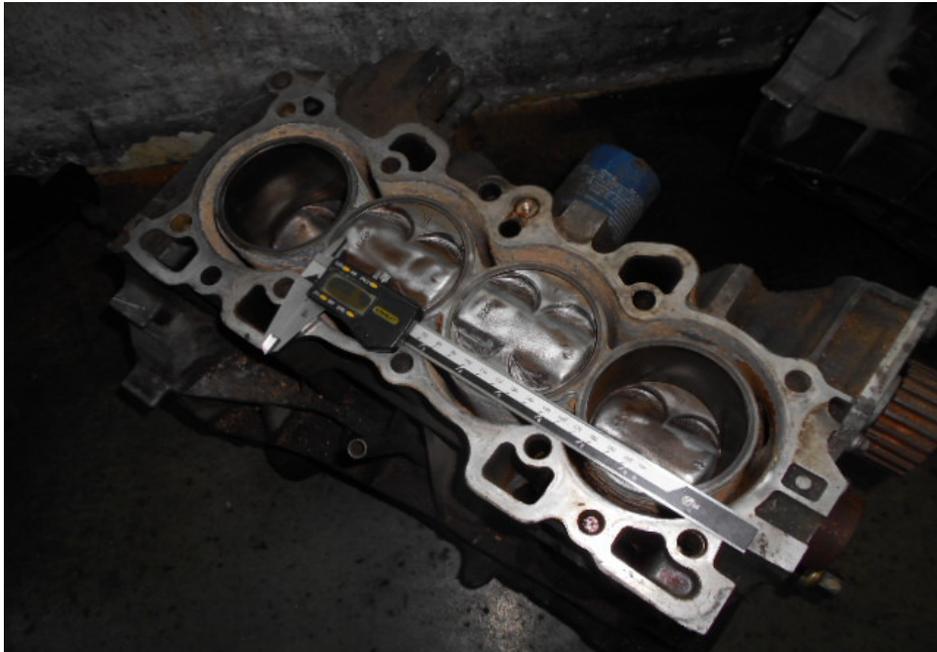
Photo 5 shows the bottom block of the Honda engine and the digital Vernier Caliper that was used to measure the bore and stroke of the Honda engine. The digital Vernier Caliper was calibrated before the start of the measurements.

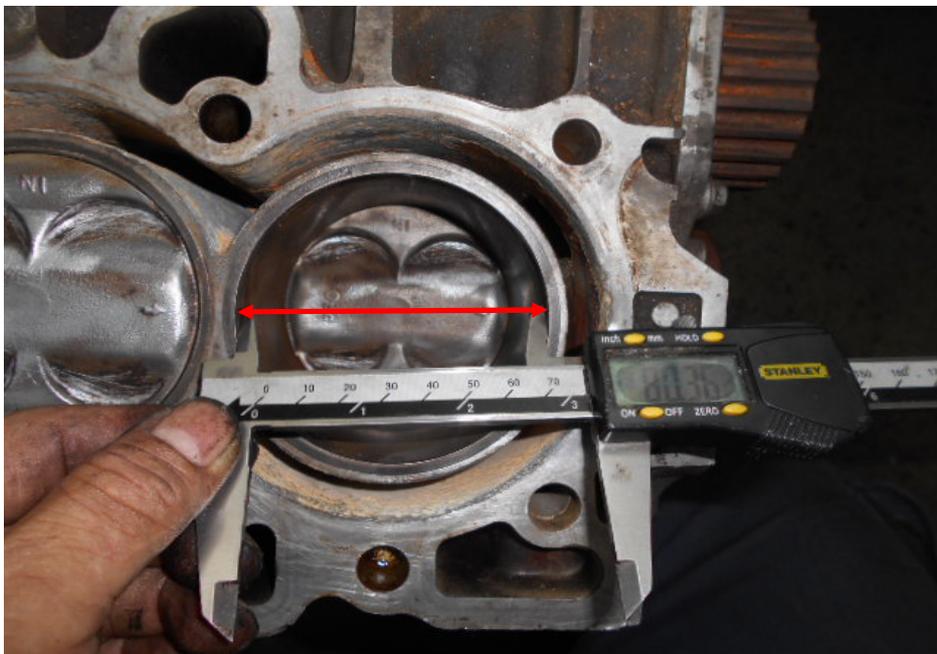
Photo 6 shows measurement being carried out to the bore (arrowed) of cylinder 1 of the Honda engine. The bore measurement of cylinder 1 was recorded to be 80.36mm.

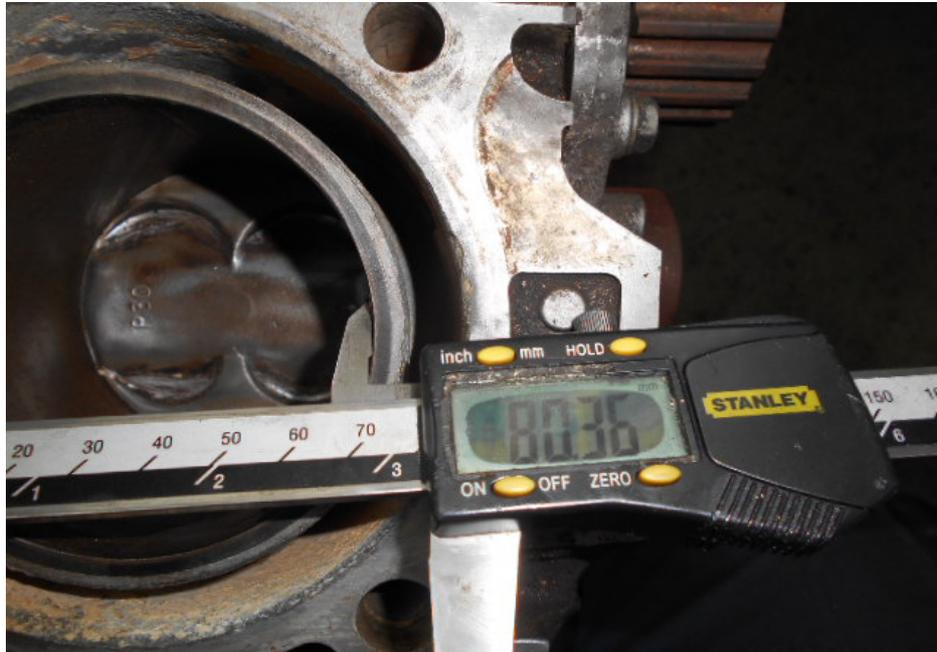
Photo 7 shows the bore measurement of cylinder 1, which was recorded to be 80.36mm.

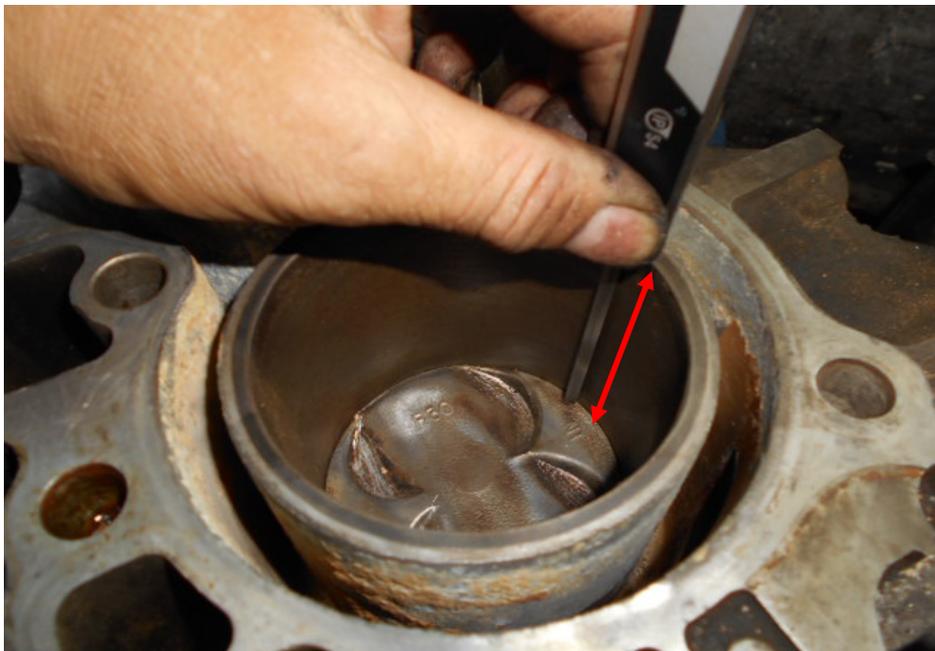
Photo 8 shows measurement being carried out to the stroke (arrowed) of cylinder 1 of the Honda engine. The bore and stroke measurements of the Honda engine were carried out using a digital Vernier Caliper.

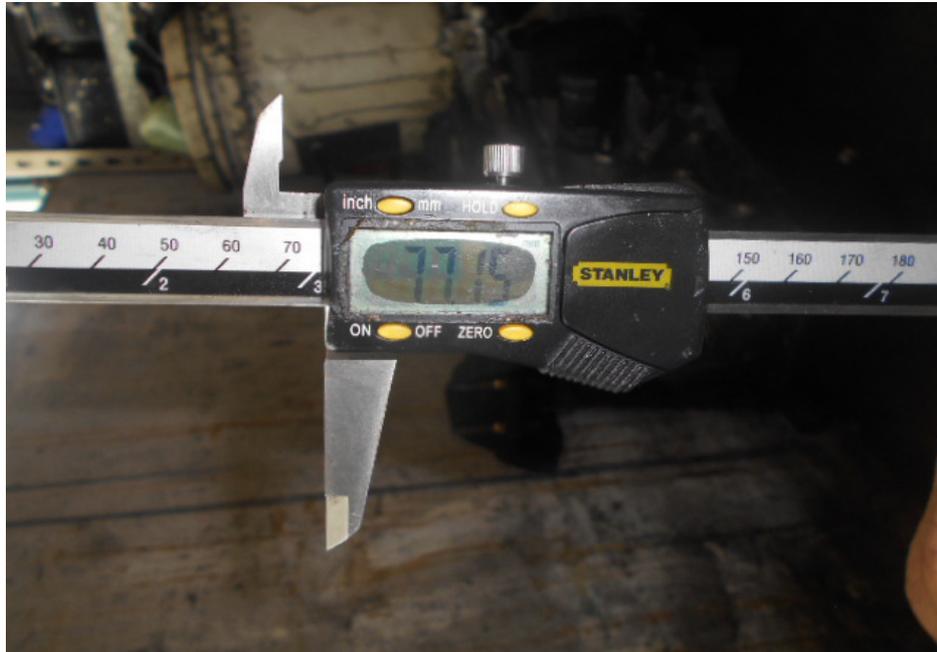
Photo 9 shows the stroke measurement of cylinder 1, which was recorded to be 77.15mm.

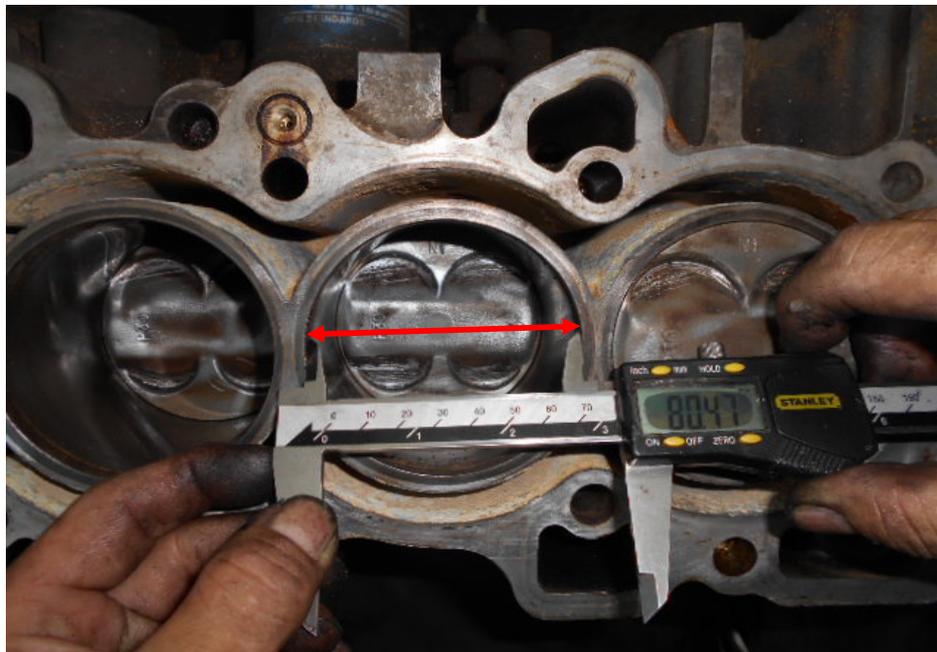
Photo 10 shows measurement being carried out to the bore (arrowed) of cylinder 2 of the Honda engine. The bore measurement of cylinder 2 was recorded to be 80.47mm.

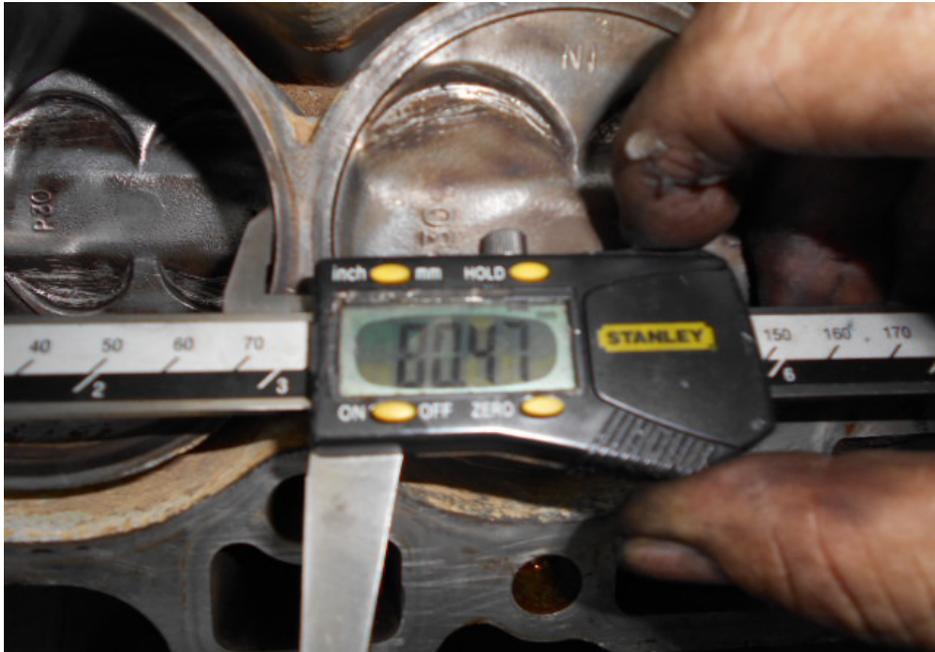
Photo 11 shows the bore measurement of cylinder 2, which was recorded to be 80.47mm.

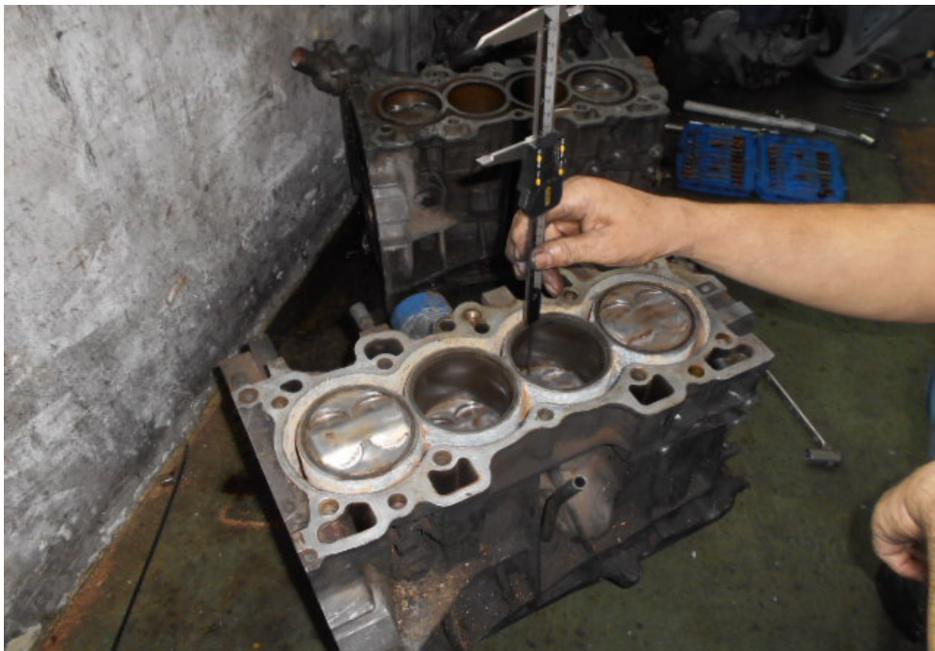
Photo 12 shows measurement of the stroke of cylinder 2 of the Honda engine that I had inspected. The bore and stroke measurements of the Honda engine were carried out using a digital Vernier Caliper, which was calibrated before the start of measurements.

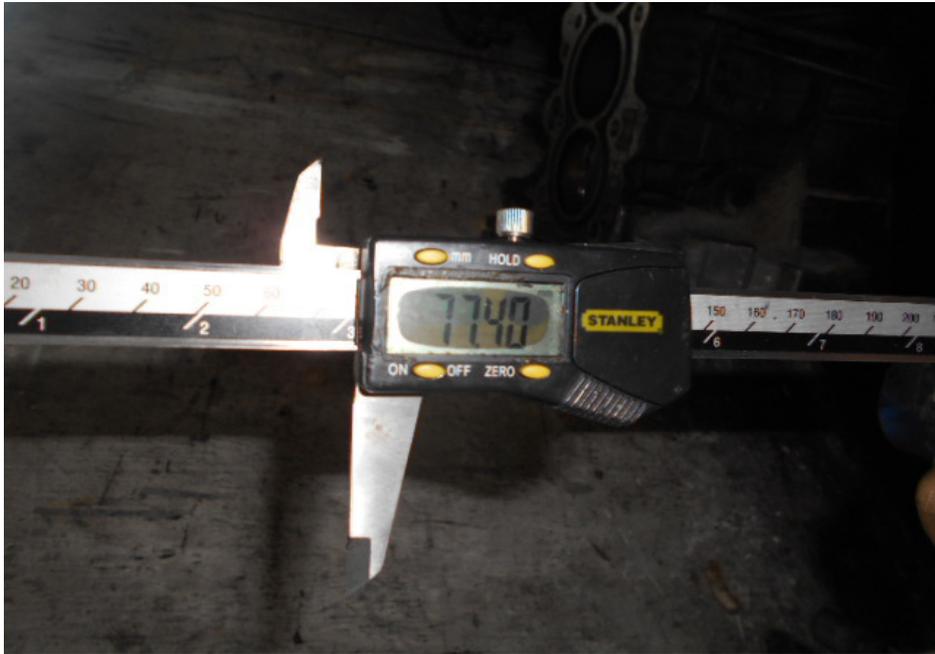
Photo 13 shows the stroke measurement of cylinder 2, which was recorded to be 77.40mm.

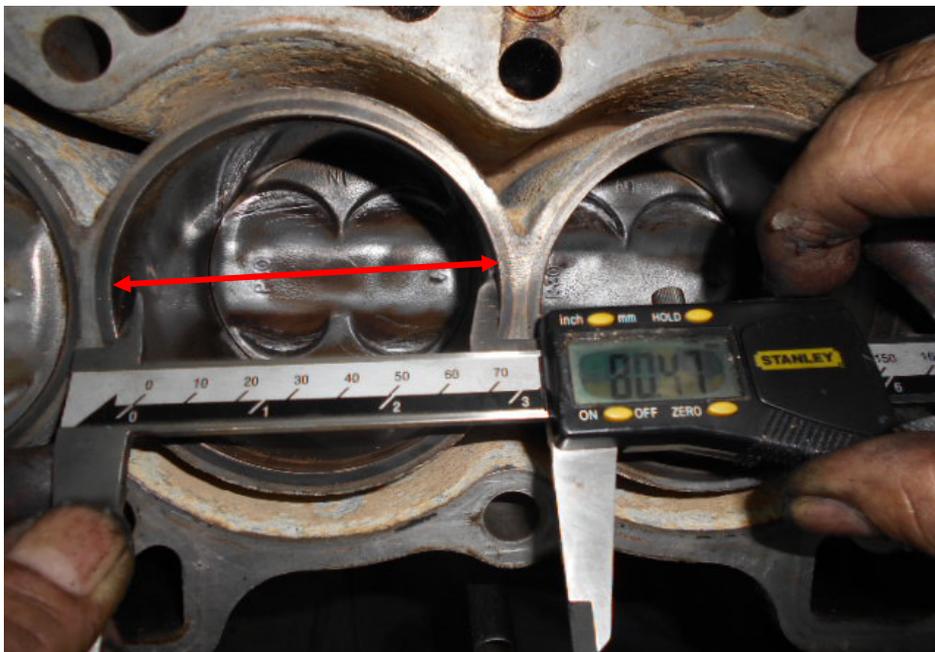
Photo 14 shows measurement being carried out to the bore (arrowed) of cylinder 3 of the Honda engine. The bore and stroke measurements of the Honda engine were carried out using a digital Vernier Caliper. The bore measurement of cylinder 3 was recorded to be 80.47mm.

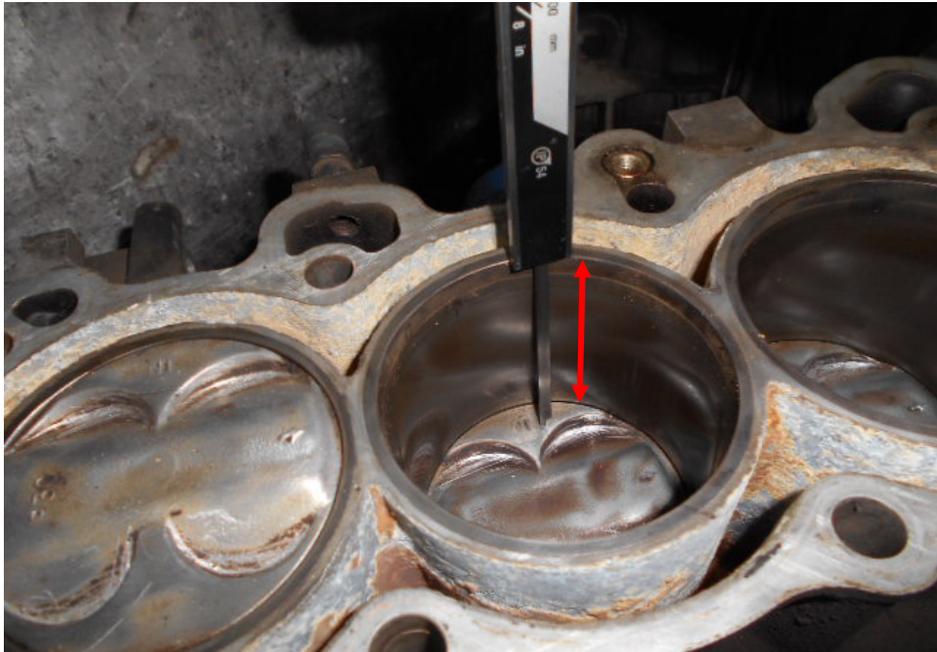
Photo 15 shows measurement of the stroke (arrowed) of cylinder 3 of the Honda engine that I had inspected. The bore and stroke measurements of the Honda engine were carried out using a digital Vernier Caliper that was calibrated before the start of measurements.

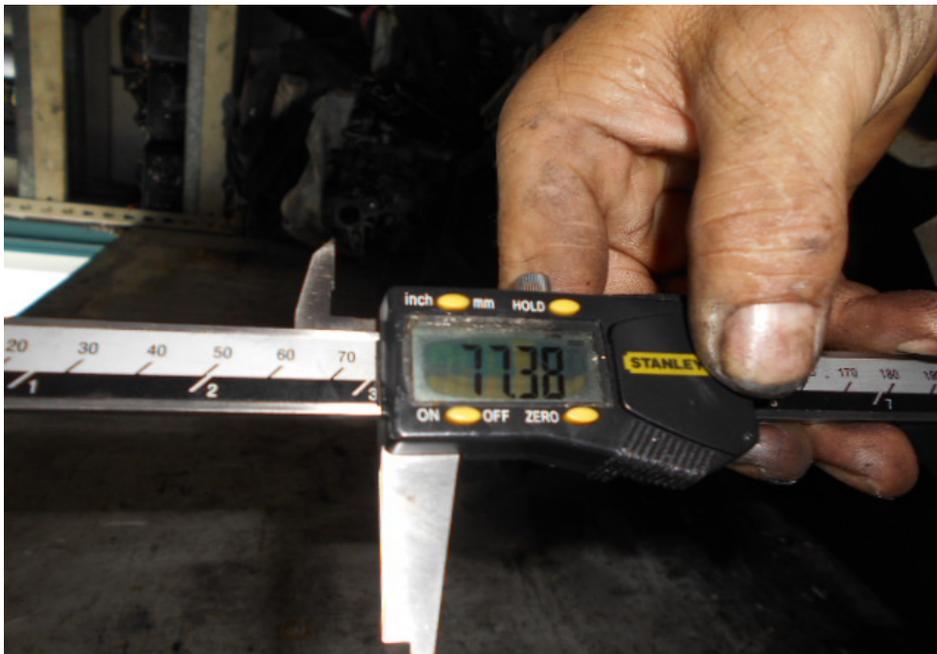
Photo 16 shows the stroke measurement of cylinder 3, which was recorded to be 77.38mm.

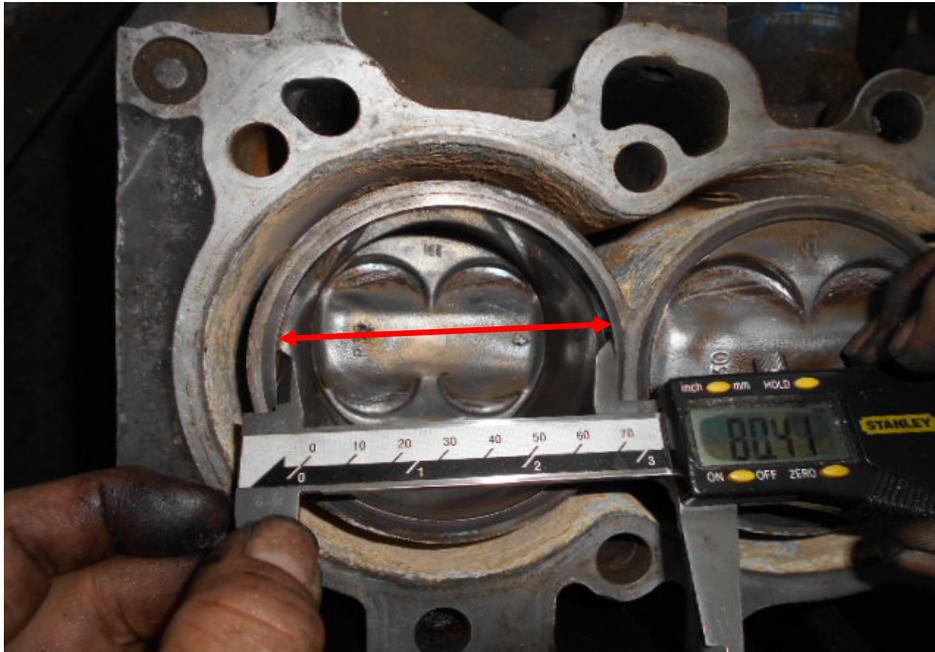
Photo 17 shows measurement being carried out to the bore (arrowed) of cylinder 4 of the Honda engine. The bore and stroke measurements of the Honda engine were carried out using a digital Vernier Caliper. The bore measurement of cylinder 4 was recorded to be 80.41mm.

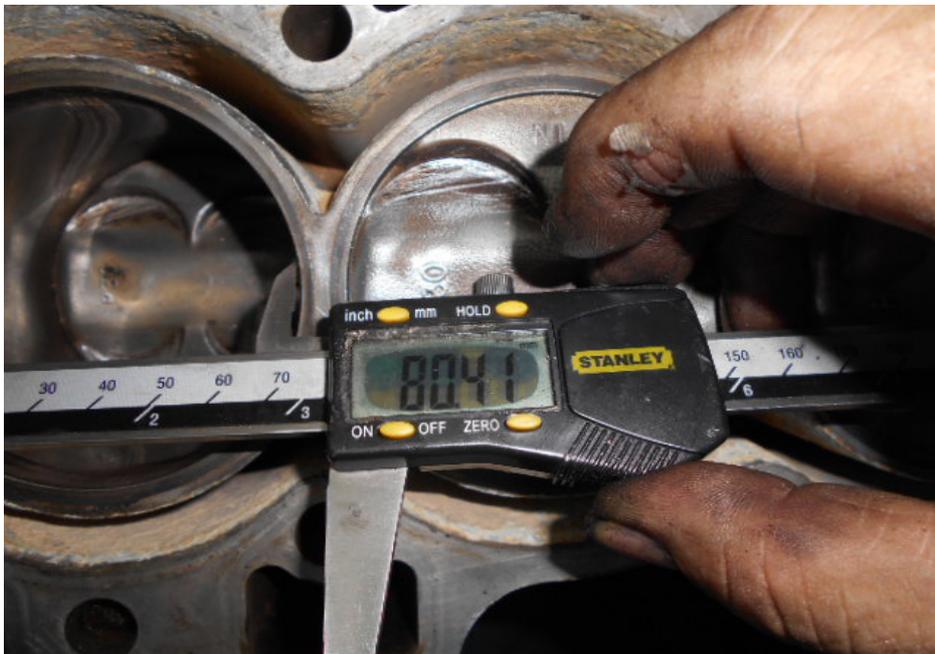
Photo 18 shows the bore measurement of cylinder 4, which was recorded to be 80.41mm.

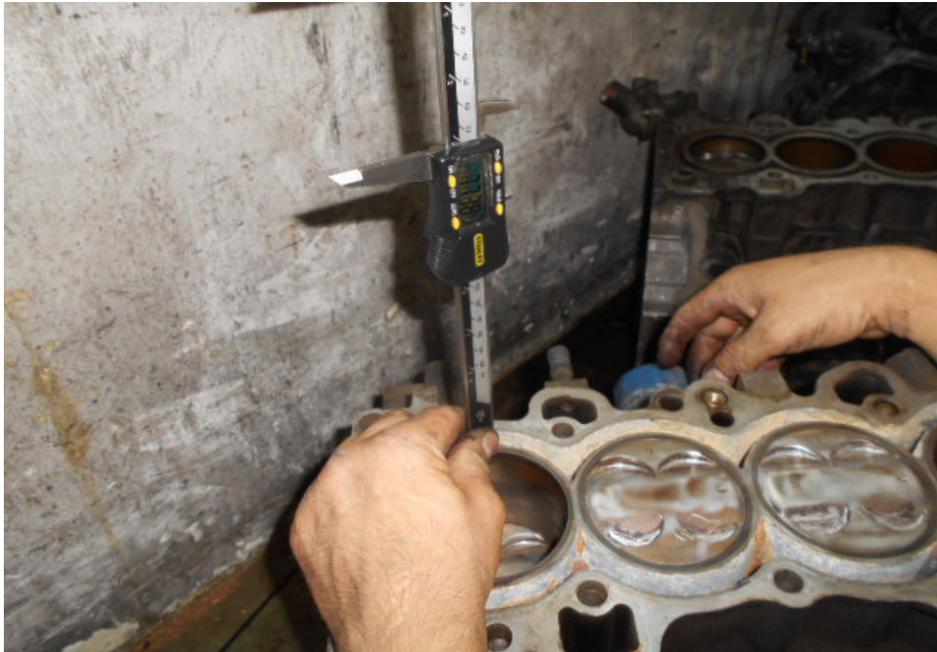
Photo 19 shows measurement being carried out to the stroke of cylinder 4 of the Honda engine. The bore and stroke measurements of the Honda engine were carried out using a digital Vernier Caliper that was calibrated before the start of measurements.

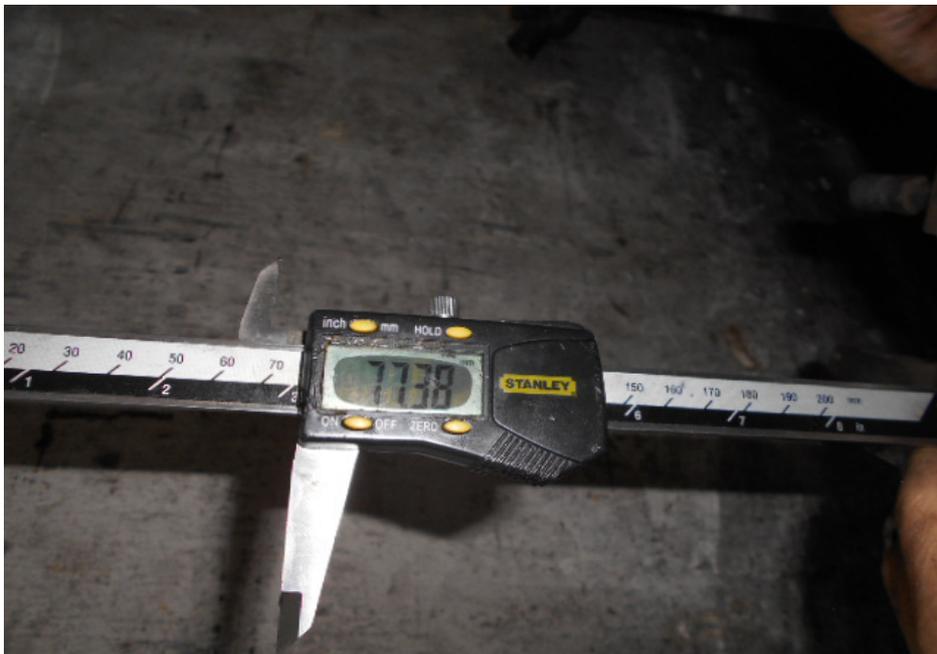
Photo 20 shows the stroke measurement of cylinder 4, which was recorded to be 77.38mm.
