## AUTOMOBILE ASSESSMENT REPORT

Assessment of Vehicle No : SLK 9465H  
Date of Accident : 18/05/2018  
Date of Inspection : 21/05/2018

## **4. DESCRIPTION OF DAMAGE**

At the time of inspection observed that this vehicle had sustained damages to the REAR portion

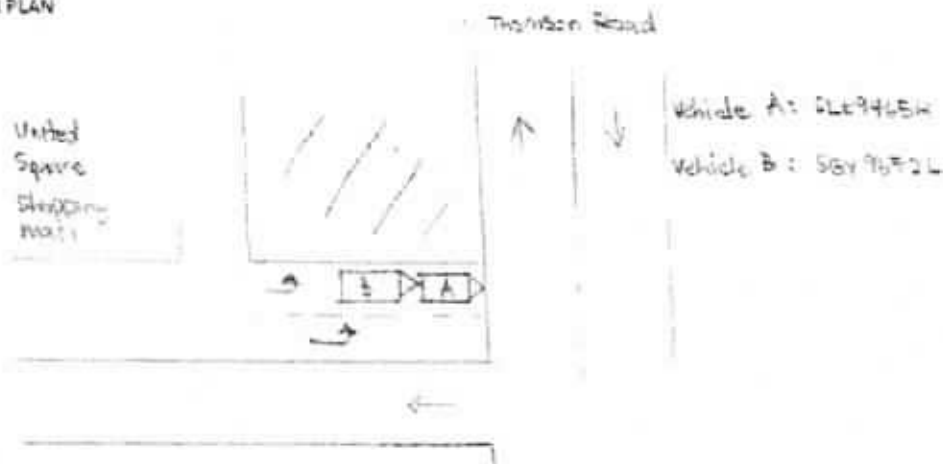
## SKETCH PLAN

On 12/05/19 at about 2035hrs I was driving out from United Square Shopping mall exiting onto Thomson Road when I heard some sounds from the vehicle and saw some lights coming on. I switched on the hazard lights and stopped along the side of the road to contact the vehicle rental company. After about 5mins, vehicle B, SGV 9672L suddenly bang into the rear portion on my vehicle.

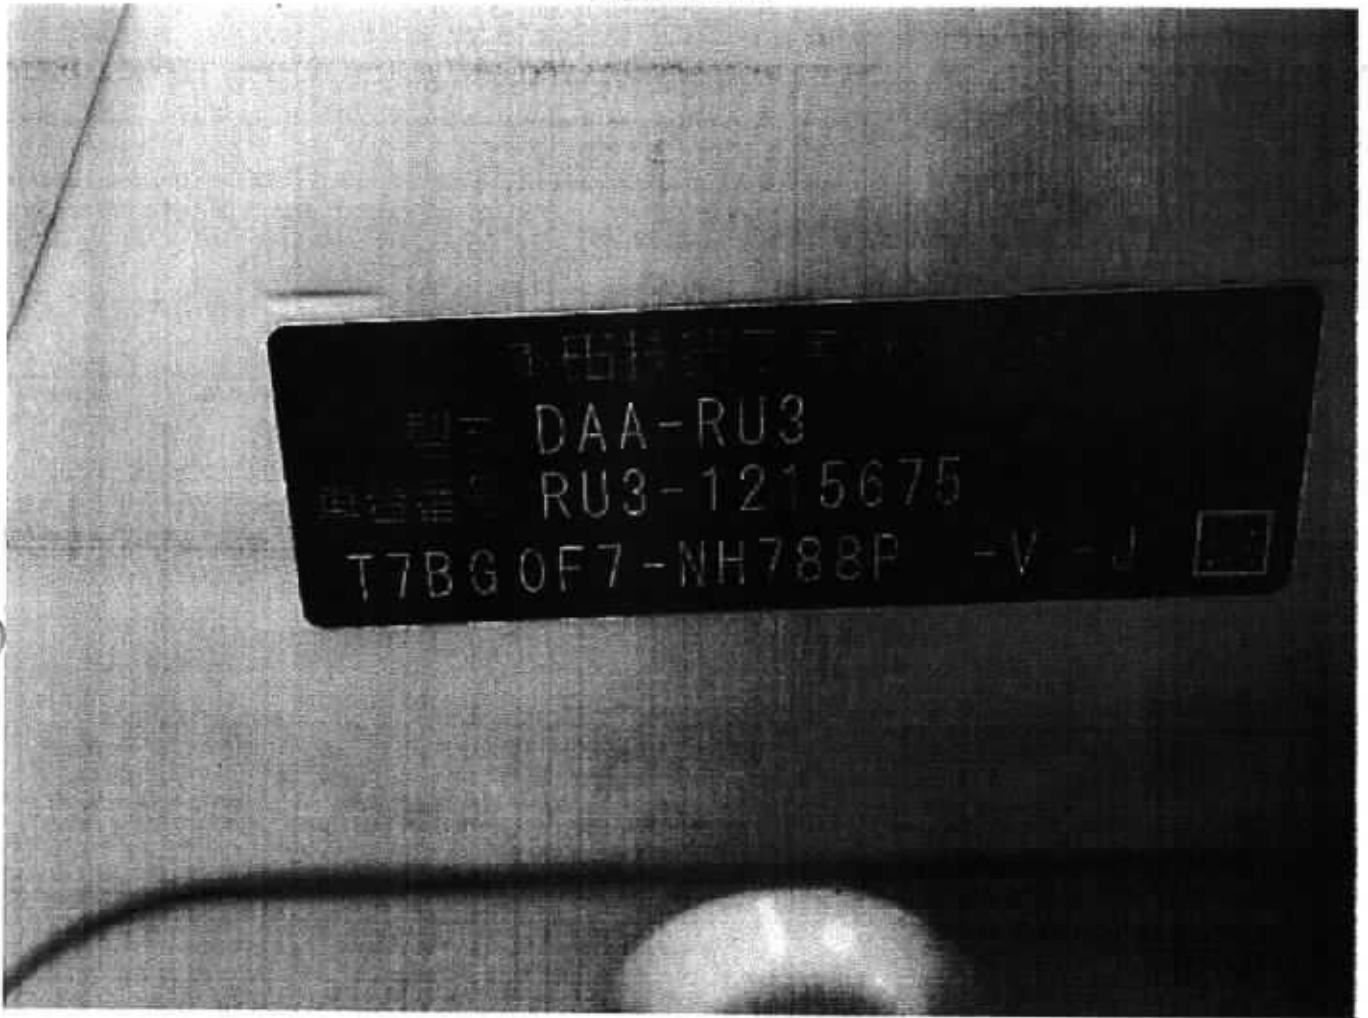
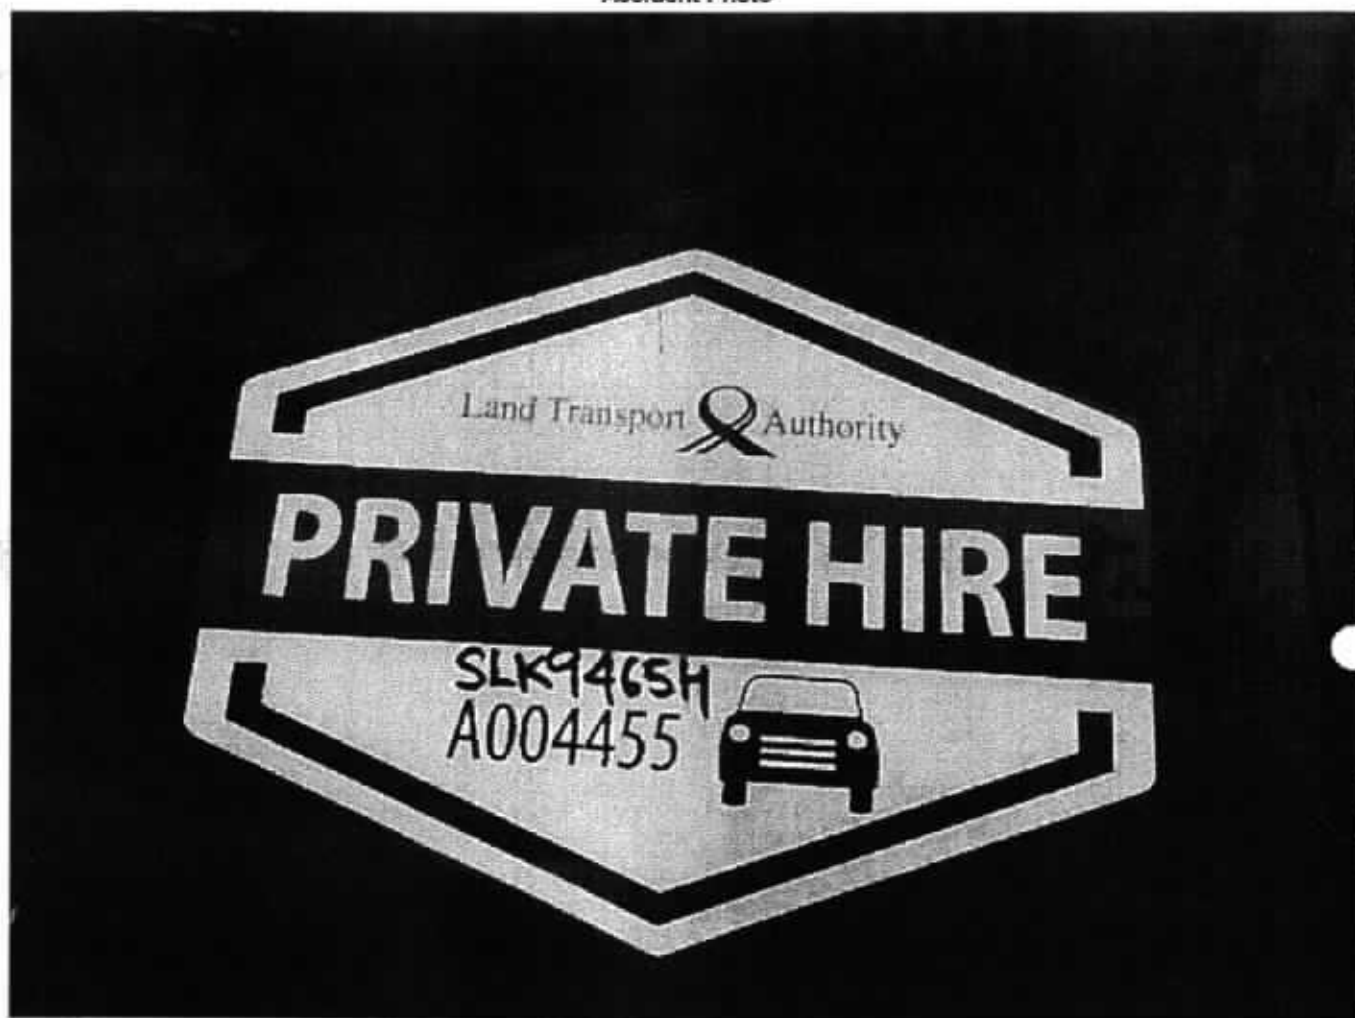
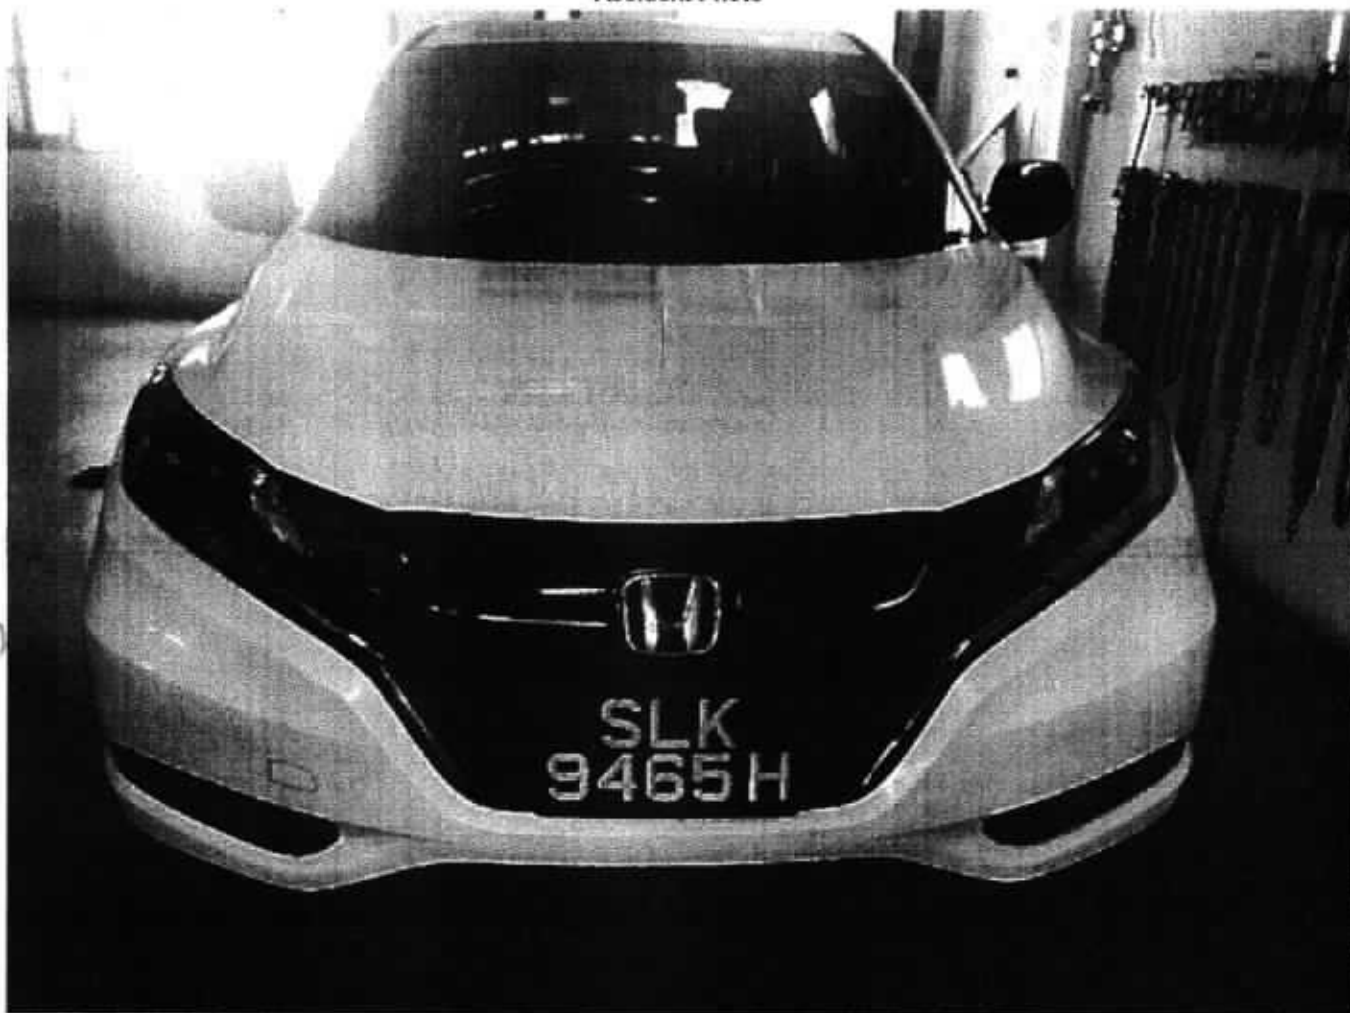
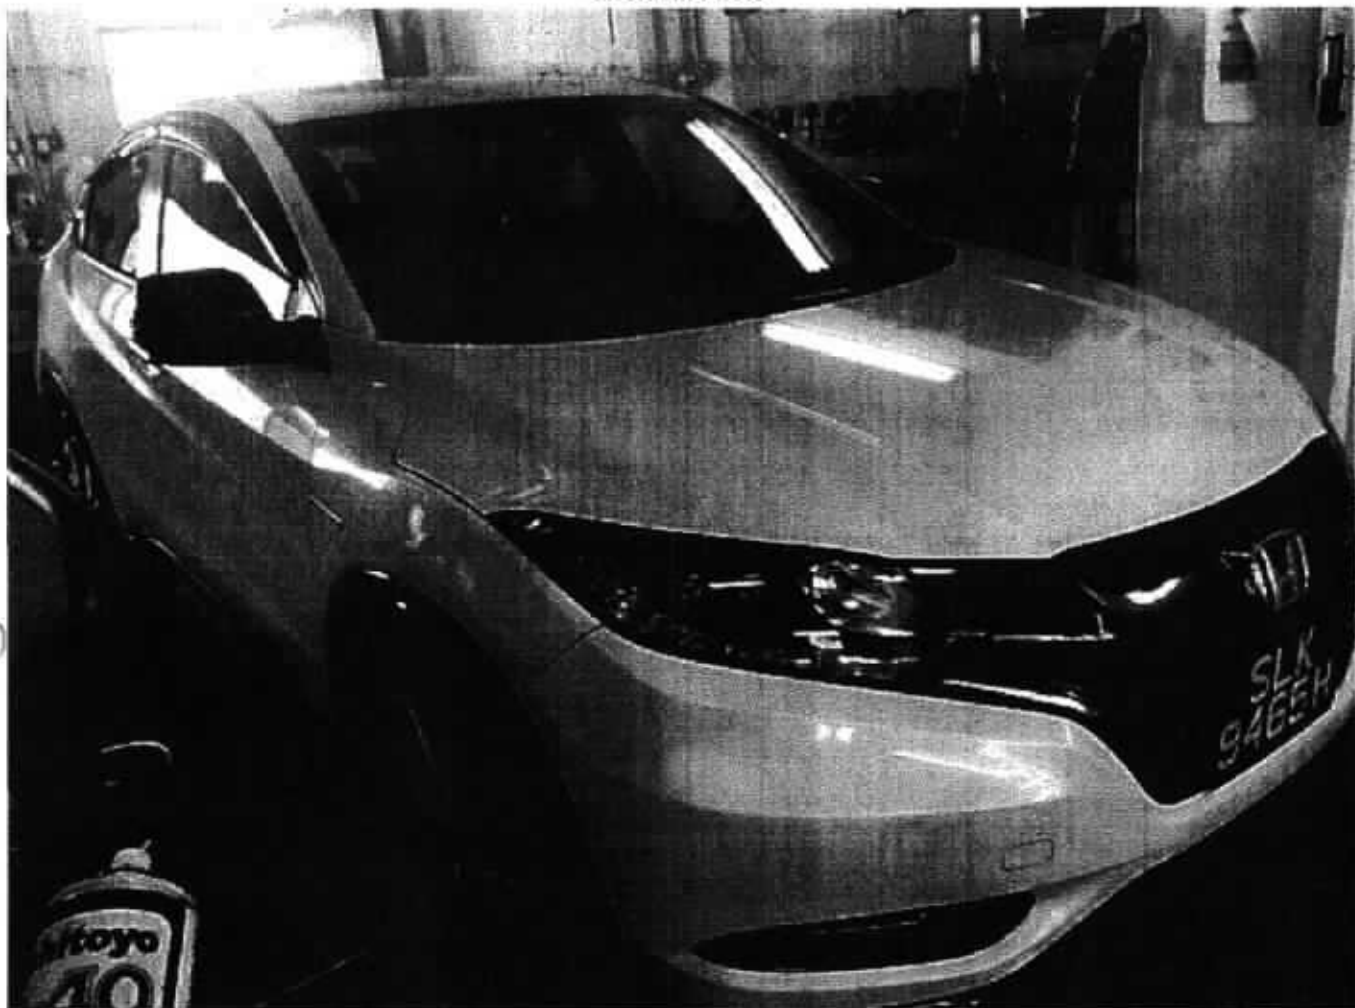
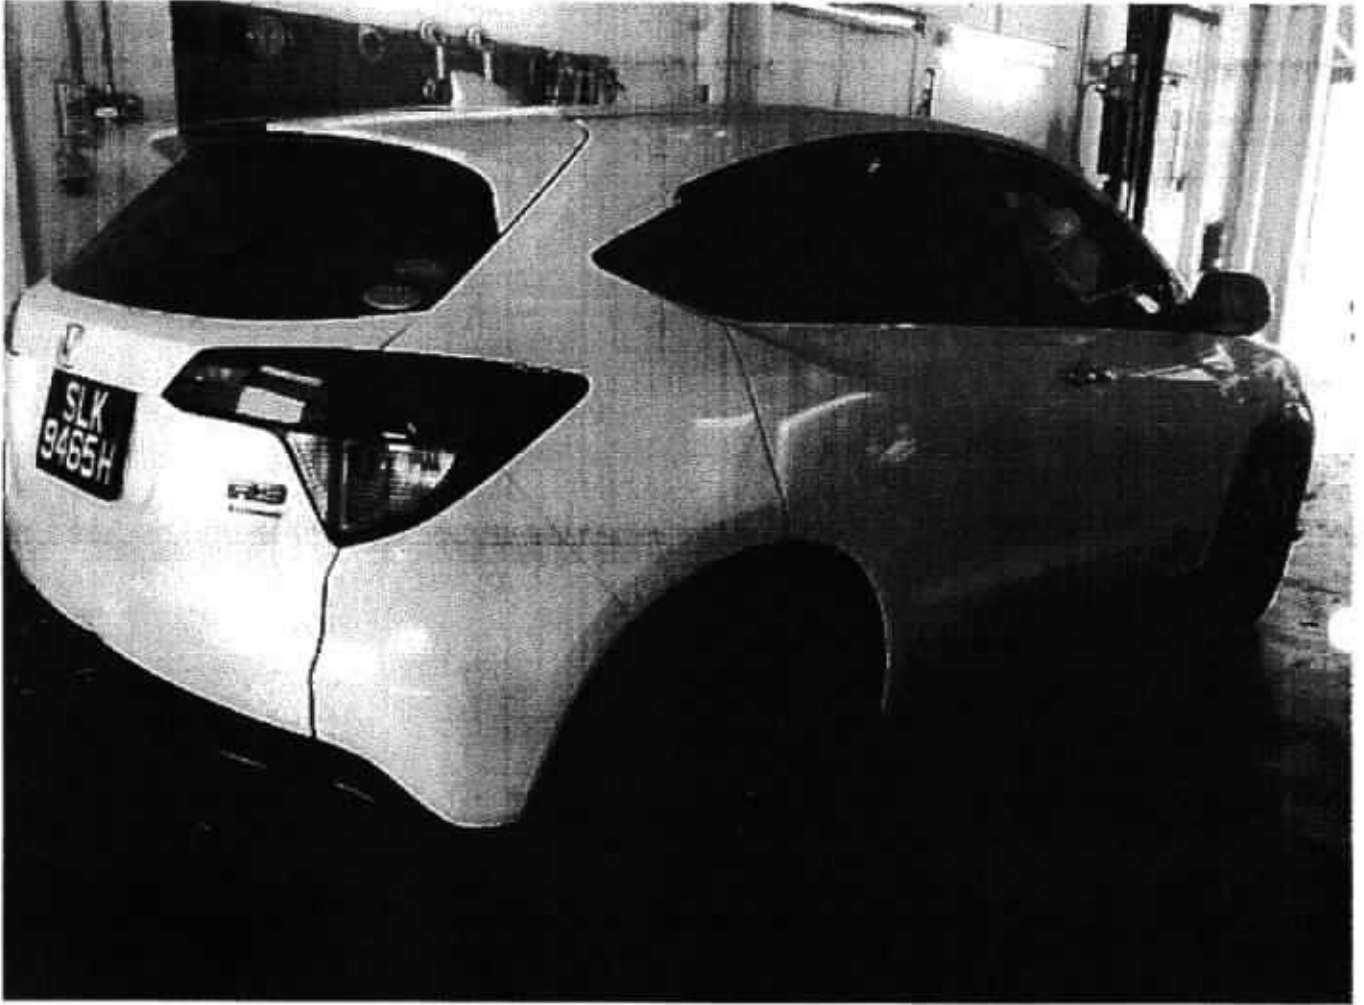
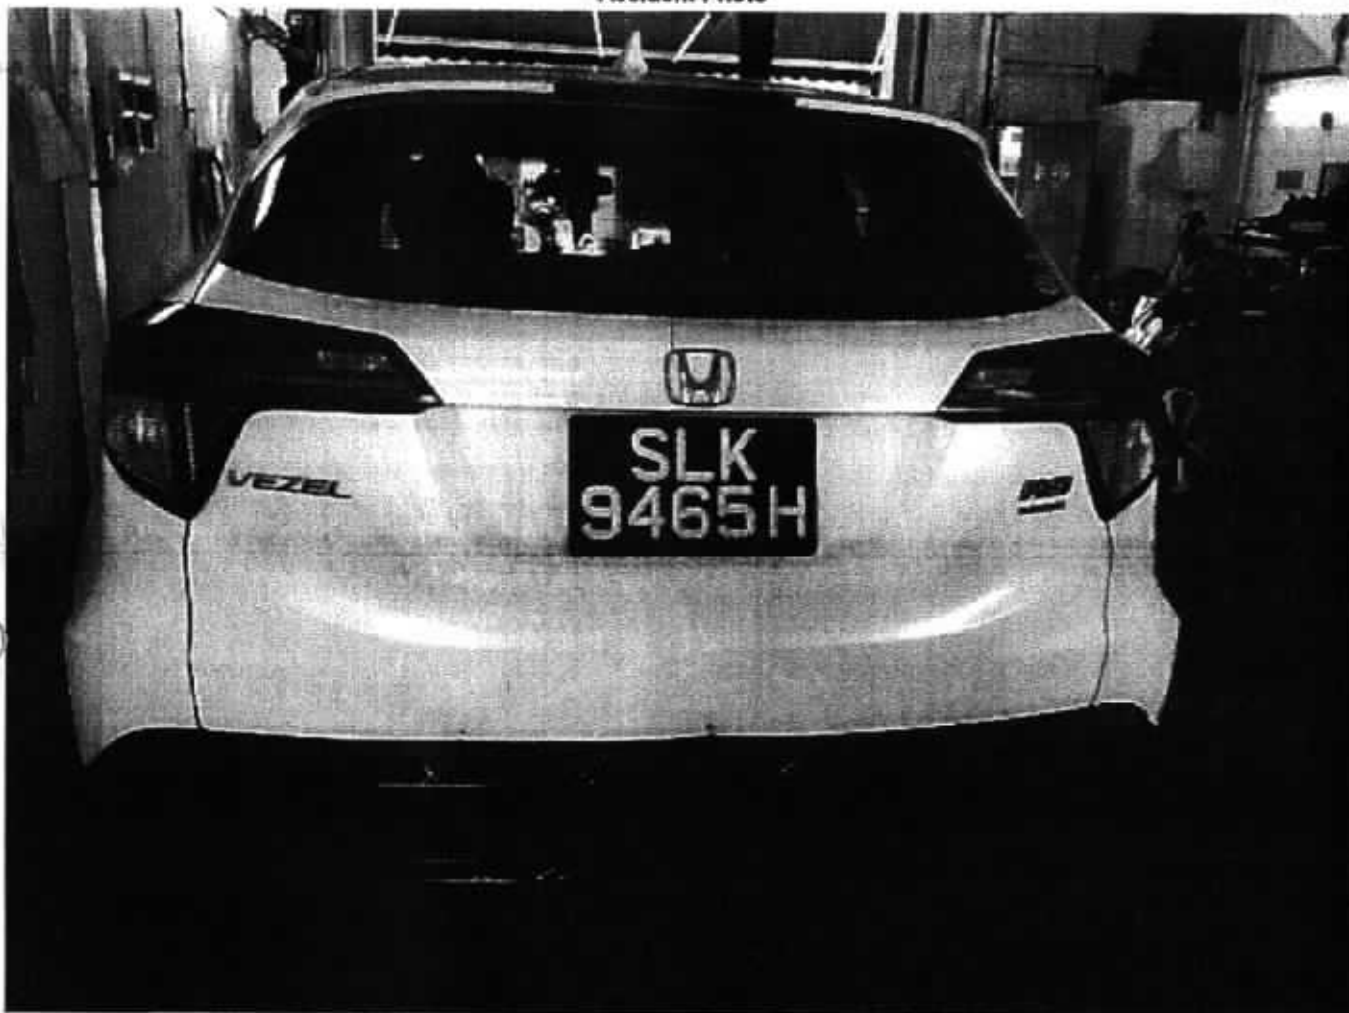
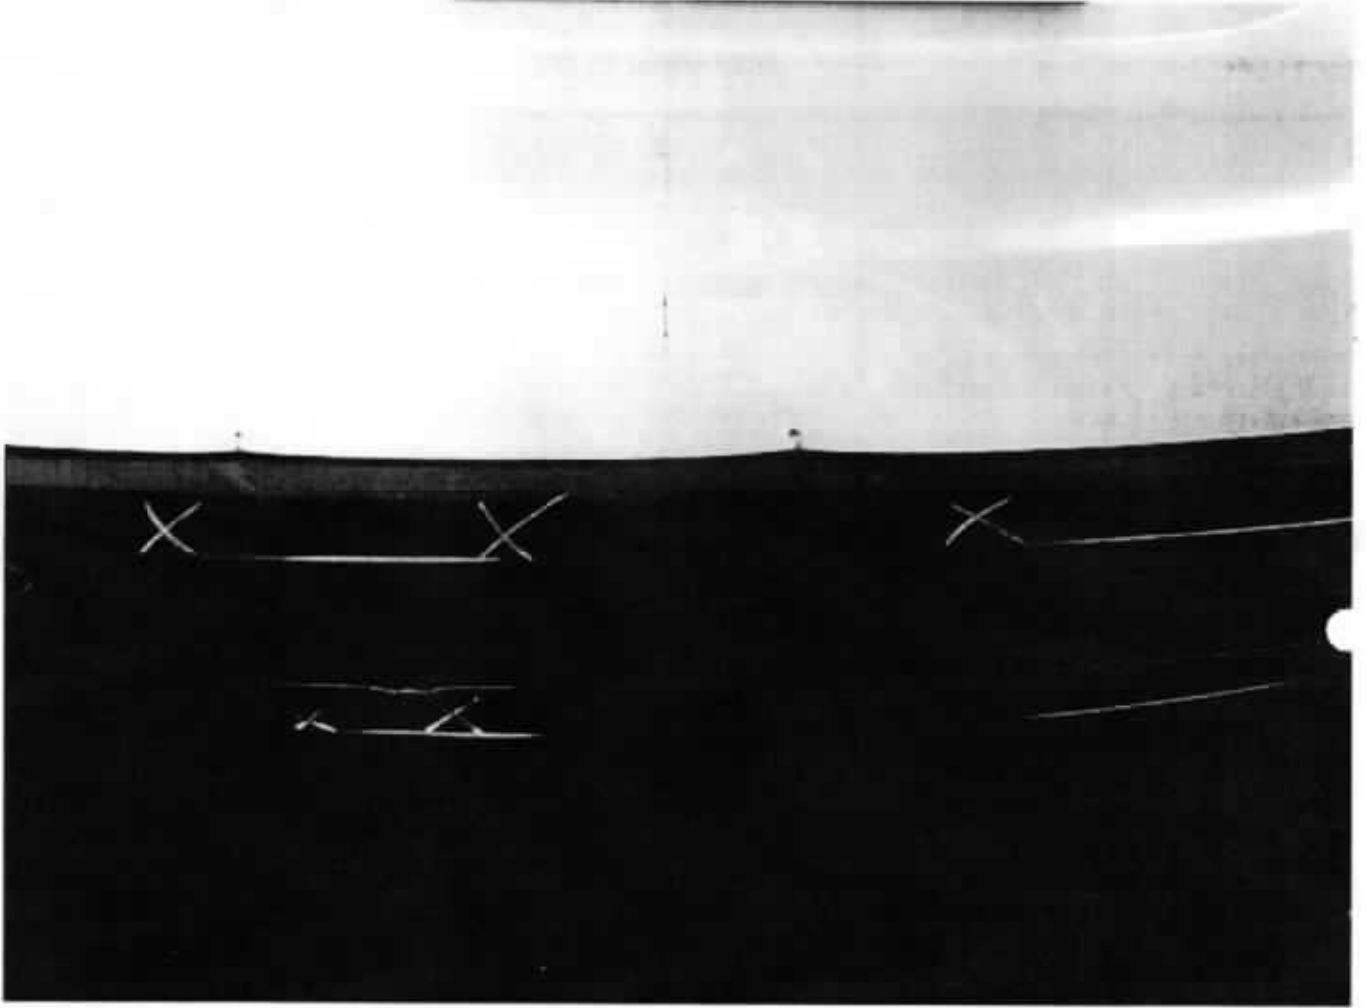
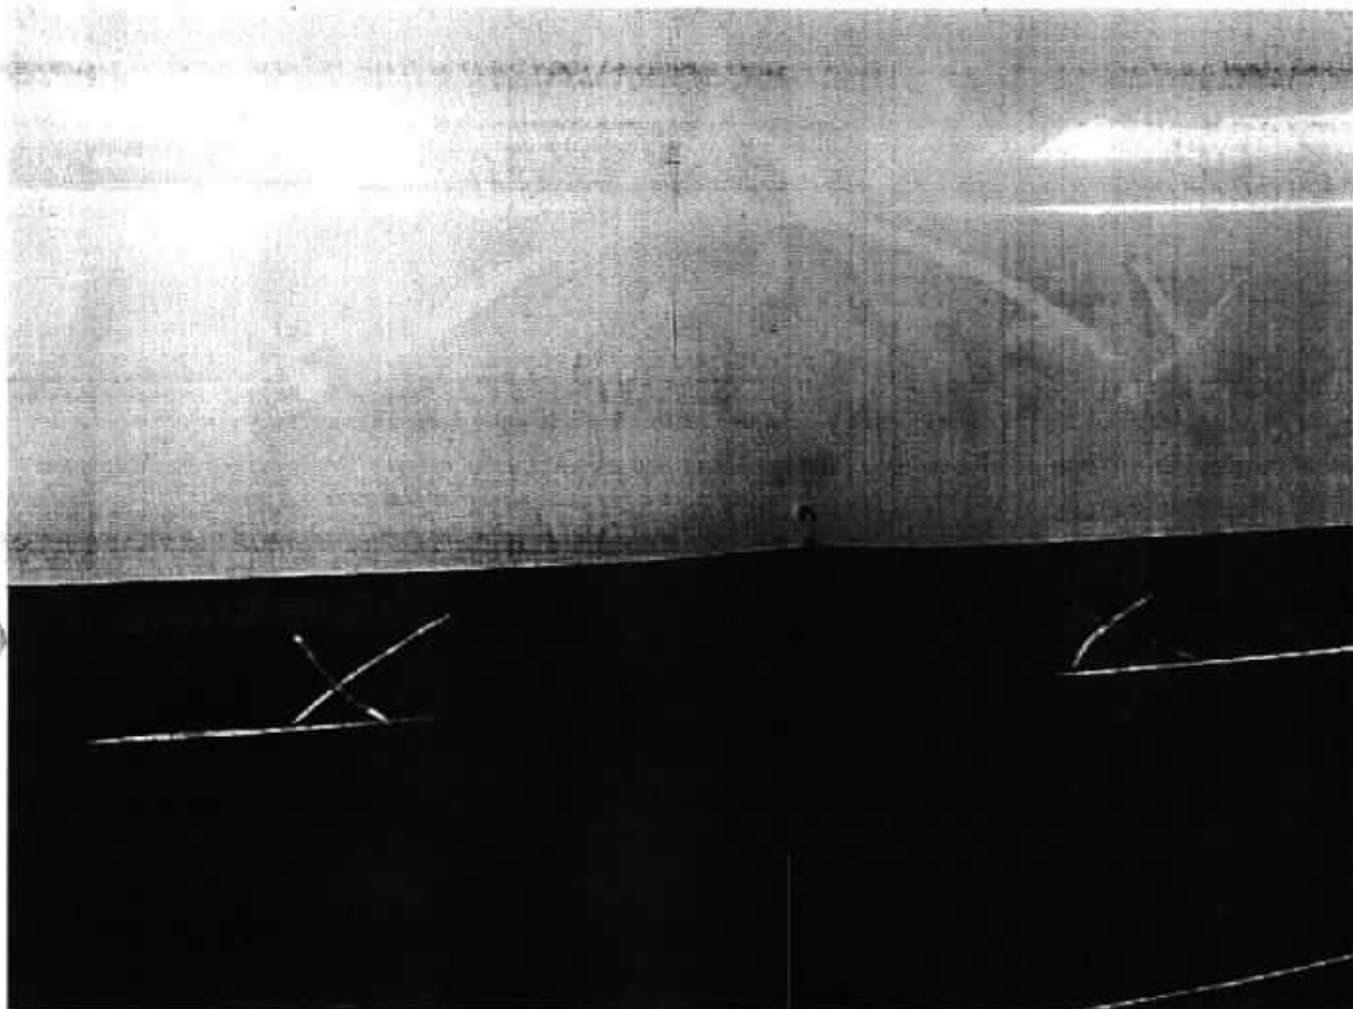
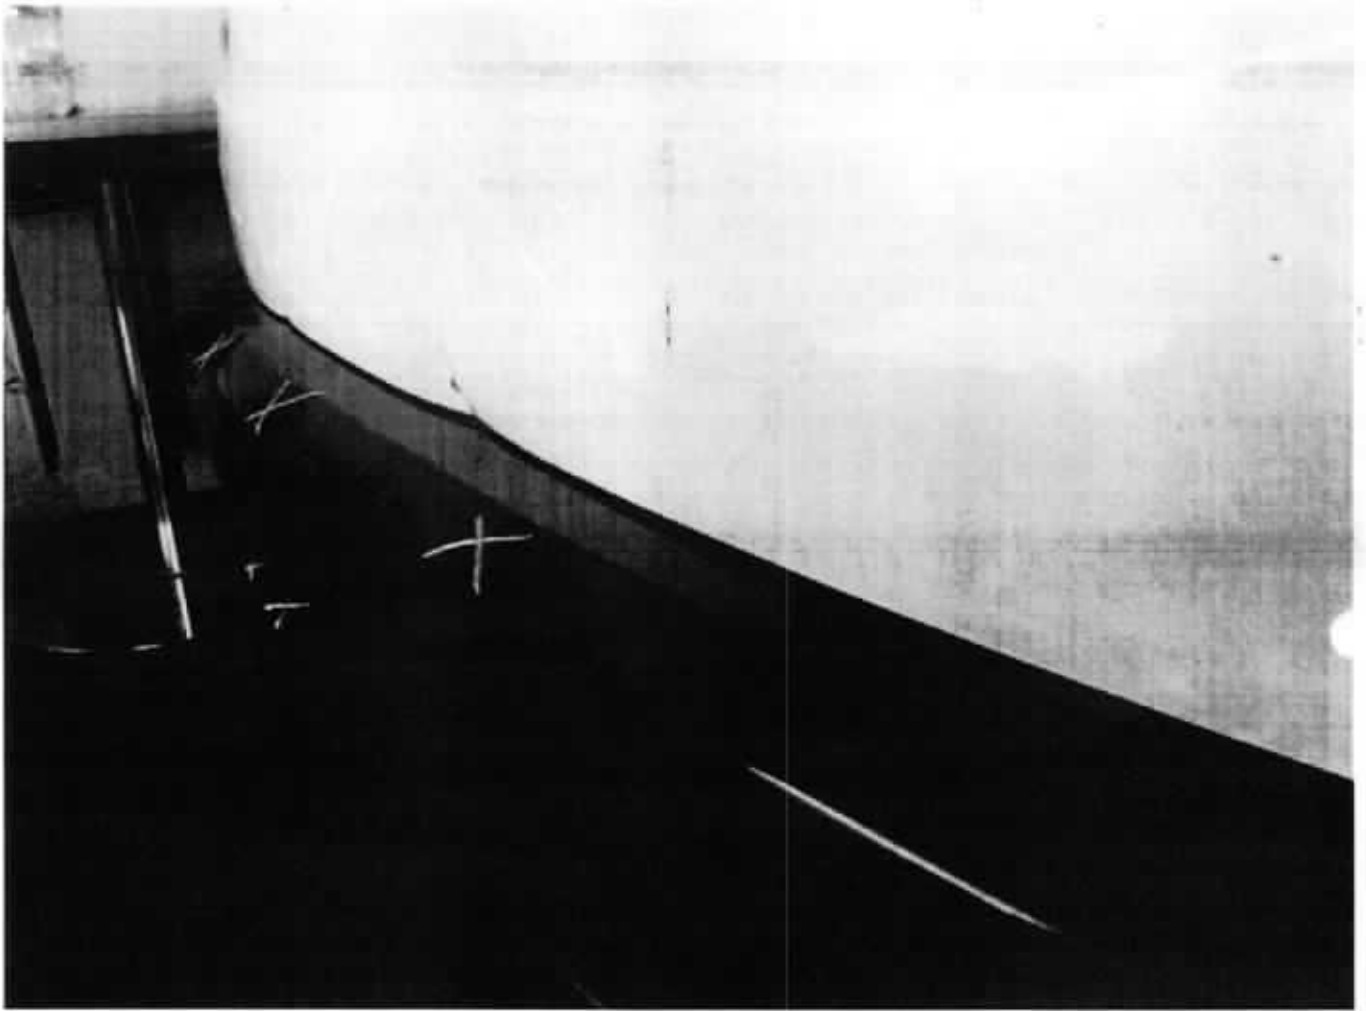
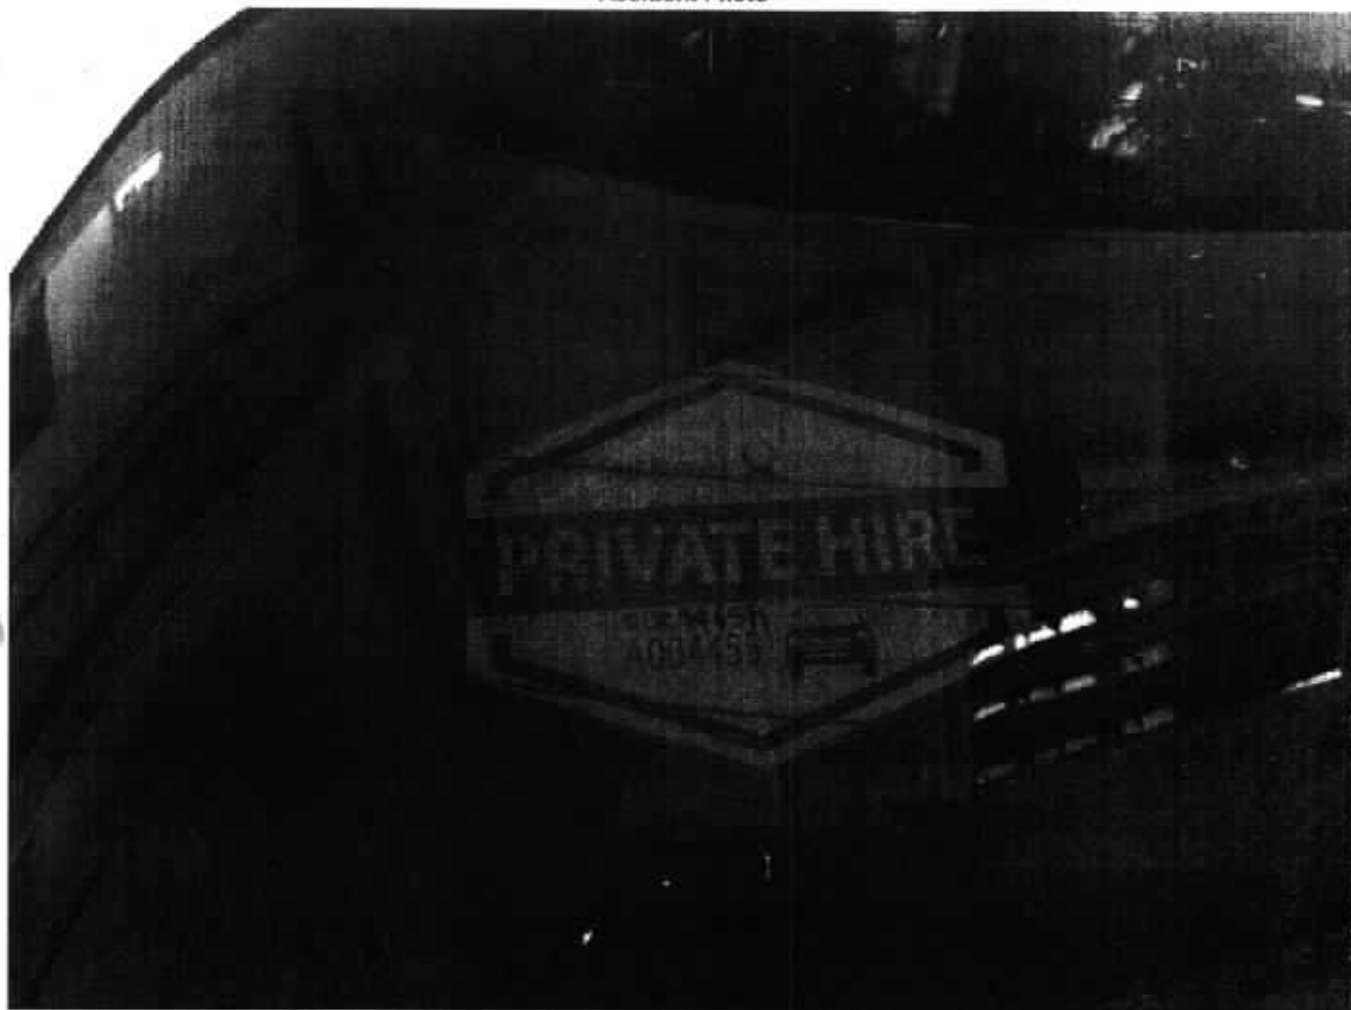
Type Of Accident	COLLISION - HEAD TO REAR
Weather Conditions	CLEAR
Road Surface	DRY
