Preliminary Advice

Insured Vehicle No	: SLN7138A	Accident Date	: 06/08/2018
TP Vehicle No	: SHC1102Y	Assignment Date	: 08/08/2018
Make	: TOYOTA PRIUS	Est. Duration of Repair	: 4.00
Date of Inspection	: 08/08/2018		
Inspection At	: COMFORTDELGRO ENGINEERING PTE LTD (LOYANG) 59 LOYANG DRIVE SINGAPORE 508969

The vehicle sustained impact / damages front o/s portion and parts claimed are consistent to the accident.

VEHICLE DAMAGE INSPECTION REPORT

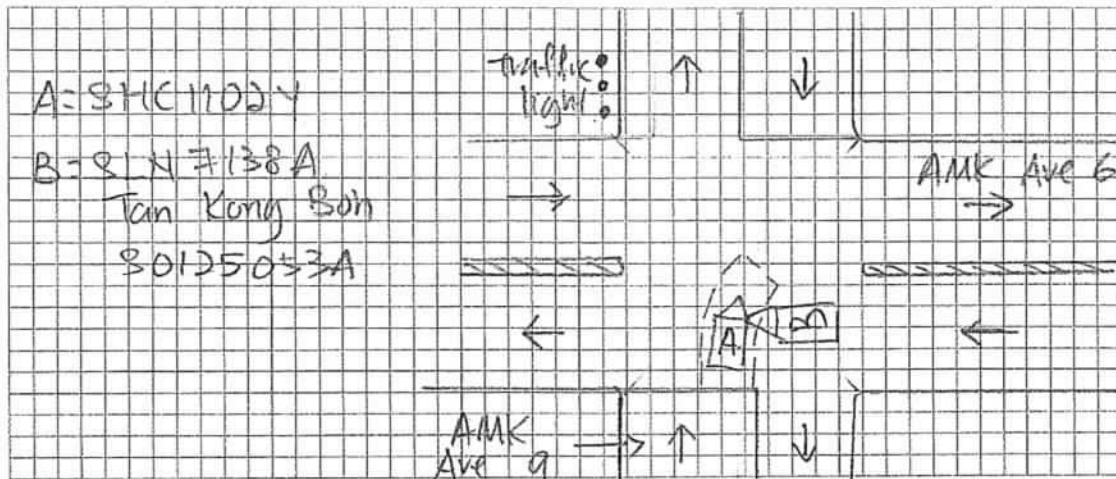
SKETCH PLAN

On 6/8/18 at about 21:05 hrs, I was driving along AMK Ave 9 towards AMK Ave 6. I switched on signal to indicate my intention going turn to Amk Ave 6, I slowly turning to another side junction as traffic light at my favor. Suddenly Veb B come out from my right hand side, i immediately applied brake upon seeing this but it was too late. As a result, the Veb B front left portion hit onto the right front portion of my taxi. 02 female passengers on board my taxi. I felt pain on my neck and right leg after the accident.
