Ref : CS/MSG18014458/Usd3

Preliminary Advice

Insured Vehicle No	: EV6699U	Accident Date	: 30/06/2018
TP Vehicle No	: SGS125R	Assignment Date	: 08/08/2018
Make	: VOLKSWAGEN JETTA GP	Est. Duration of Repair	: 3 days
Date of Inspection	: 13/08/2018		
Inspection At	: Sm Automotive - Kaki Bukit (HQ) BLOCK C - 1, KAKI BUKIT AVE 6, #01-43 Singapore 417883

VEHICLE DAMAGE INSPECTION REPORT

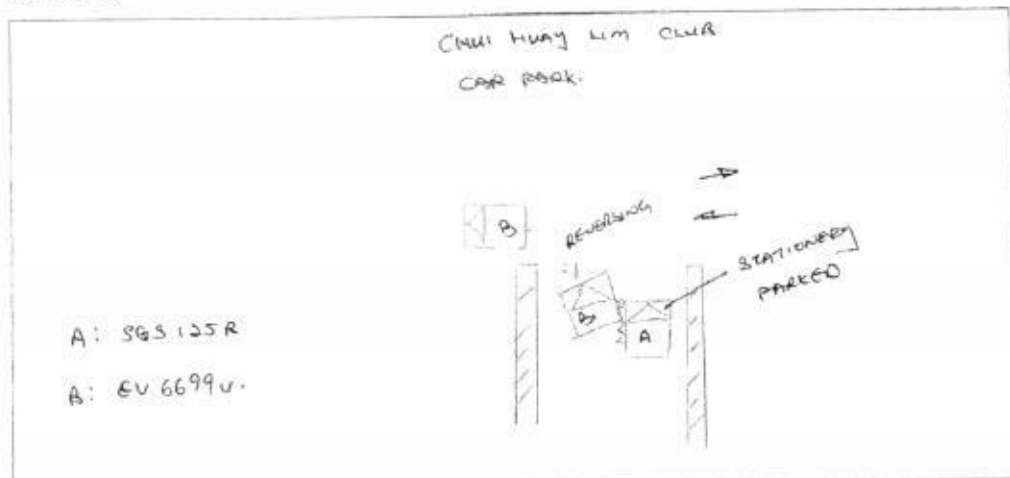
SKETCH PLAN

ON THE 30-06-2018, I PARKED MY VEHICLE AT THE CARPARK OF CHUI HUAY LIM CLUB AT ABOUT 1915HRS AND WENT FOR DINNER AT THE SAID CLUB. AT ABOUT 2230HRS, I WENT BACK TO MY CAR AND REALISED THAT THERE WAS DAMAGE ON THE LEFT SIDE OF MY VEHICLE. I THEREFORE CHECK ON MY IN-CAR CAMERA AND SAW THAT A M/CAR EV 6699U HAD REVERSED HIS VEHICLE AND COLLIDED ONTO MY STATIONARY PARKED VEHICLE. AFTER THE ACCIDENT THE CAR EV 6699U DROVE OFF AND THE DRIVER OF THE SAID M/CAR ALSO DID NOT COME DOWN AND CHECK BEFORE HE LEFT.
