To Inspect Vehicle No: SLE 382D

# LKK Auto Consultants Pte Ltd

## Policy Particulars :- THIRD PARTY CLAIM

## VEHICLE DAMAGE INSPECTION REPORT

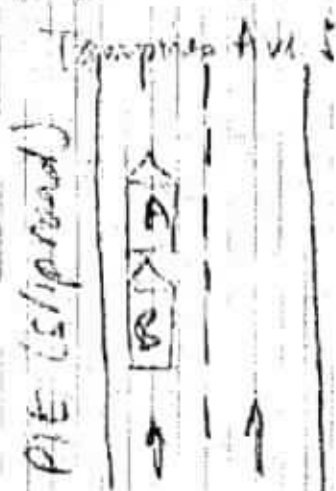
## SKETCH PLAN

A: SLE 382.D

B: GBE 2947E

On 8/8/18 @ 0735 hrs, I was travelling on PIE sliproad towards Tampines Ave 5.

There was a zebra-crossing in front of me. I stopped to allow a pedestrian to cross.

Suddenly vehicle B, GBE 2947E bang into my rear and caused severe damages to my car.
