cs3/MSG17024241/B7d3-1
ASSIGNMENT (001001)
10/08/2018

ACCIDENT DAMAGED VEHICLE INSPECTION REPORT (WITHOUT PREJUDICE)

REPAIR DETAILS (SFW 4381 G)

VEHICLE DAMAGE INSPECTION REPORT

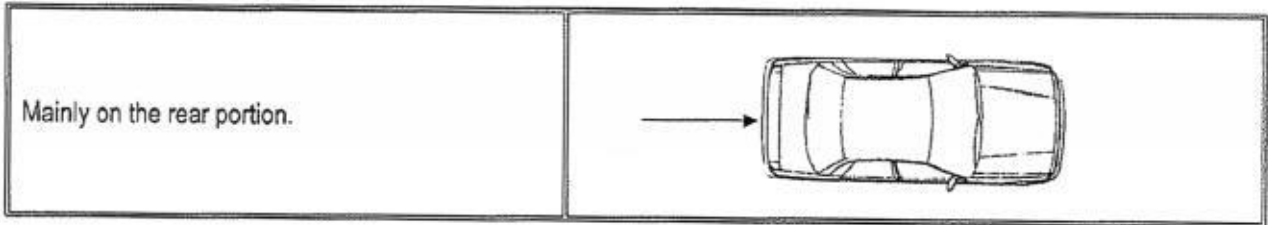
(5) POINT OF IMPACT

(6) GENERAL DESCRIPTION OF DAMAGES

The impact of the collision has damaged/affected the trunk lid, spare wheel floor panel, rear end panel, rear combination lamps, rear bumper fascia, exhaust muffler and etc.
Please refer to the Annex for a detailed account of the damages and photographs taken.

(7) RECOMMENDATION

We have inspected thoroughly the actual damages found on the vehicle before we conclude as to whether the parts needed replacement or repairs. The estimated cost of repair submitted by the repairer is **\$12,592.75**. We have adjusted the cost to **\$10,947.50** and recommend that the repairs to be taken on a lump sum basis of **\$8,760.00**. In our opinion, the damaged parts are consistent with that caused by the accident.
