Ref : CS/TP18014587/Urbn2

1. Policy Particulars :- THIRD PARTY CLAIM

THE VEHICLE SUSTAINED DAMAGES AT THE O/S FRONT PORTION.
DAMAGES SEE DETAILS.

ADJUSTMENT ON REPAIR COST FOR VEHICLE NO. SDZ 8337S

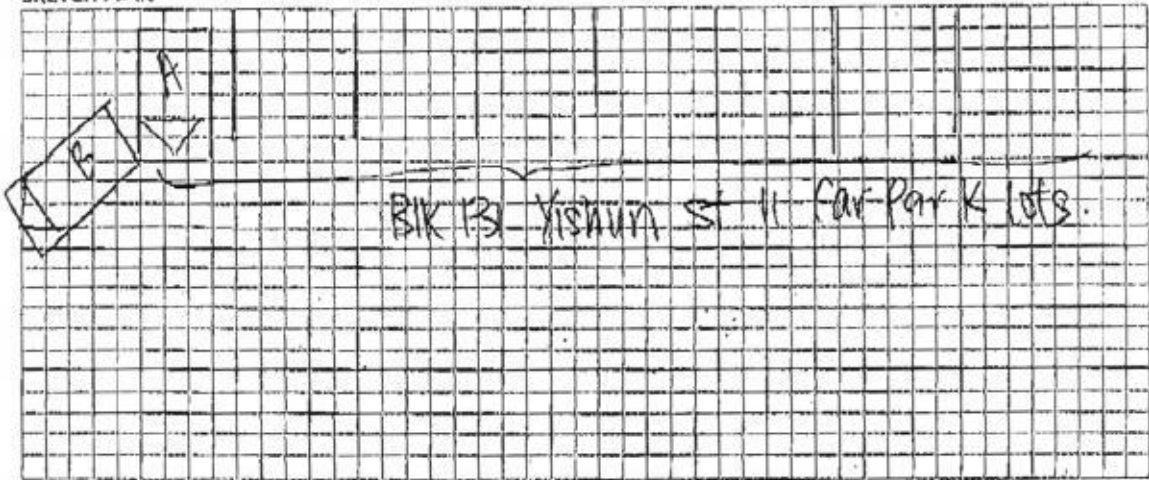
Sketch Plan #2 Pg. 1

DESCRIBE CIRCUMSTANCES OF THE ACCIDENT

On 01/08/18 at about 530pm, my car (A) was parked in a lot near to the gantry. I saw a note left on my front windscreen the next day morning (02/08/18). I called the number and the driver told me that while he was doing the reversing, he accidentally hit the front R/H side of my car (A). After quoting the driver the repair cost, he asked me to claim against the vehicle insurance.
