Ref : CS3/SPF18014646/Nz4b

**ACCIDENT INVOLVING GOVT VEHICLE QX 562 S AND OTHER VEHICLE SLL 9825 Y ON
21 July 2018**

DAMAGE ASSESSMENT REPORT

OPINION ON REPAIR COST FOR VEHICLE NO. SLL 9825Y

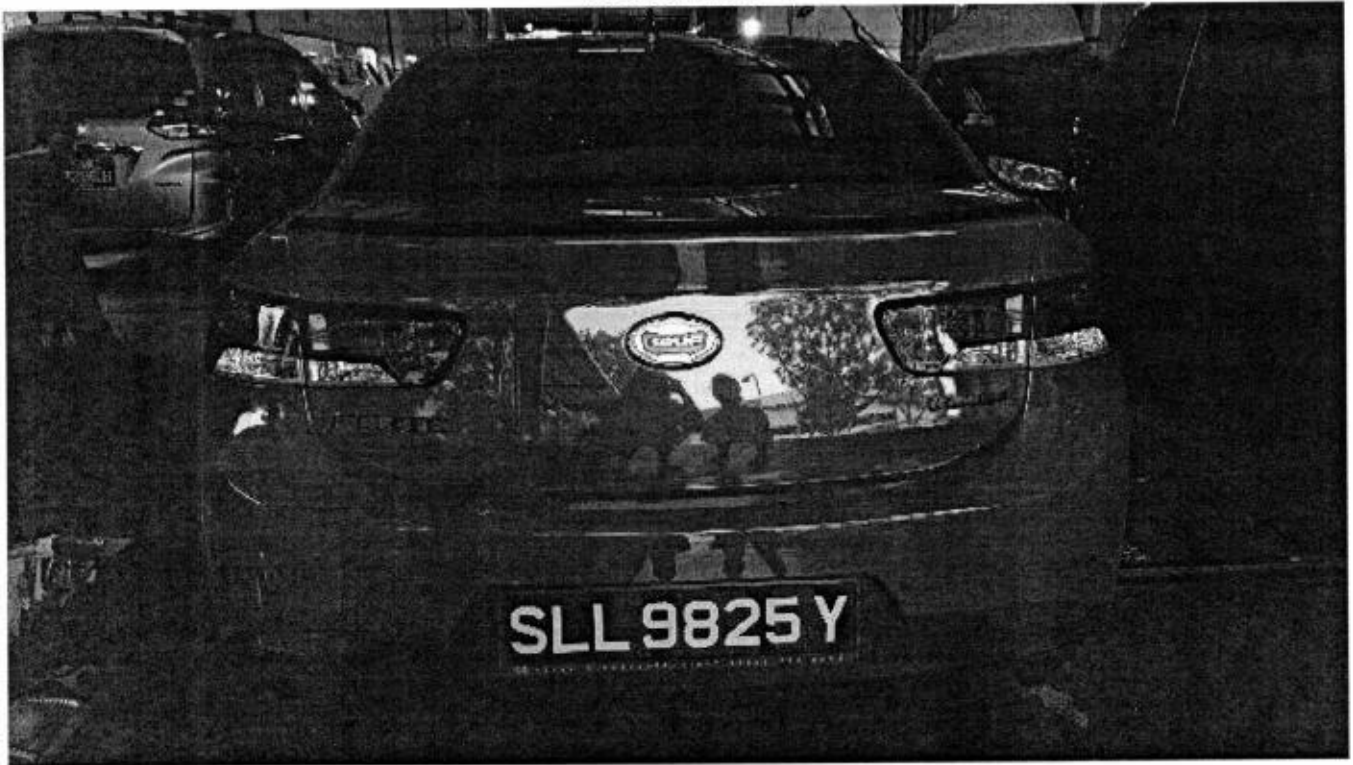
Accident Photo

The officer then informed me that she has to report the matter to her supervisor and Traffic Police. She had also taken photos of the damage. My car sustained a dent and scratches to the rear bumper. Traffic Police officer and her supervisor then came down. The Traffic Police officer then advised me to lodge a Traffic Accident Report under TP IO Sharulnizam Tel: 65476904 vide incident J/20180721/0158.

THE VEHICLE SUSTAINED DAMAGES AT THE REAR PORTION. DAMAGES SEE DETAILS.
--

Qty	Description of Parts	Condition	Recommended (\$)
REPLACEMENT OF PARTS			
1	REAR BUMPER	CUT	685.00
1	REAR BUMPER LOWER	CUT	150.00
1	REAR BUMPER CLIPS (@ \$45.00 DISC 10%)	NECESSARY	40.50
1	REAR BUMPER SPONGE	DENTED	151.00
			1,026.50
LABOUR			
	PAINTING OF REAR BUMPER.		200.00
	RNR THE REAR BUMPER.		400.00
			600.00
GRAND TOTAL			1,626.50
RECOMMENDED COST OF LUMP SUM REPAIRS (TO ITS PRE-ACCIDENT CONDITION)			1,300.00
