Preliminary Advice

Estimated repair cost for vehicle no: SGE3358P MAZDA 6 2.0 A 4DR '16

VEHICLE DAMAGE INSPECTION REPORT

Handling Insurer:	MSIG Insurance (Singapore) Pte. Ltd.	Policy No:	MSD/MT/17-374303-CA	Claim No:	MSC/118-001100
Claimant Vehicle No :	SGE3358P	Insured Vehicle No :	FBM3699Y		
Date of Loss:	13/08/2018	Nature of Claim:	TP

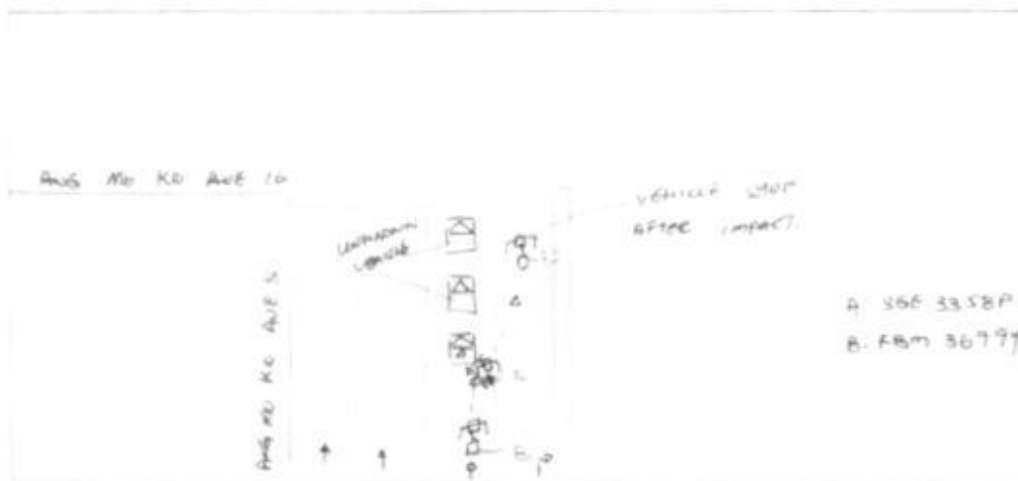
SKETCH PLAN

I WAS TRAVELLING ALONG THE SECOND RIGHT LANE OF A LANE ALONG ANGUS MC KD AVE 5, WHILE TRAVELLING, I CAME TO A STOP BEHIND VEHICLE AT THE JUNCTION WITH ANGUS MC KD AVE 10, DUE TO TRAFFIC RED LIGHT AHEAD. WHILE WAITING FOR THE TRAFFIC LIGHT TO TURN GREEN, ONE MOTORCYCLE FBM 36994 CAME FROM MY REAR AND COLLIDED INTO THE REAR RIGHT PORTION OF MY STATIONARY STOP VEHICLE. AFTER THE ACCIDENT, WE BOTH STOP TO EXCHANGE PARTICULAR AND THE RIDER ALSO ADMITTED HIS FAULT.
