# ASSIGNMENT

Veh No: SLQ 4997R Yr Regn: 2017, July  
 Type: M. Car / M. Cycle / Bus / Van / Lorry / Taxi / Prime Mover /  
 Truck / Trailer or  
 Make: Opel Mokka c.c. 1598  
 Colour: Brown A/C: Insured / Std / NI / NA  
 Sp. Reading: 5792 T/Radio: Insured / Std / NI / NA  
 Eng/No: A2170185GU7X0563  
 C/No: W0LJD7EC2HB181508  
 Gen. Cond: Good / Fair / Poor / Burnt  
 Steering: In order / Jammed / Leaked / Burnt or  
 Brake: In order / Jammed / Leaked / Burnt or  
 Modi: Nil / S/Rim / STD A/Rim or  
 Tyre Size: F: 215/65 R18  
 R: ---

Survey held at BM2 Sin Ming  
 Des. of Damages: Frt / Rear / O/S / N/S / U/C / Rooftop or.  
N/S Body y N/S Rear  
 The U/C / Chassis frame / Body Structure affected due to collision.

## VEHICLE DAMAGE INSPECTION REPORT

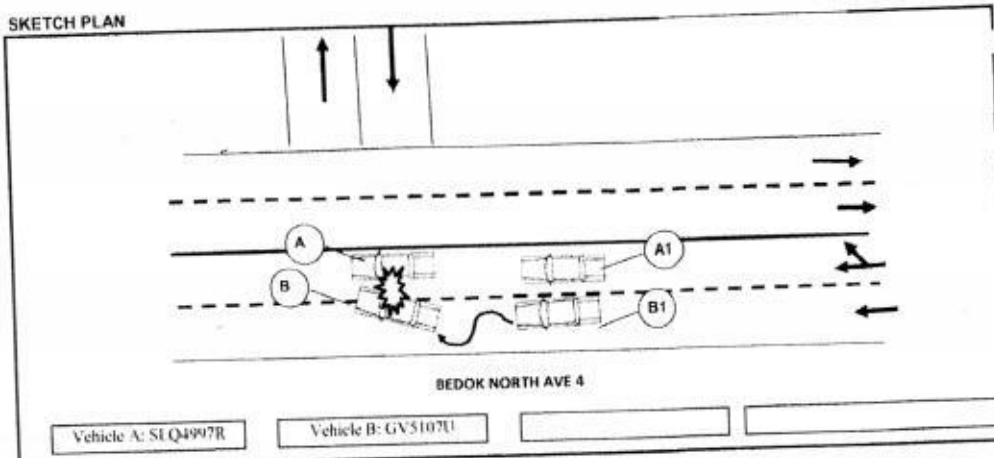
## SKETCH PLAN

MY VEHICLE WAS TRAVELLING ON THE RIGHT LANE OF BEDOK NORTH AVE 4. VEHICLE B WAS ON THE LEFT LANE. VEHICLE B WAS UNABLE TO MAKE UP HIS MIND AND SWERVING LEFT AND RIGHT ON THE LEFT AND ABIT ON THE RIGHT LANE. I PROCEED TO GO STRAIGHT. SUDDENLY, VEHICLE B MADE A SUDDEN RIGHT TURN (ILLEGAL U-TURN) AND HIT ONTO MY VEHICLE LEFT PORTION. AFTER THE ACCIDENT, WE STOPPED ON THE OPPOSITE EMPTY SPACE TO EXCHANGE PARTICULARS AND TAKE PHOTO. VEHICLE B DRIVER ADMITTED HIS FAULT AND SIGNED ON CONFESSION NOTE.
