## VEHICLE DAMAGE INSPECTION REPORT

Reg No:	SJM2045X	Make &	Nissan
Reg date:	24/12/2008	Model	Latio 1.5
Colour:	Grey	Engine No:	HR15037117B
Type:	Motor Car	Chassis No:	JN1BAAC11Z0020415
Type of Claims:	Third Party	Odometer No:	123117km
		Engine Cap:	1498cc

## ADJUSTMENT ON REPAIR COST FOR VEHICLE NO. SJM 2045X

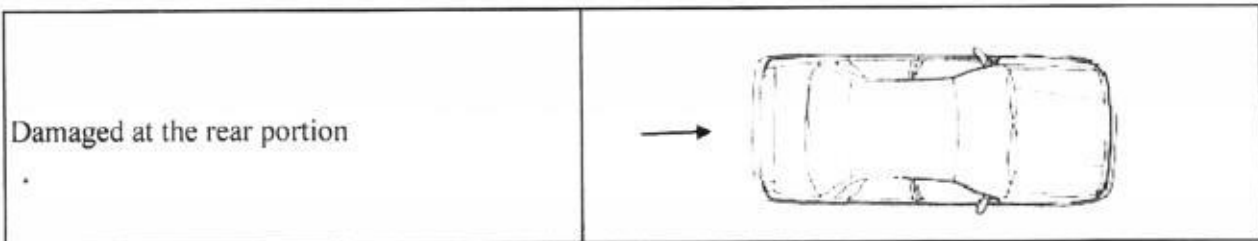
### POINT OF IMPACT

The Insured's vehicle collided onto the Third Party's vehicle along TPE Expressway.

Our visual inspection of the vehicle revealed that the damages noted are at the rear portion.

We have inspected the actual damages found on the vehicle and recommend the replacement of parts and repairs accordingly. The estimated repair cost is \$8,291.09. The repairer has agreed to undertake the repairs at our adjusted lump sum amount of \$6,200.
