RTA ON 14 AUGUST 2018 INVOLVING GOVT VEH GZ3371P AND YOUR CLIENT'S VEH GU4394T

DAMAGE ASSESSMENT REPORT

AUTOMOTIVE ENGINEERING & MGT DIVISION Ref: CS3/SPF18015023/Grd3s2

OPINION ON REPAIR COST FOR VEHICLE NO. GU 4394T

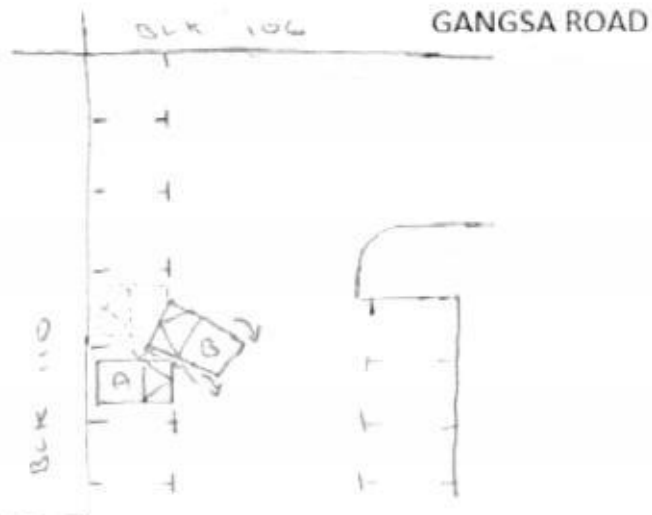
SKETCH PLAN

DESCRIBE CIRCUMSTANCES OF THE ACCIDENT

AS PER POLICE REPORT

VEHICLE A - GU 4394 T (STATIONARY PARKED)
VEHICLE B - G2 3571 P (POLICE VEHICLE)
