CHINA TAIPING INSURANCE (S) PTE LTD

Ref : CS/CTI18015029/Ktd3

Insured Veh.	YP 8449G	Veh. Inspected	SJG 1261H
Policy No.		Coverage (\$)	0.00
Claim No.	SNM18D03992C02/9	Excess (\$)	0.00
Assign From	MERIMEN (HWANG SHIANG YI)	Assign Date	17/08/2018

VEHICLE DAMAGE INSPECTION REPORT

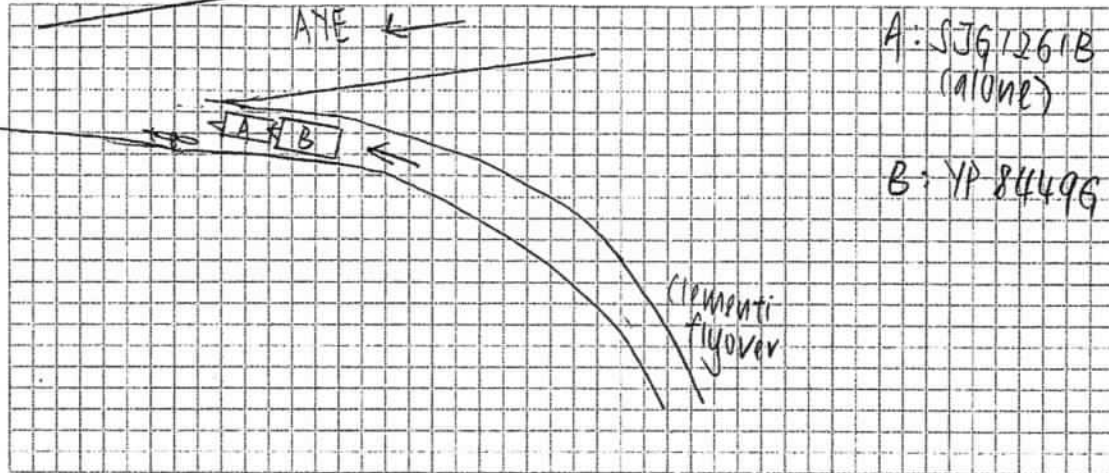
SKETCH PLAN

Vehicle No: SJ61261B (AXA)
Date & Time: 15/08/2018 @ 1725
Location: From Clementi flyover towards AYE
Unknown motor bike stop before the slip road, i follow too
Next moment, an impact came from the rear. Motor lorry
YP 84496 had hit onto my vehicle rear portion.
