VEHICLE DAMAGE INSPECTION REPORT

Our File No: CS/MSG18015130/AQD3E2

Claimant Vehicle
No : SLM9386S

Make & Model: TOYOTA COROLLA, 1.5 X AXIO (A)

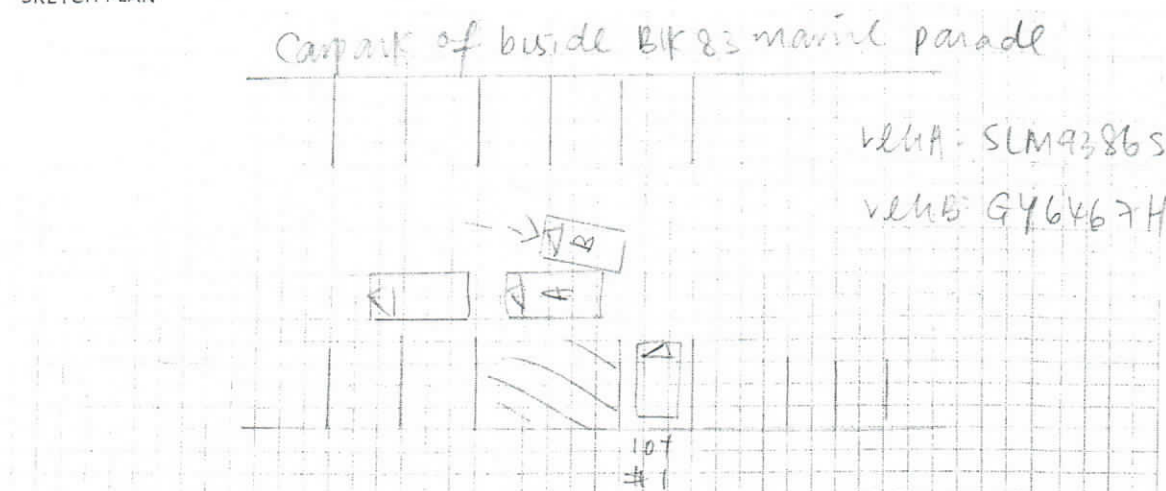
SKETCH PLAN

On 15 August 2018, I, Chua Meng Hwei Serene of NRIC: S7524557B, drove vehicle number SLM 9386S to carpark MP 15 beside Block 83 Marine Parade Central S440083 at approximately 1120.

At that point in time, a van with vehicle number GY6467H driven by Su Fanhu was parked perpendicular to motorcyclist lots & carpark lot #1. As I saw Su Fanhu entering his van, I drove passed him & positioned my car in front of his van while waiting for available parking lot.

Su drove off from his position, but as he saw the car that was parked at carpark lot #1 left, he quickly reversed & knocked into the rear of my vehicle which was stationary.
