To inspect Vehicle No: SHC 6015H

ESTIMATE REPAIR BILL FOR KIA OPTIMA REGN NO: SHC 6015 H

ACCIDENT INVOLVING SHC6015H, SHD3494Y & OTHERS ALONG AYE – TUAS ON 16.08.18

VEHICLE DAMAGE INSPECTION REPORT

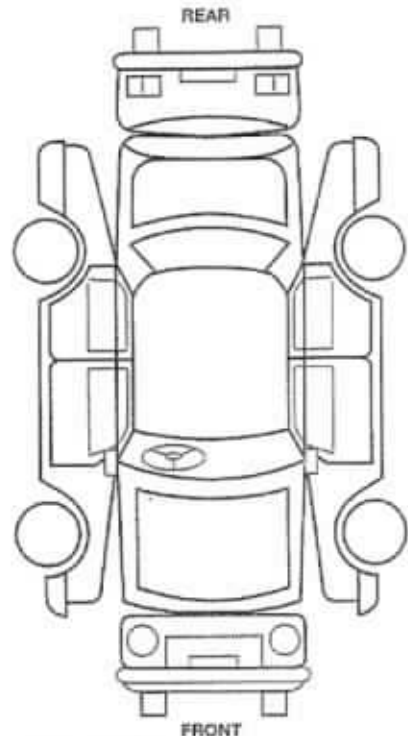
INDICATE AREA OF DAMAGE HERE:

SERVICE / REPAIRS DONE	DRIVER'S REMARKS
<input type="checkbox"/> SERVICING <input type="checkbox"/> T / BELT <input type="checkbox"/> AIRCON SYSTEM <input type="checkbox"/> TURBO <input type="checkbox"/> BRAKE SYSTEM <input type="checkbox"/> CLUTCH SYSTEM <input type="checkbox"/> BULB <input type="checkbox"/> UNDER CARRIAGE <input type="checkbox"/> CPF <input type="checkbox"/> BATTERY	<p>OTHERS: TP / V</p> <p>ACCIDENT: DATE / TIME OF ACCIDENT: 160818 1400</p>
