**SINGLE JOINT EXPERT FOR THE PLAINTIFF'S MOTOR VEHICLE NO. SKT 6078B  
M C SUIT NO. 15483 OF 2017  
ROAD TRAFFIC ACCIDENT ON 4/6/2017 INVOLVING VEHICLE NOS. SKT 6078B AND PA 8604K**

# Treasure Appraisal Services

## VEHICLE DAMAGE INSPECTION REPORT

### ADJUSTMENT ON REPAIR COST FOR VEHICLE NO. SKT 6078B

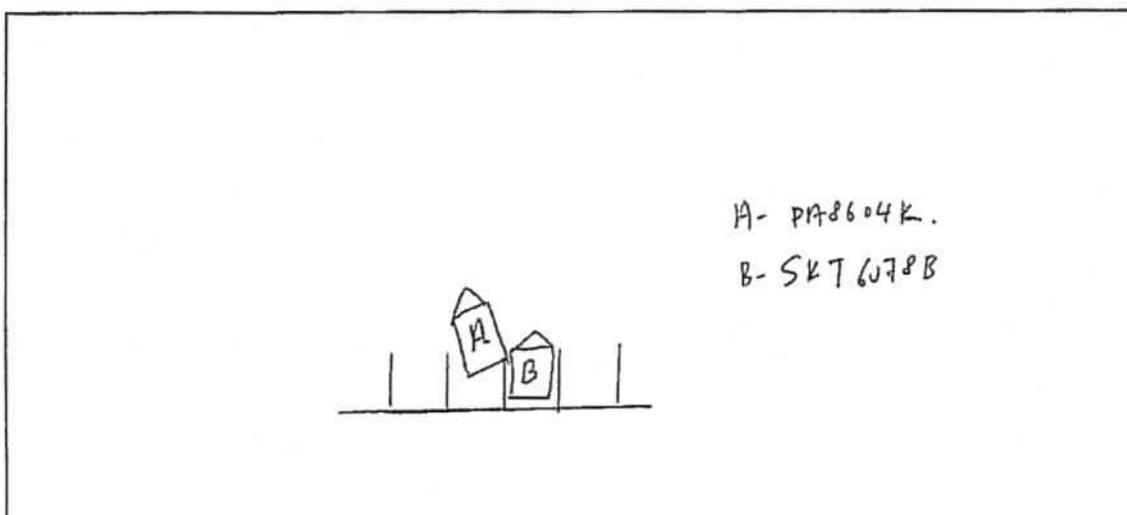
Sketch Plan

When I check my car, the left passenger side got  
damage. I call the mobile number and he admits  
he hit my car at 1800h on the 5th Jun 2017 when he  
try to park. He then ask me to make insurance report.
