VRN : SLH 2000 H.
 Make : MB C43 AMG
 Workshop Binau

4. Description of Damages

THE VEHICLE SUSTAINED DAMAGES AT THE ROOFTOP. DAMAGES SEE DETAILS.

ADJUSTMENT ON REPAIR COST FOR VEHICLE NO. SLH 2888H

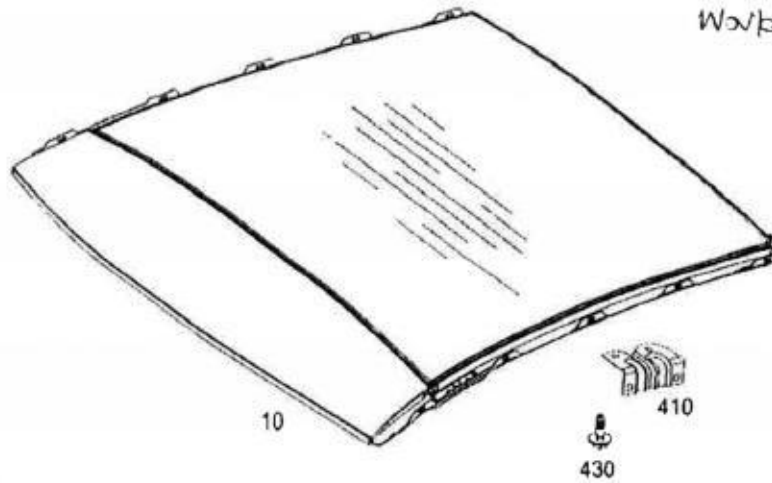
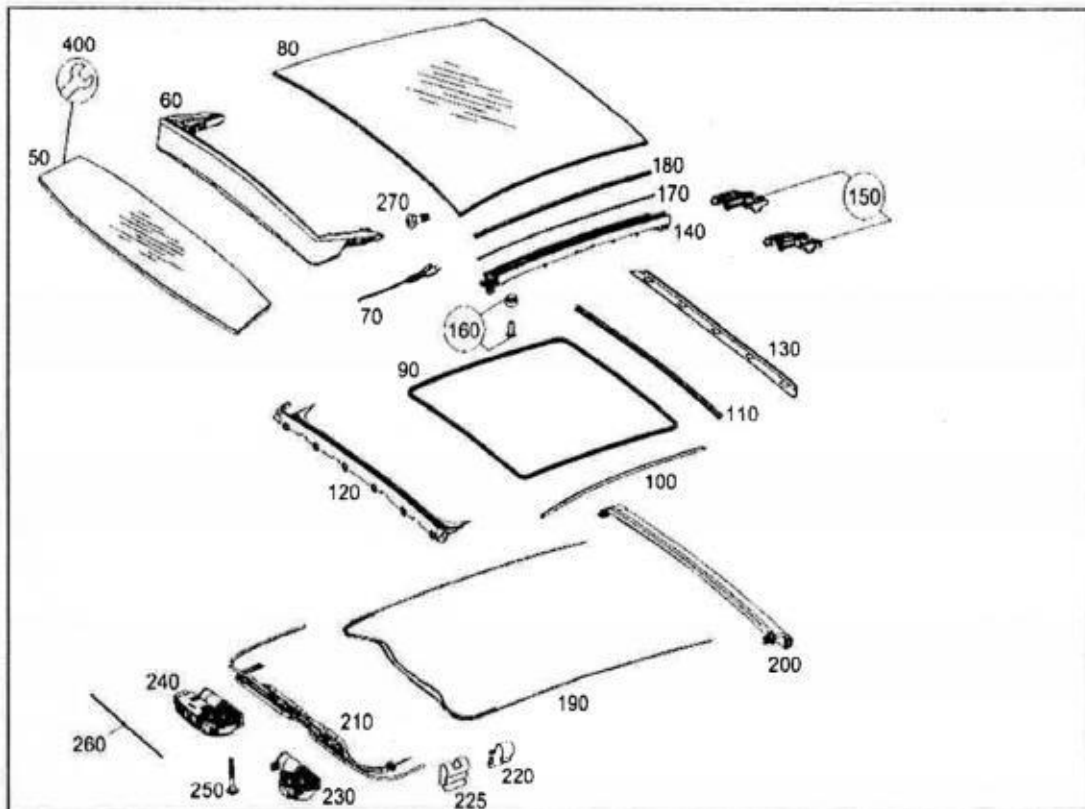
ITEM NO.	PART NO.	DESCRIPTION	QTY	Cost (\$)
10	A 205 780 05 29	SLIDING ROOF FRAME X PANORAMIC GLASS SUNROOF COMPLETE AT FRONT	01	Assembly Unit
50	A 205 780 33 00	COVER OSR GLASS ROOF, FRONT FIXED / SM	01	14/168. 85.00 (SM)
60	A 176 780 11 00	AIR DEFLECTOR	01	
70	A 176 782 00 20	BEARING F WIND DEFLECTOR WIND DEFLECTOR AT LEFT AND RIGHT	02	
80	A 205 780 21 00	SLIDING ROOF PANEL GLASS GLASS SLIDING ROOF	01	
90	A 205 782 04 00	SLIDING ROOF SEAL GLASS ROOF AT CENTER, ACOUSTIC SEAL	01	
90	A 205 782 09 00	SLIDING ROOF SEAL GLASS ROOF AT CENTER	01	
100	A 205 782 05 00	SLIDING ROOF SEAL LATERAL LEFT	01	
100	A 205 782 06 00	SLIDING ROOF SEAL LATERAL RIGHT	01	
110	A 205 782 07 00	SLIDING ROOF SEAL REAR	01	
120	A 205 780 74 00	COVER FRAME FRONT	01	
130	A 205 780 26 00	COVER FRAME REAR	01	
140	A 205 780 30 00	SLIDING ROOF MECHANICS LEFT	01	
140	A 205 780 31 00	SLIDING ROOF MECHANICS RIGHT	01	
150	A 222 780 00 00	TS SLIDE SHOE	01

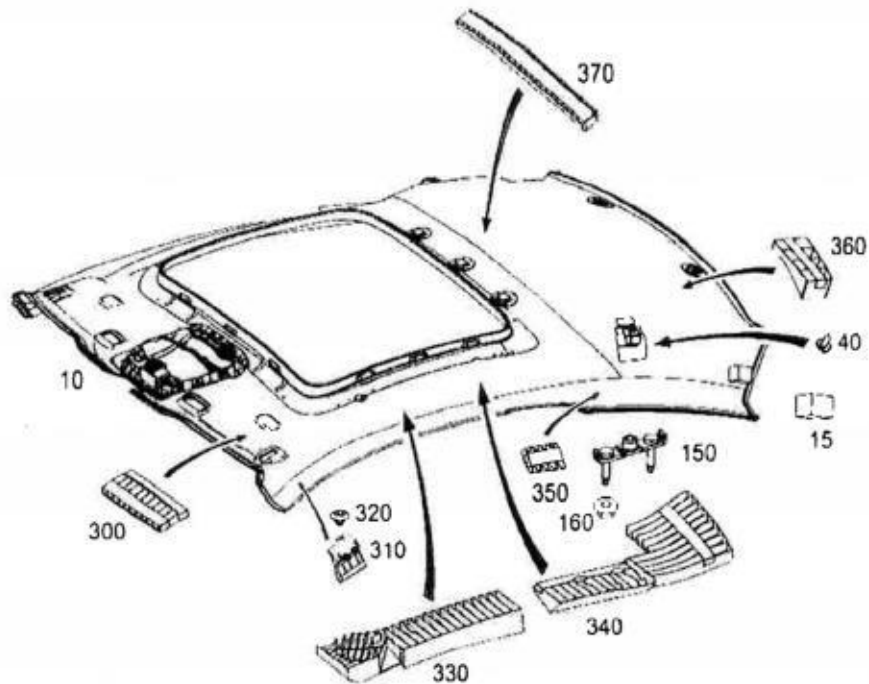
ITEM NO.	PART NO.	DESCRIPTION	QTY	COST (\$)
		Roof Liner Assembly <i>ll</i>	01	2600
S/Nett		Roof Liner Clips/Fasteners <i>16c</i>	1 set	120
Labor		Retrofit Panoramic Roof Assy		1200
		WaterProofing Test		180
		Respray Roof & Affected Areas		1200
		Paint Protection on Affected Areas		800
		Windscreen & Windows Polishing & Debris Removal		650
		Diagnostics & Reset Fault codes		250
		Coding of Control unit (Roof Motor)		550
		Removal & Replacement Roof Liner		450
