1. Policy Particulars :- THIRD PARTY CLAIM			
Insured Veh.	SLK 2650K	Veh. Inspected	SHC 3331P
Policy No.	5087307994-01	Coverage (\$)	0.00
Claim No.	MT/1008414-002	Excess (\$)	0.00
Assign From		Assign Date	24/08/2018

4. Description of Damages			
THE VEHICLE SUSTAINED DAMAGES AT THE N/S FRONT PORTION.			
DAMAGES SEE DETAILS.			
5. General Information			
Accident Date	23/08/2018	Inspection Date	24/08/2018
Survey held at	COMFORTDELGRO ENGINEERING PTE LTD 59 LOYANG DRIVE SINGAPORE 508969		
5a. Remarks			
A)THE INSPECTION WAS CONDUCTED ON A"WITHOUT PREJUDICE" BASIS. B)IN ACCORDANCE TO YOUR INSTRUCTIONS, WE HAVE NOT AUTHORISED REPAIRS.			
5b. Estimate Days of Repair			
ESTIMATED NORMAL PERIOD FOR REPAIR:		3 Working Days

ADJUSTMENT ON REPAIR COST FOR VEHICLE NO. SHC 3331P

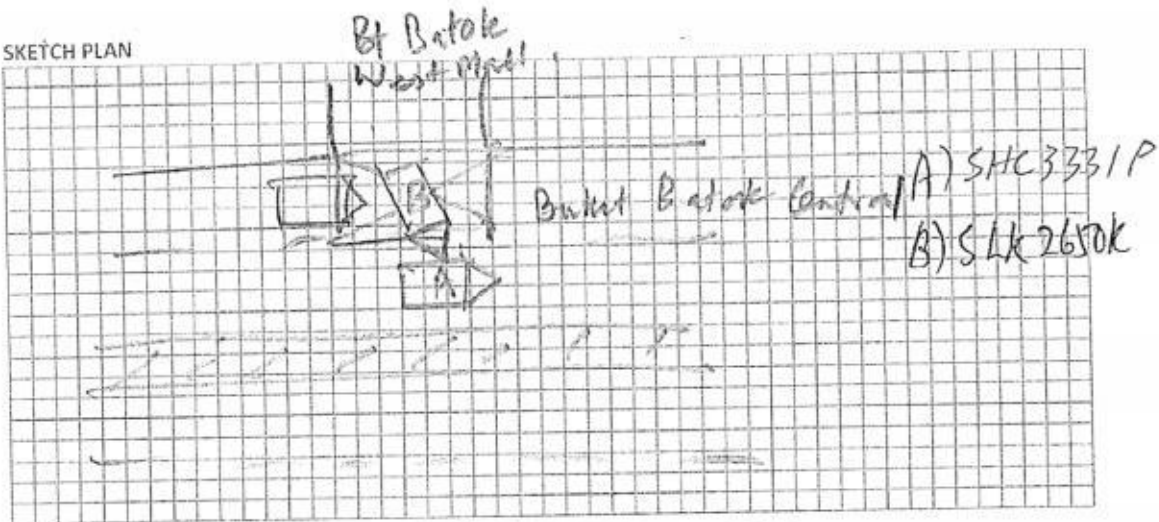
SKETCH PLAN

On 23/8/18 at about 1340hrs while I Veh A was travelling along the right lane, Veh B abruptly exited from the side road and collided on the front left portion of my vehicle.

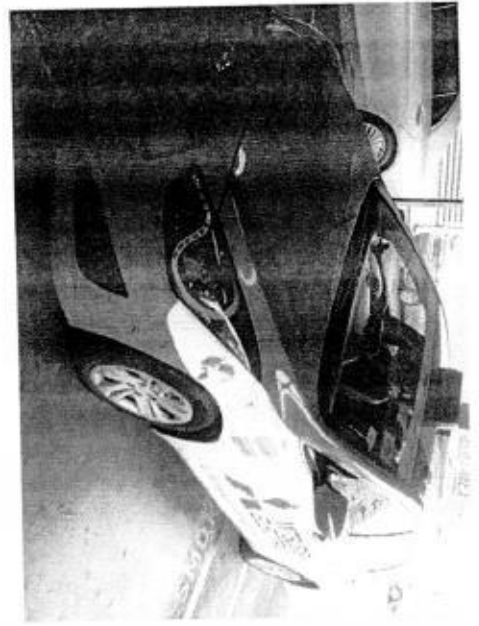
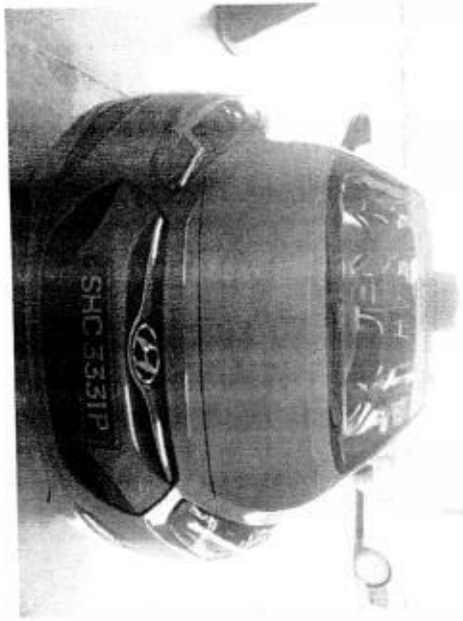
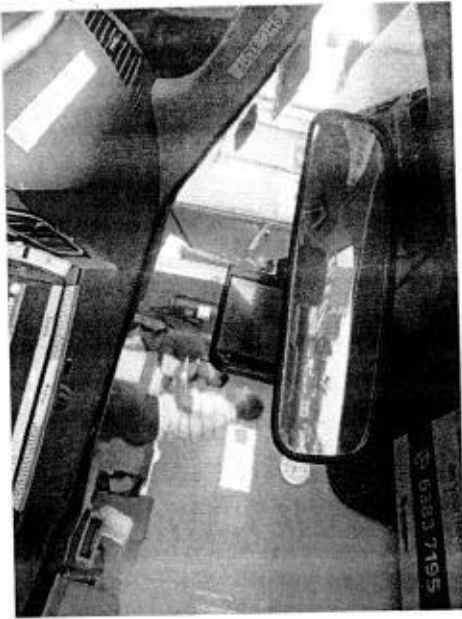
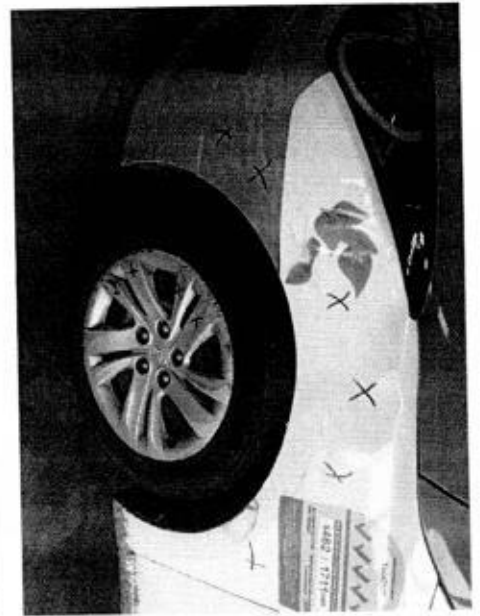
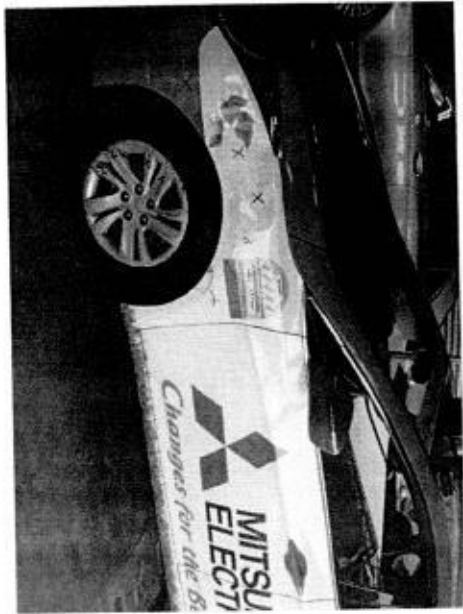
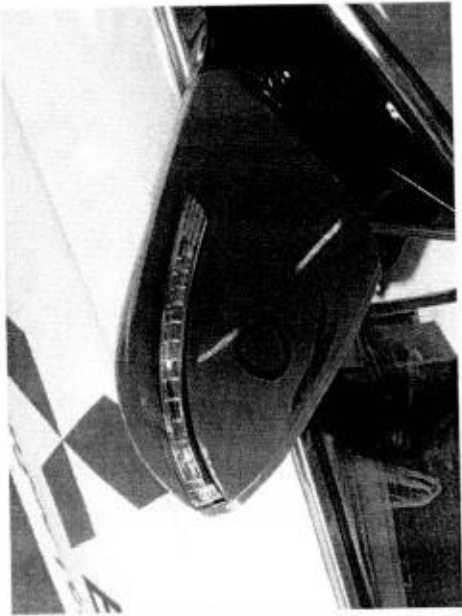
N/S Front.

The U/C / Chassis frame / Body Structure affected due to collision.

Qty	Description of Parts	Condition	Estimate By Workshop (\$)	Our Adjusted (\$)
<u>REPLACEMENT OF PARTS</u>				
1	FRONT BUMPER COVER	TO REPAIR SEE LABOUR	562.30	-
1	FRONT BUMPER BRACKET TOP (LH)	SERVICEABLE	22.40	-
1	FRONT BUMPER BRACKET (LH)	SERVICEABLE	24.60	-
1	HEADLAMP (LH)	CUT	1,388.00	1,388.00
1	FRONT FENDER (LH)	DENTED	619.00	619.00
1	FRONT FENDER SHIELD (LH)	SERVICEABLE	169.80	-
1	FRONT FENDER RETAINER	SERVICEABLE	9.20	-
1	FR WHEEL HUB CAP, LH	GRAZED	150.70	150.70
	LESS 20% DISCOUNT		-589.20	-431.54
			2,356.80	1,726.16
<u>SPECIAL NETT ITEMS</u>				
1	FRT FENDER ADVERTISEMENT LOGO (LH)(SN)	NECESSARY	100.00	100.00

100.00	100.00
<u>LABOUR</u>				
	PANEL BEATING. INCLUSIVE OF THE REPAIR OF FRONT BUMPER COVER.		560.00	300.00
	SPRAY PAINTING CHARGE.		500.00	400.00
	WIRING CHARGE.		50.00	20.00
	TUFF KOTE.		50.00	20.00
	FRT WHEEL ALIGNMENT.	NOT NECESSARY	80.00	-
			1,240.00	740.00
GRAND TOTAL			3,696.80	2,566.16
RECOMMENDED COST OF LUMP SUM REPAIRS (TO ITS PRE-ACCIDENT CONDITION) (CONFIRMED)				2,050.00
