Surveys REF: CS3 / ASM18011977 / Bv6<sup>07</sup>

**CLAIMANT: CAMPBELL TIMOTHY ELLIS**  
**ACCIDENT INVOLVING SLA 8549J AND FBL 3881S AT OLD JURONG ROAD**  
**TOWARDS UPPER BUKIT TIMAH ROAD ON 27 JUNE 2018.**

## VEHICLE INSPECTION REPORT

## ADJUSTMENT ON REPAIR COST FOR VEHICLE NO. SLA 8549J

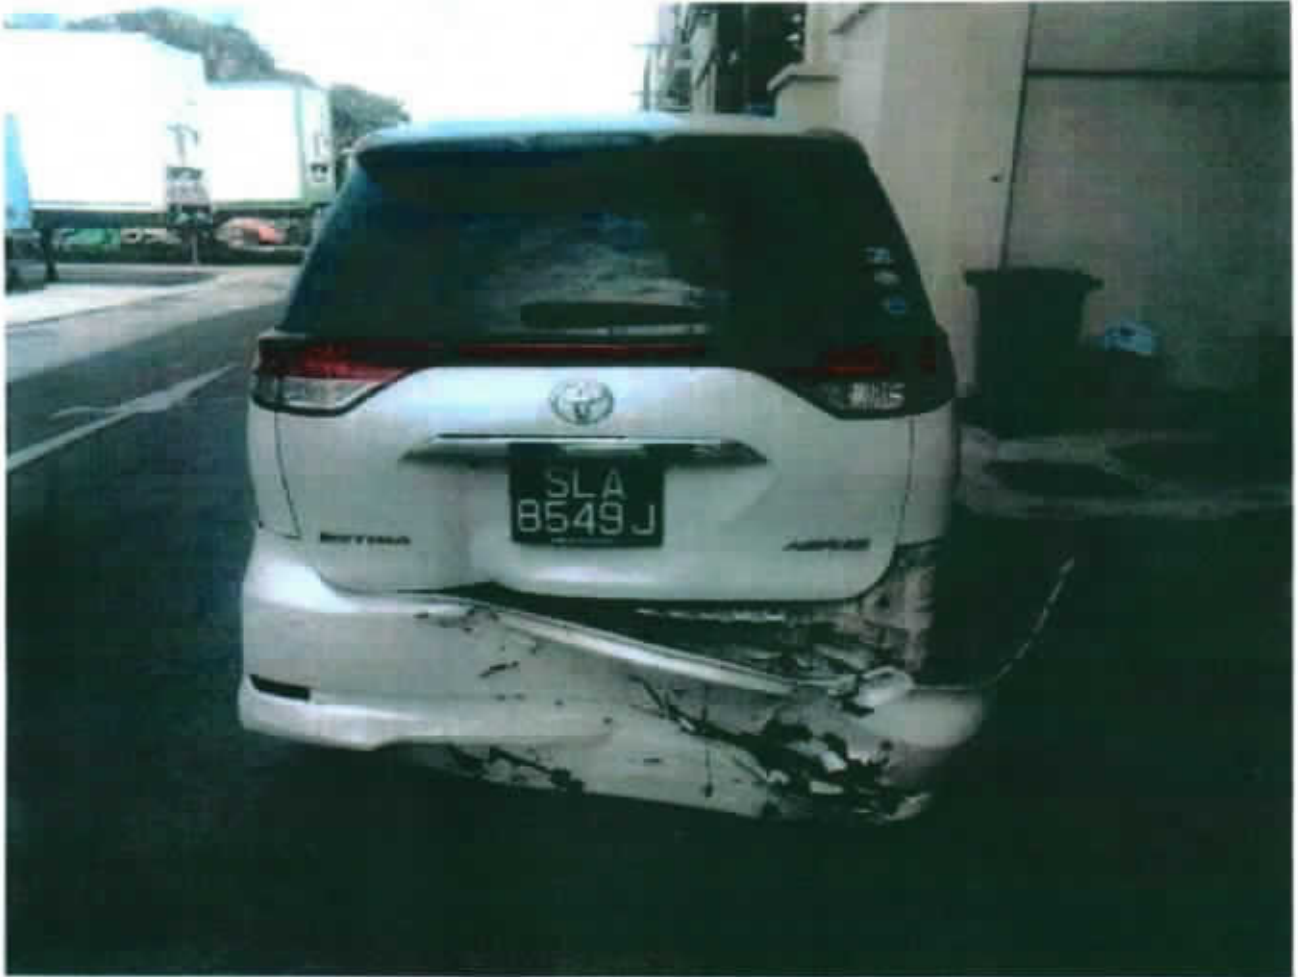
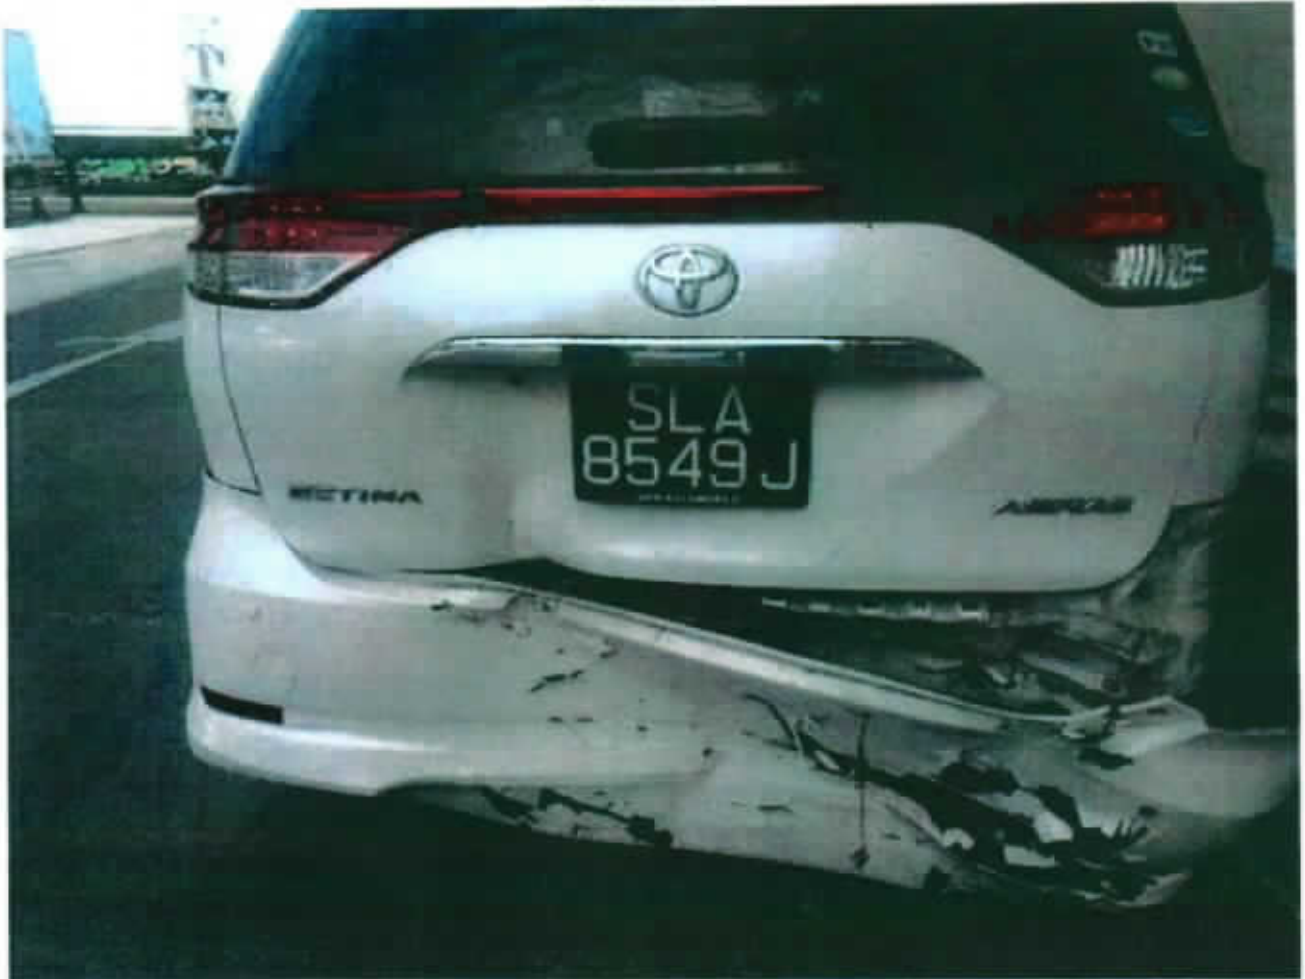
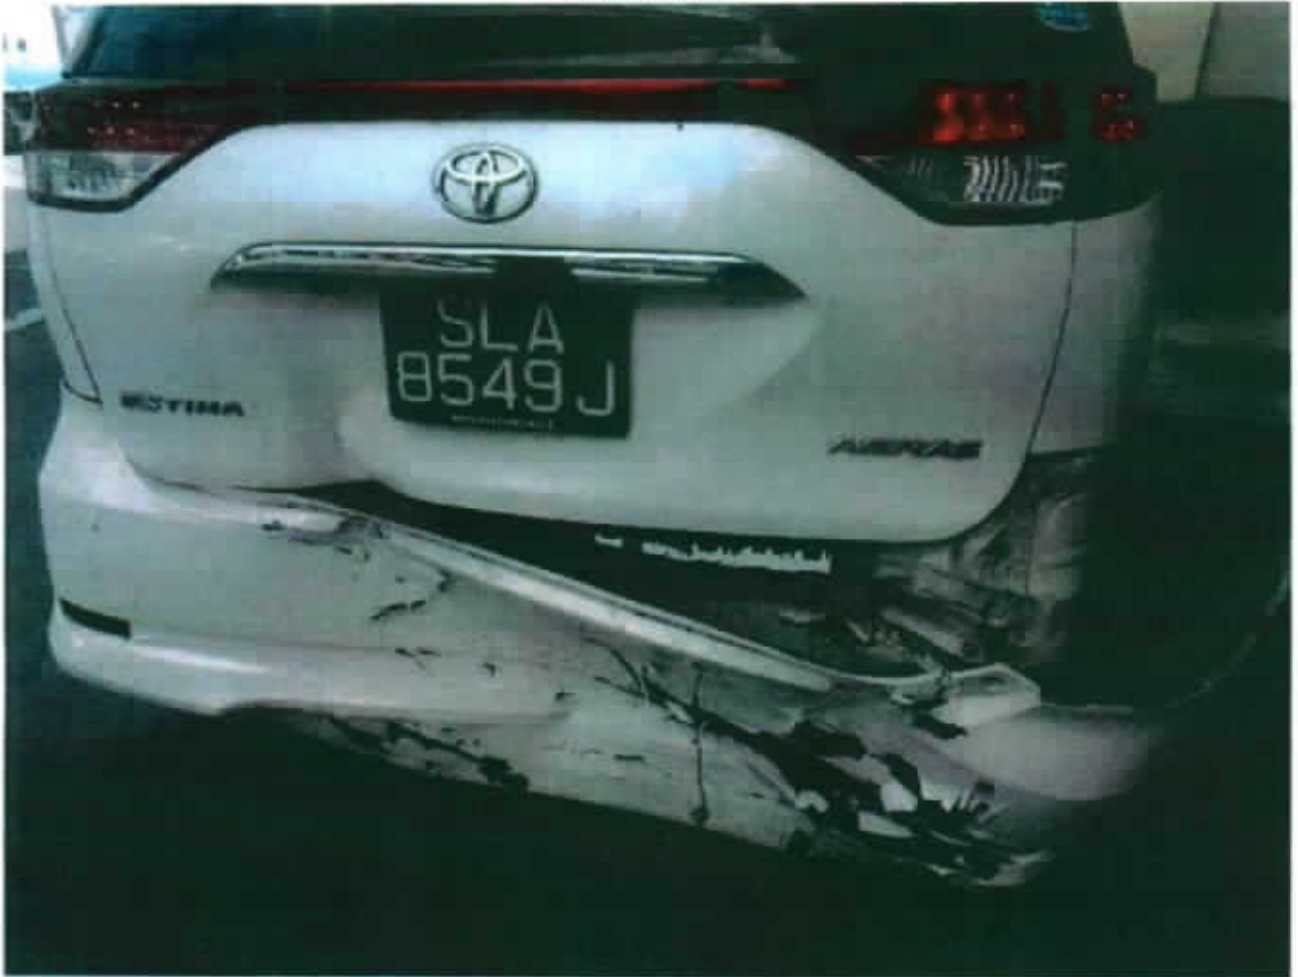
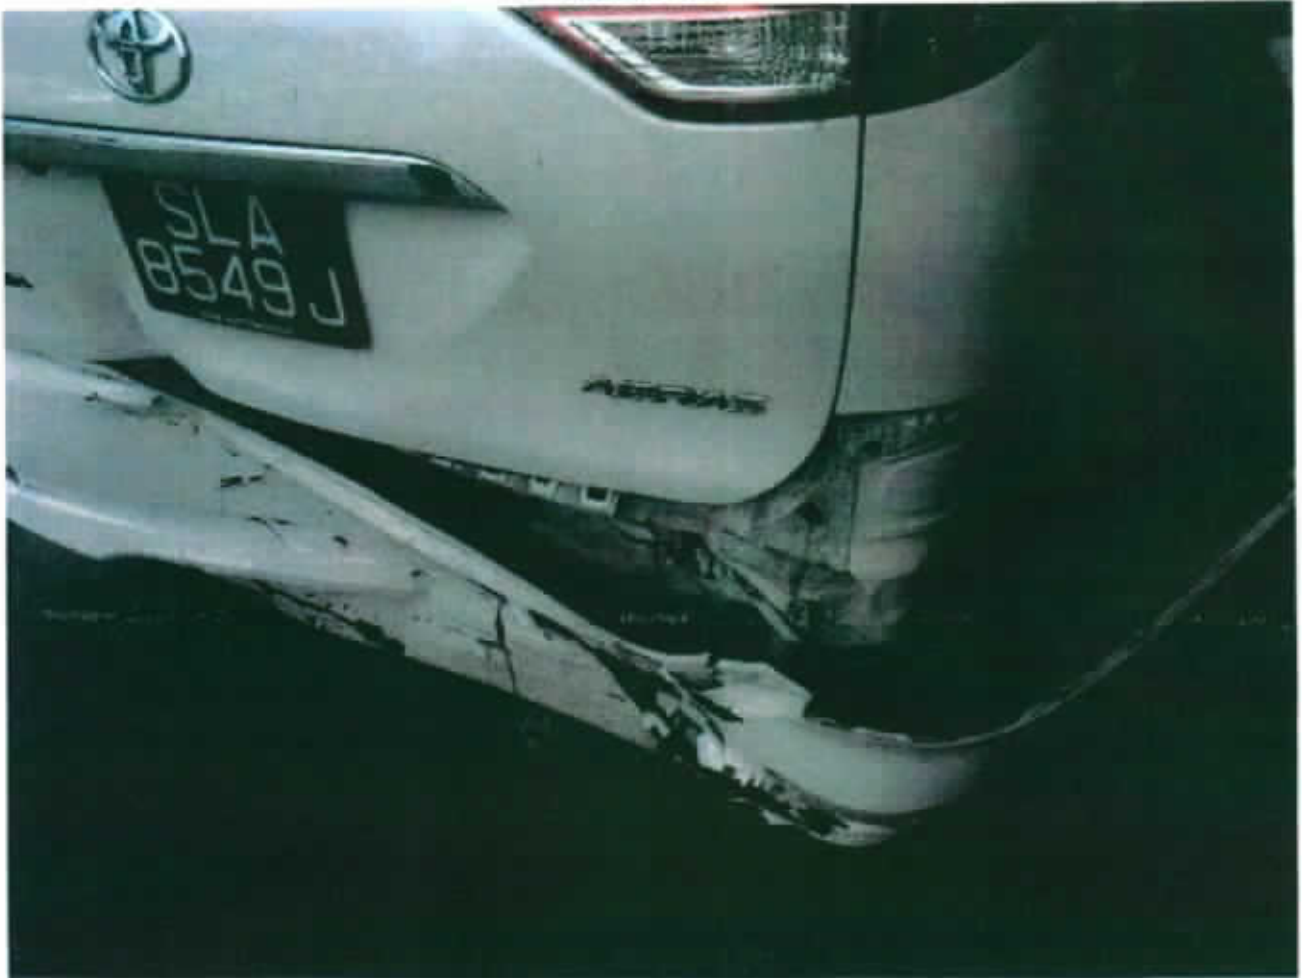
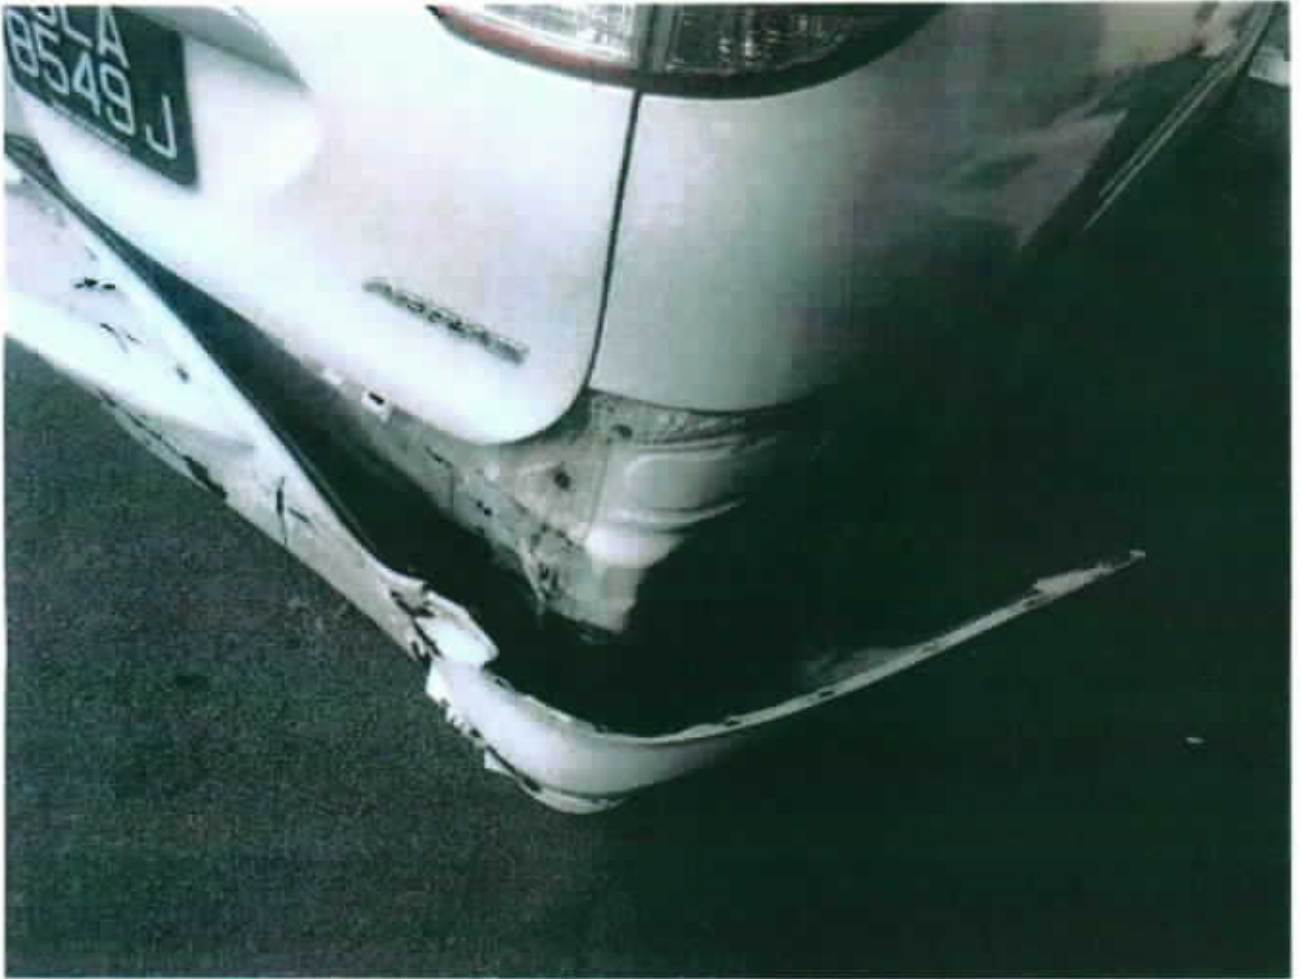
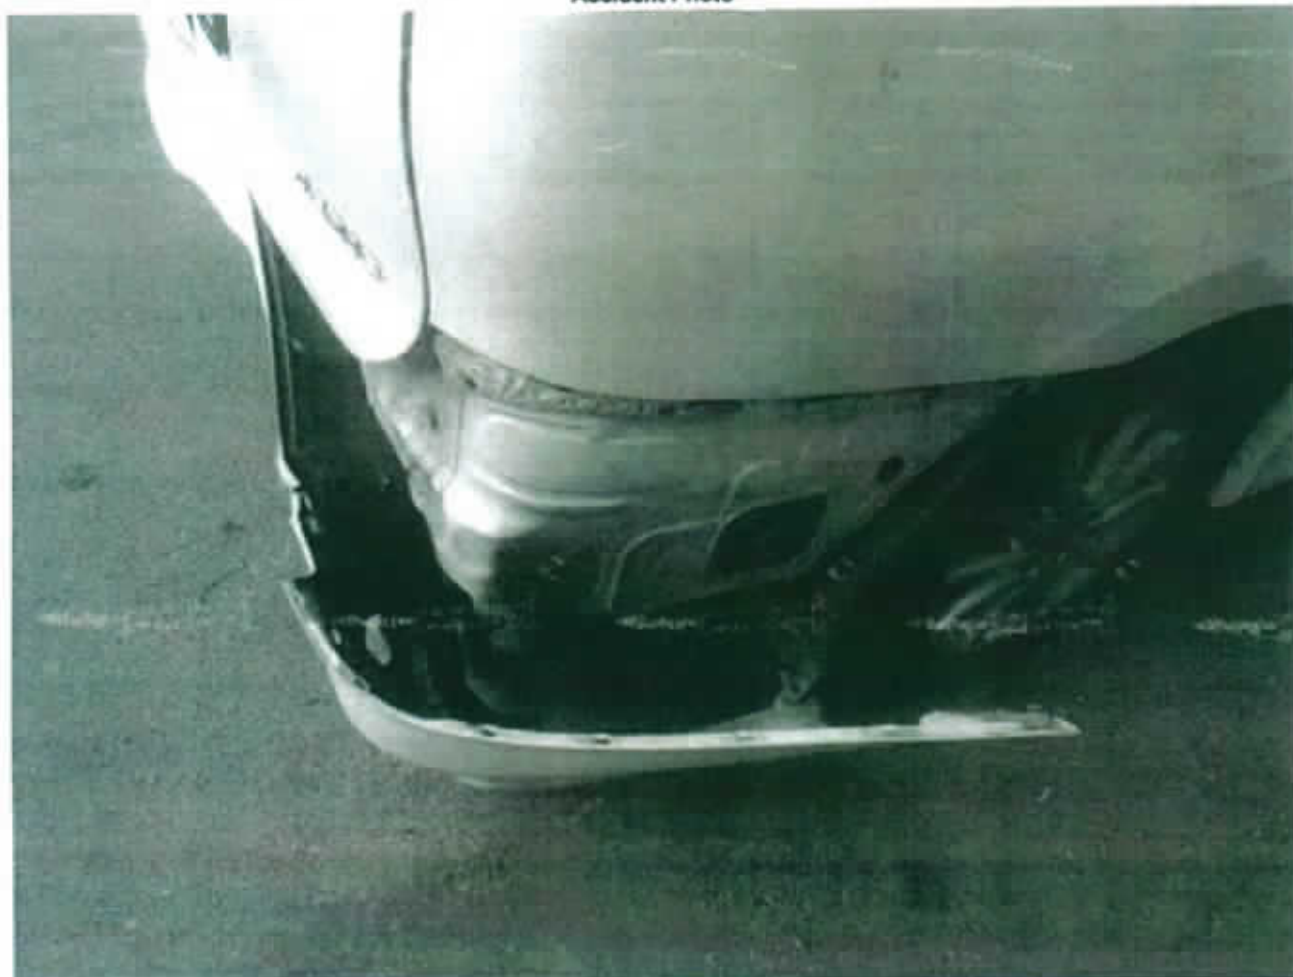
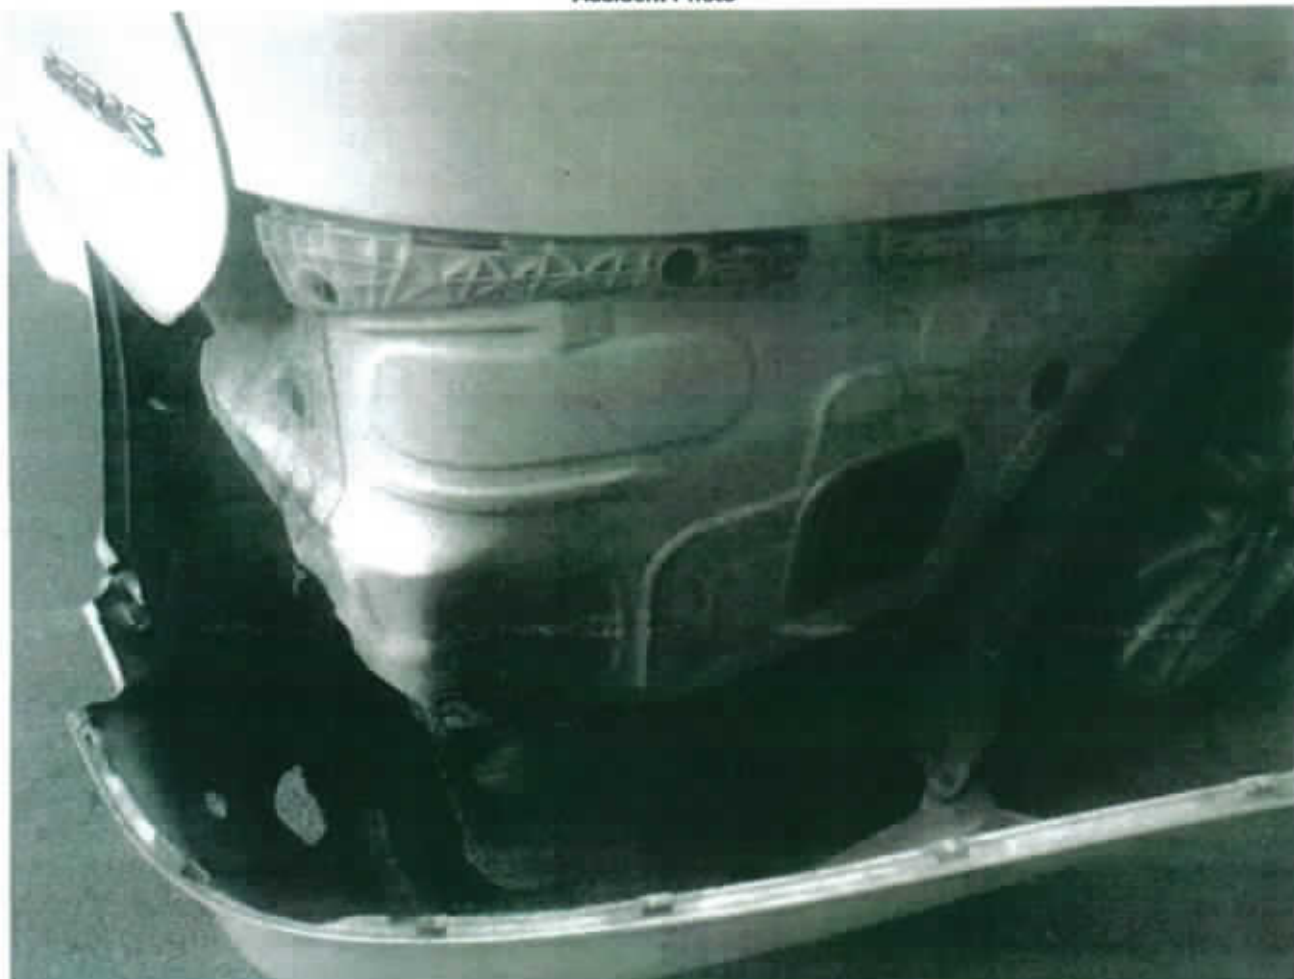
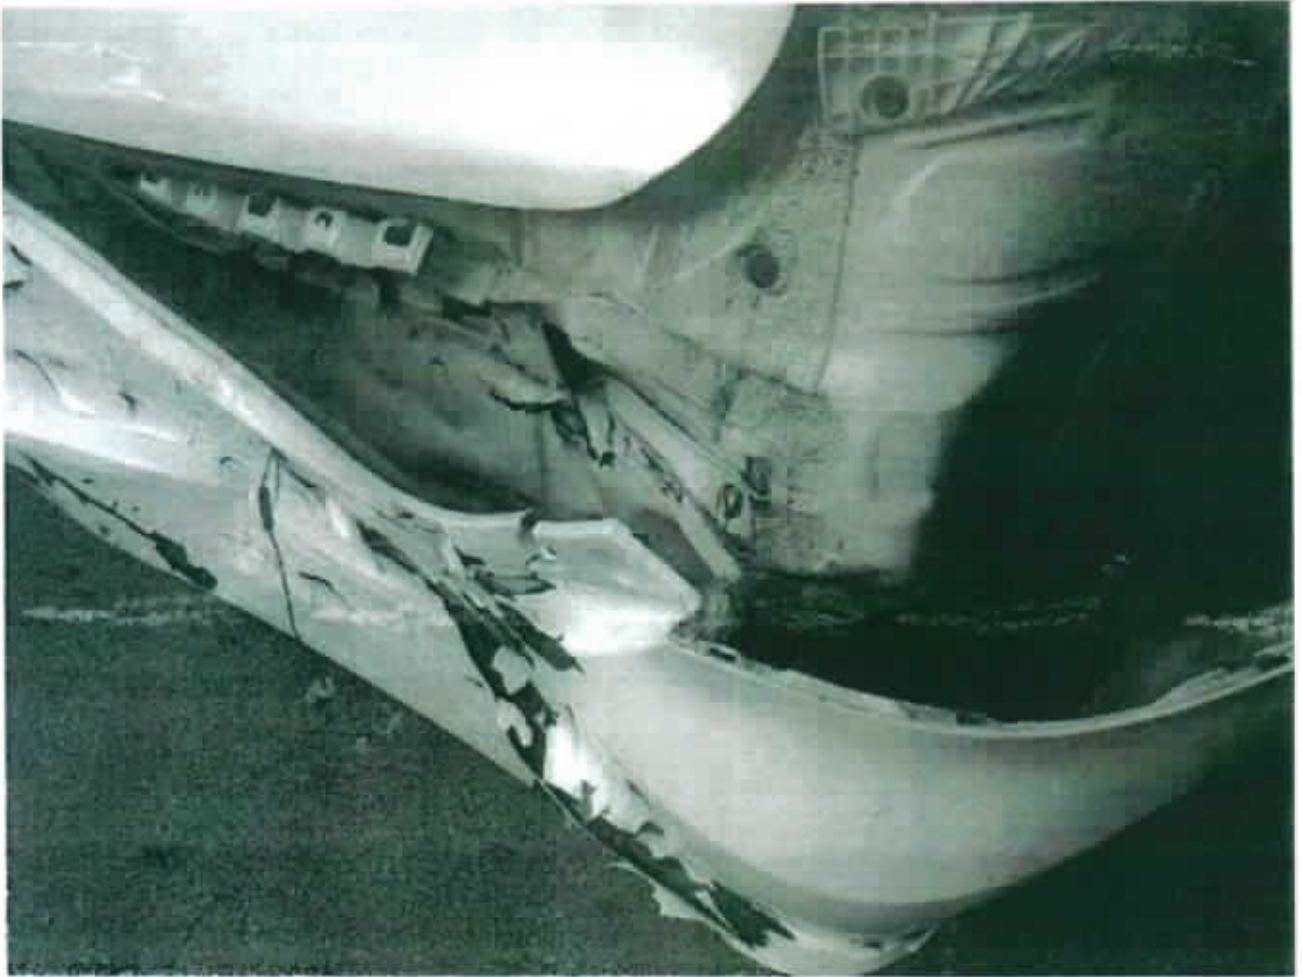
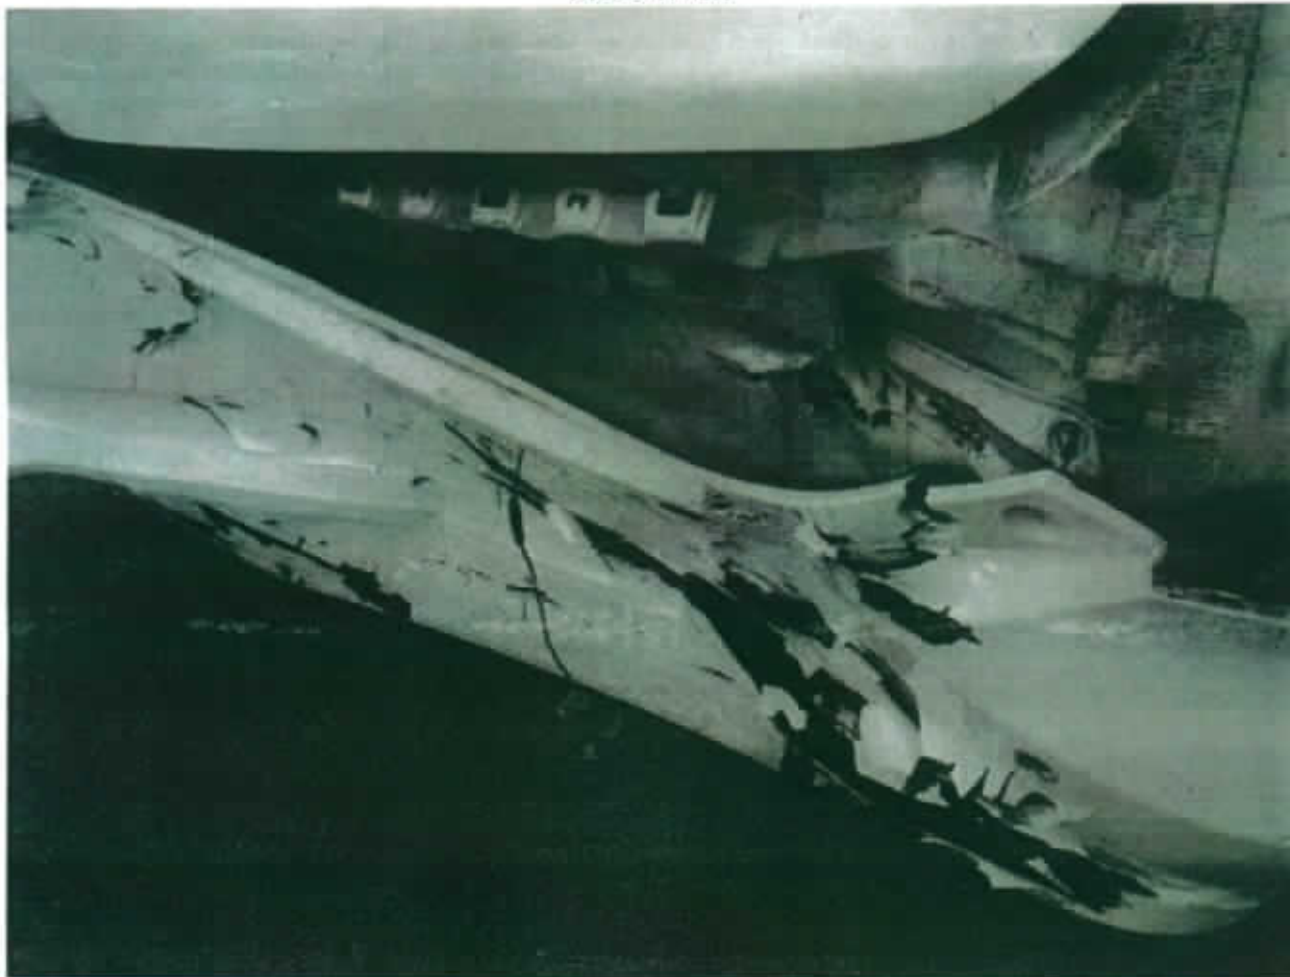
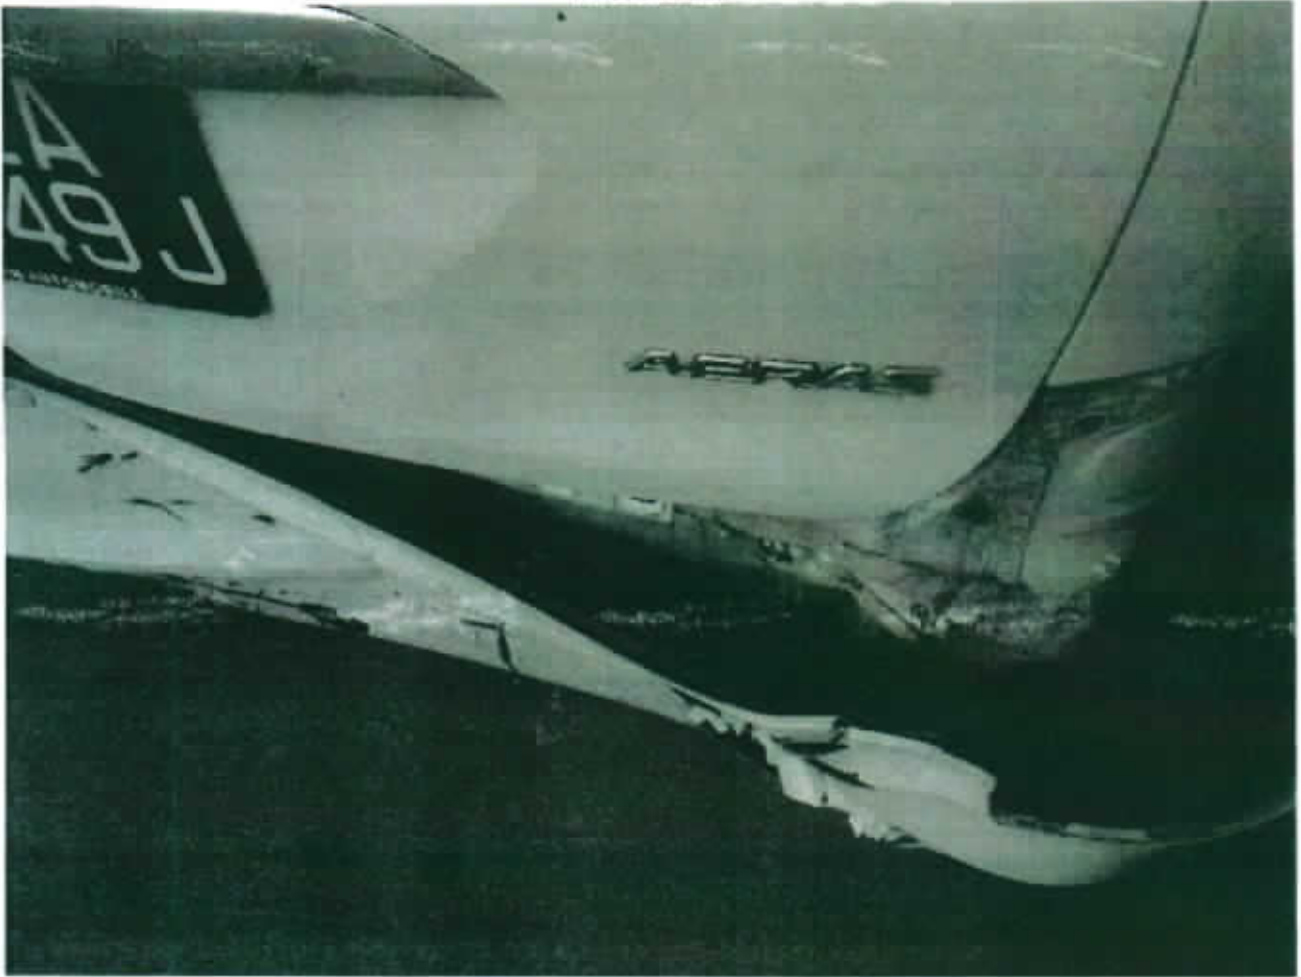
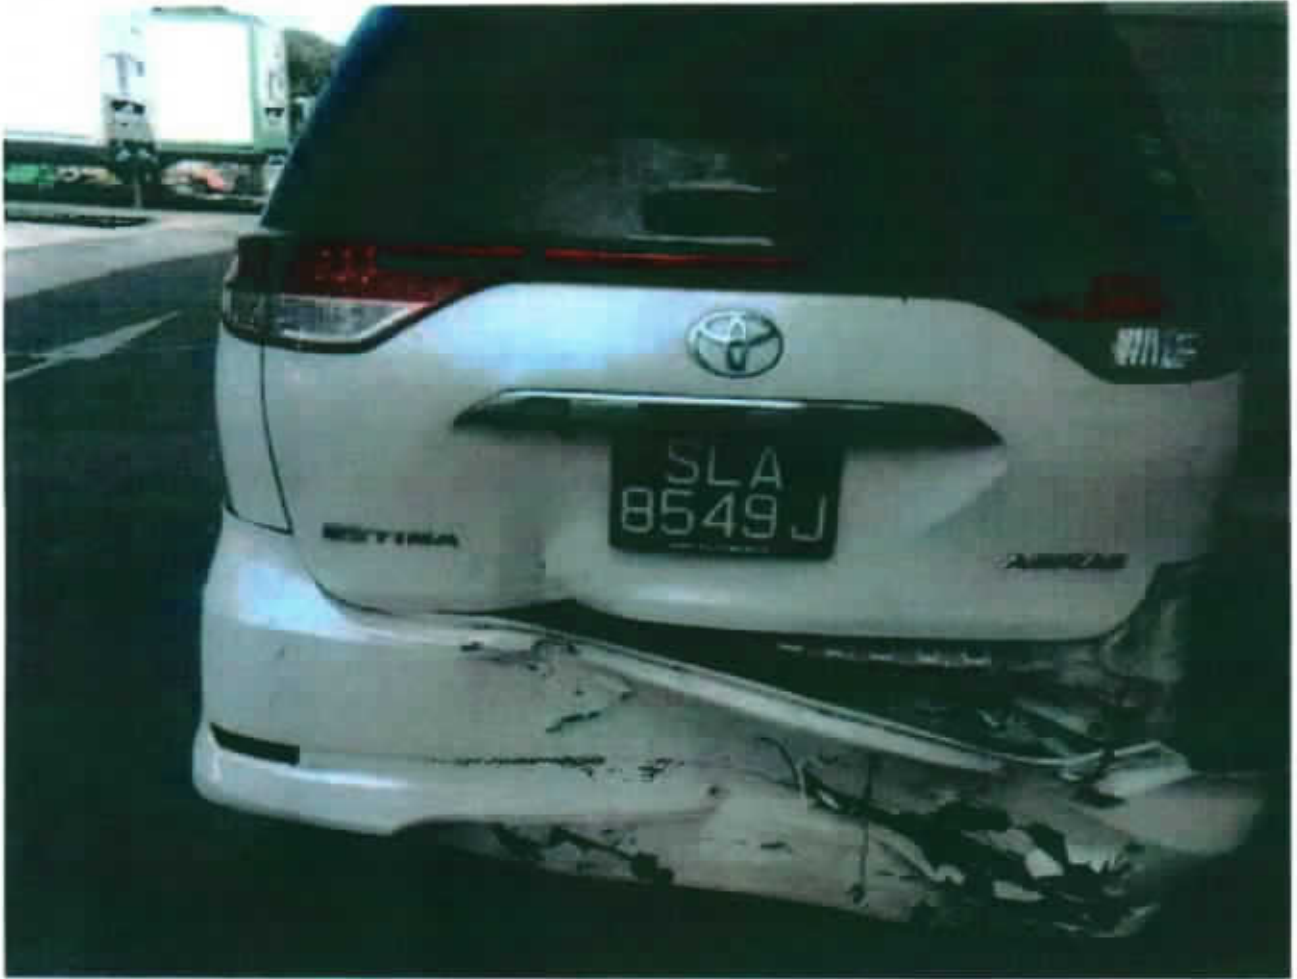
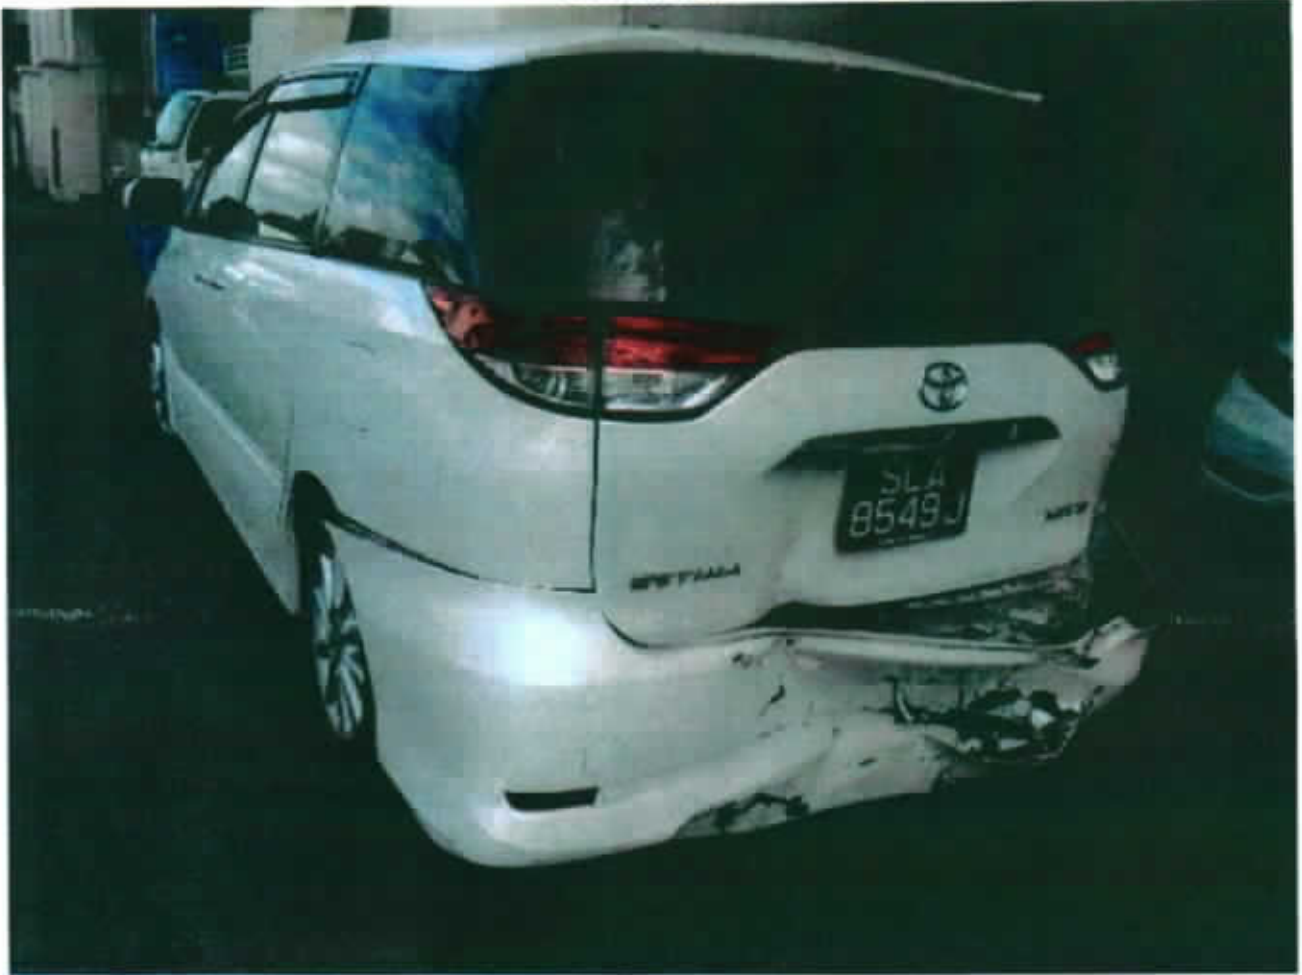
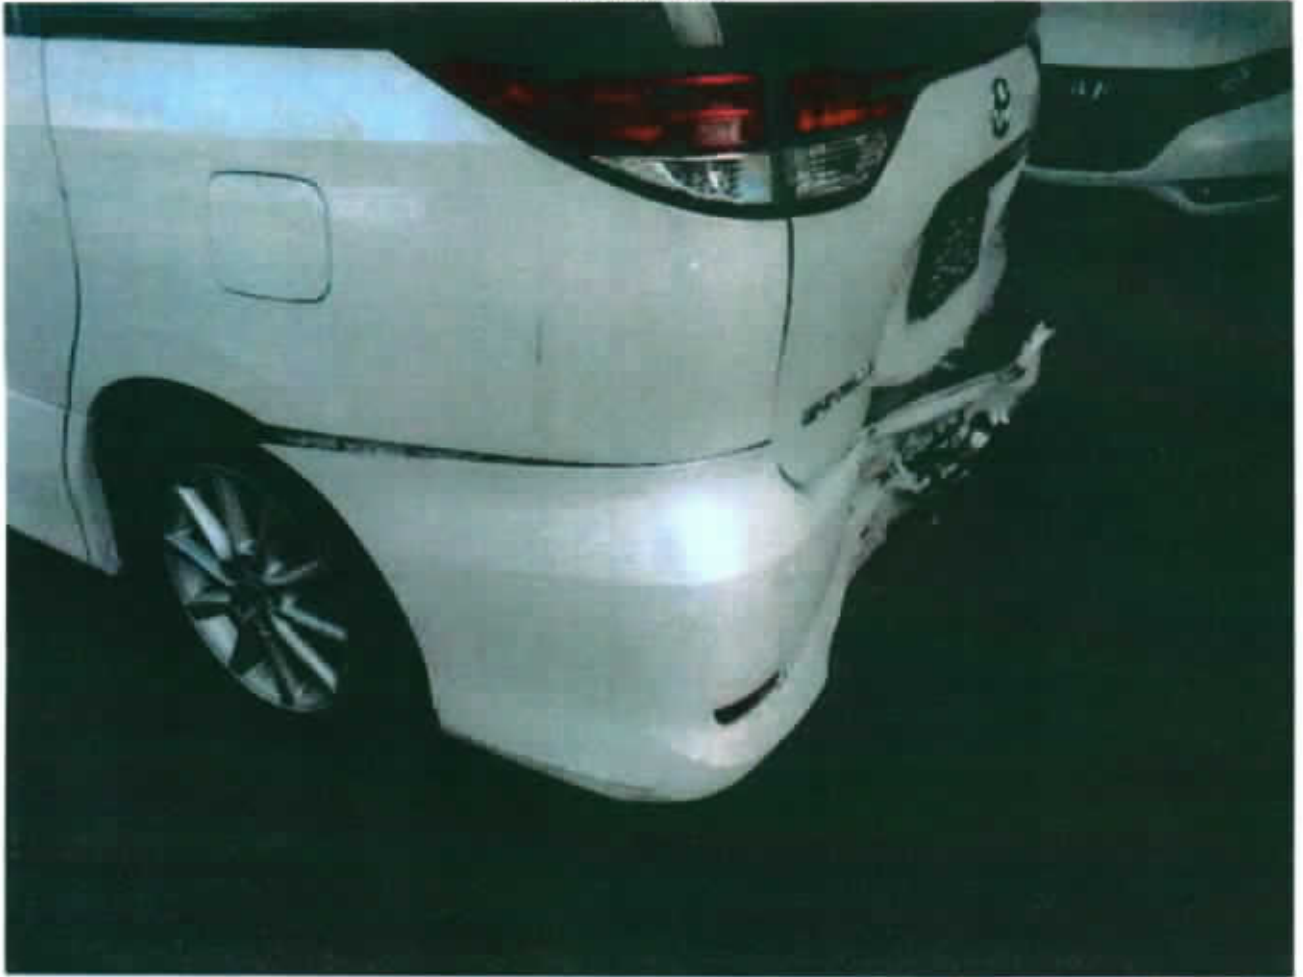
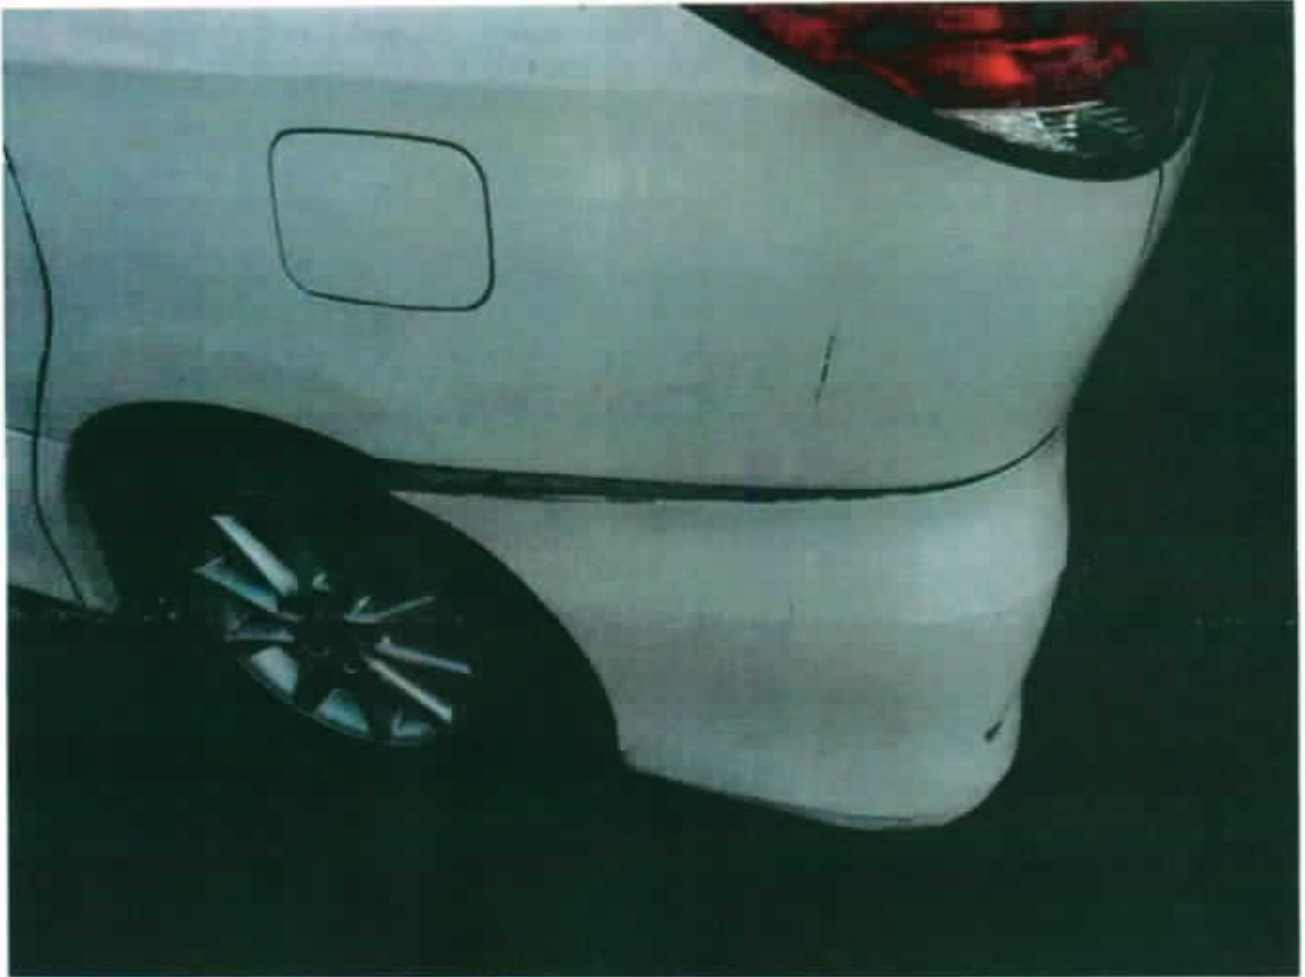
Accident Photo

The impact damages sustained on the vehicle at the time of inspection is on the rear portion.  
(Details refer to the photographs attached)
