# LKK Auto Consultants Pte Ltd

## Preliminary Advice

Insured Vehicle No	: SGJ2597X	Accident Date	: 19/08/2018
TP Vehicle No	: SLF5864S	Assignment Date	: 27/08/2018
Make	: VOLKSWAGEN POLO	Est. Duration of Repair	: 6.00
Date of Inspection	: 27/08/2018		
Inspection At	: FDK AUTOMOBILE & LEASING SERVICES PTE LTD (HQ) 39 WOODLANDS CLOSE MEGA @ WOODLANDS, #05-12 SINGAPORE 737856

## VEHICLE DAMAGE INSPECTION REPORT

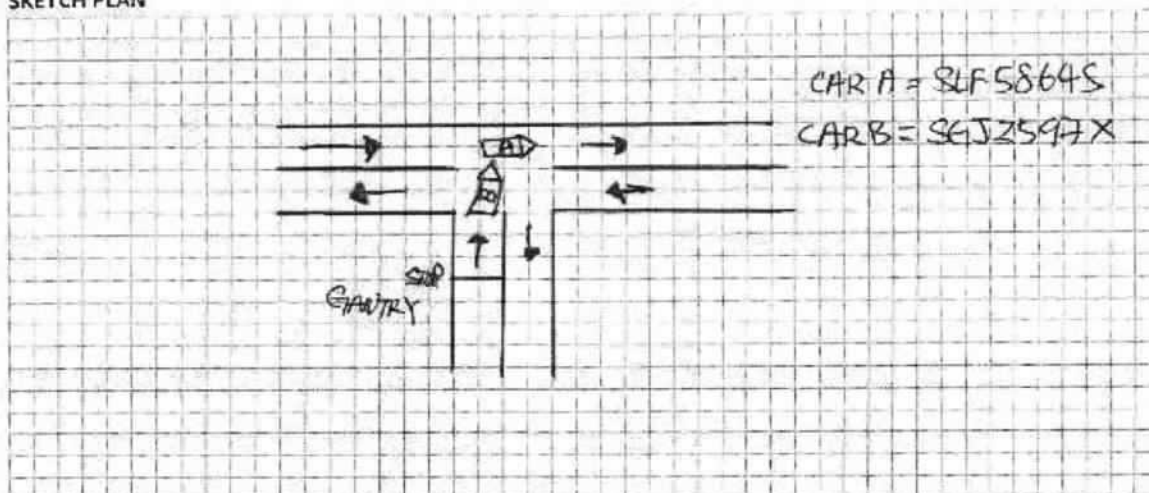
# Sketch Plan #2

I was travelling along Yishun Street 22 and iam driving in the right of way with the traffic flow. All of a sudden, A red vehicle SGJ2597X came out of the carpark from my right and hit into me.

The red car came towards my lane when my car was still traveling and there was also a car in front of me. I have always been traveling and ~~driving~~ with great care and conform to the road safety rules and regulations.

The red vehicle banged onto the back of my vehicle so hard that it drags from the back of my vehicle to the front of the driver side door.
