## SURVEY REPORT

| Affiliated to Federation Internationale Des Experts En Automobile | | | | |
|--|---|---|---|---|
| <b>1. Policy Particulars :- THIRD PARTY CLAIM (RESURVEY INSPECTION)</b> | | | | |

## ADJUSTMENT ON REPAIR COST FOR VEHICLE NO. SLP 3505P

REINSPECTION PHOTOGRAPHS

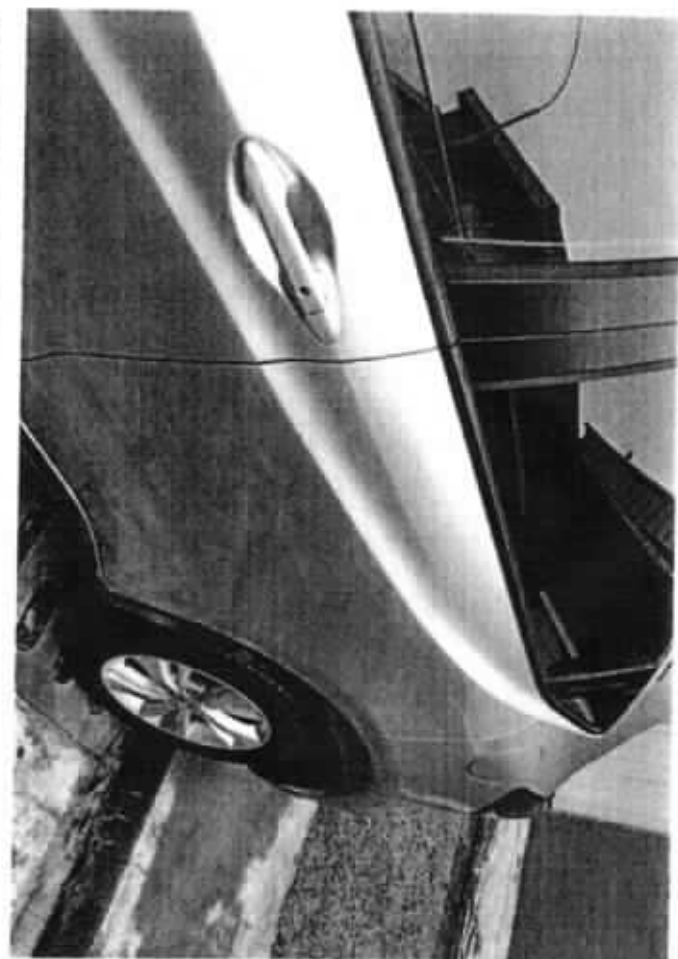
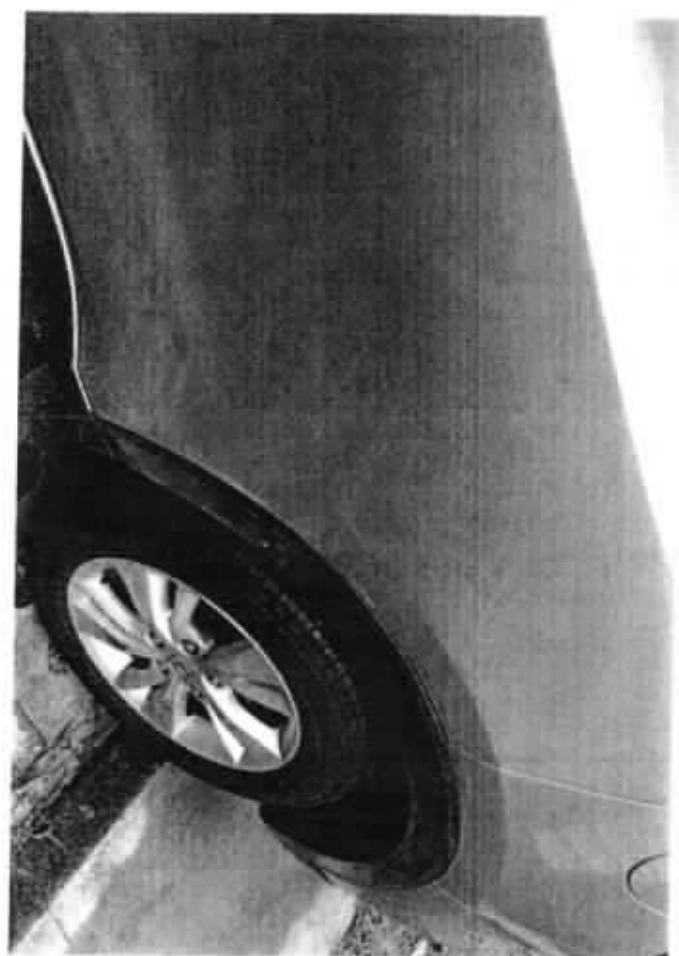
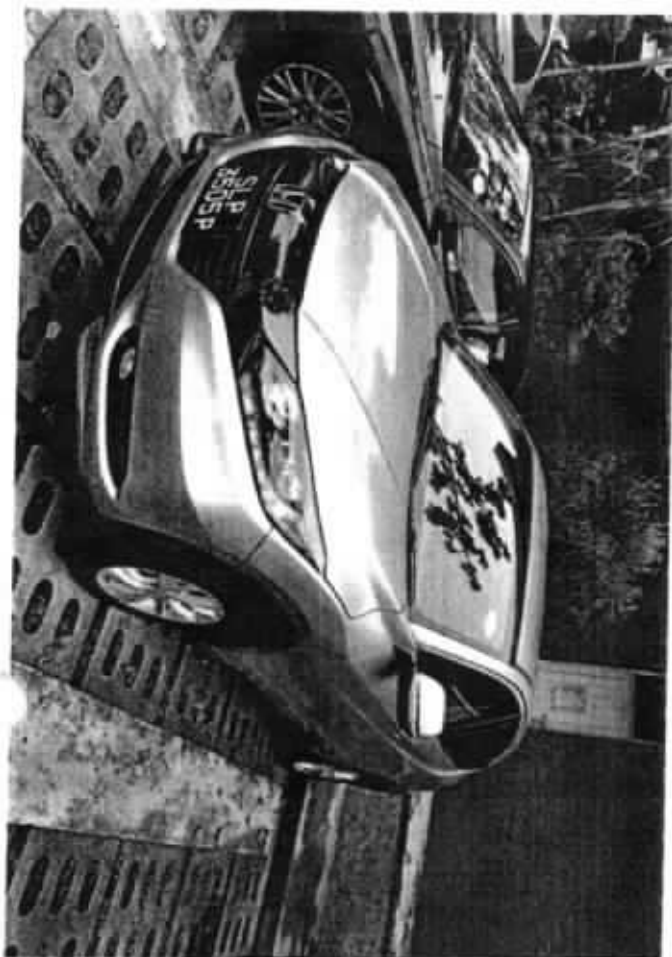
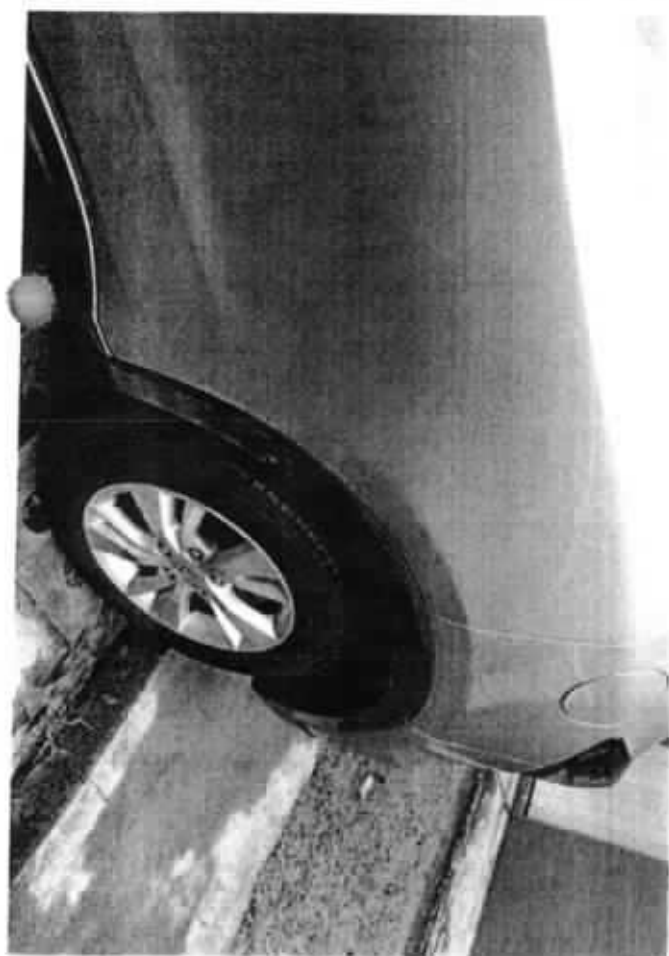
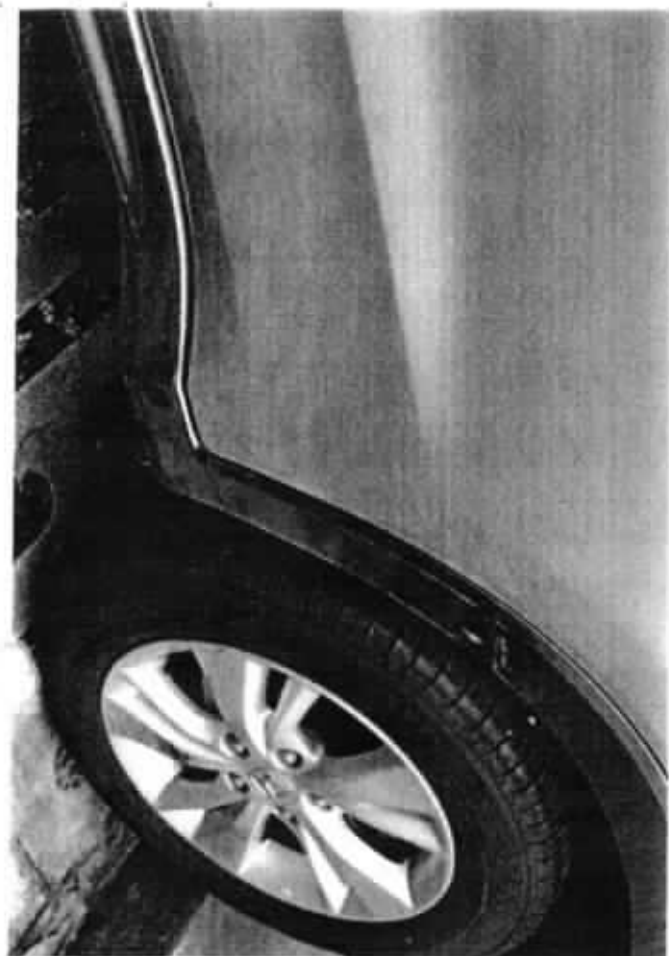
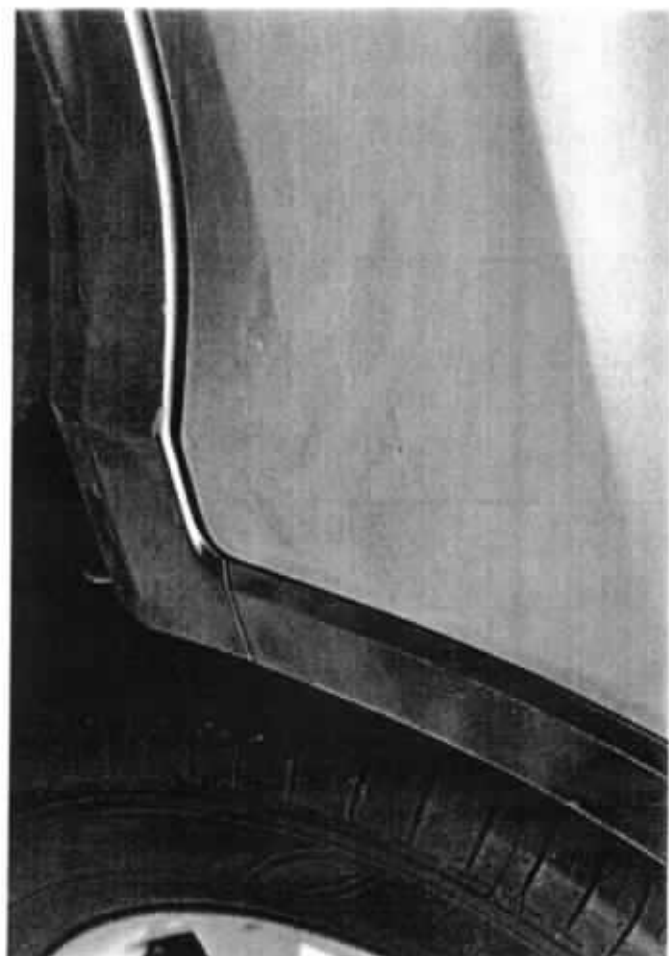
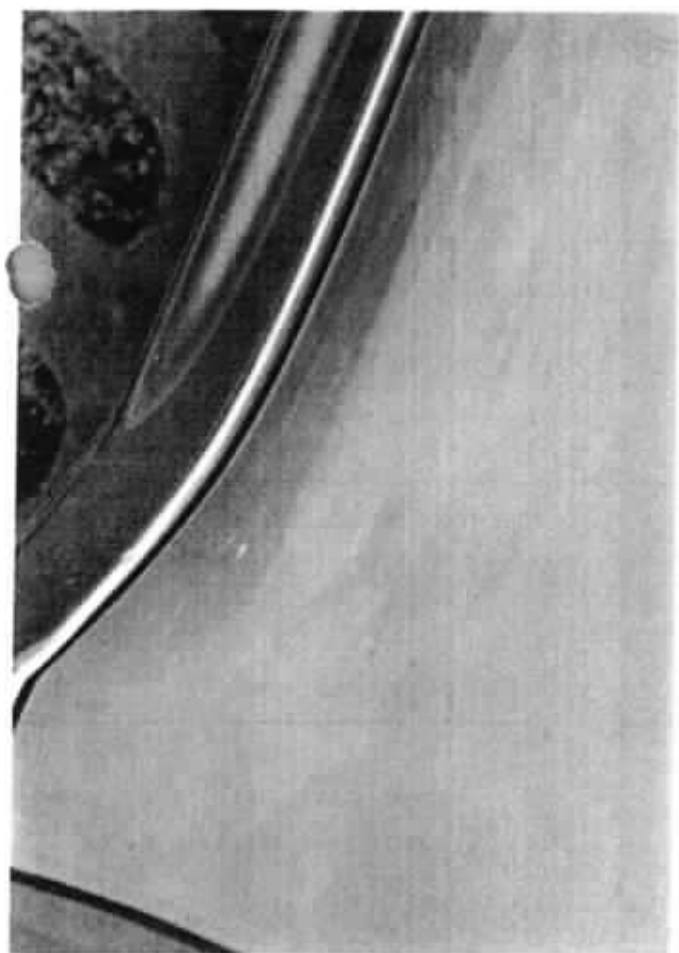
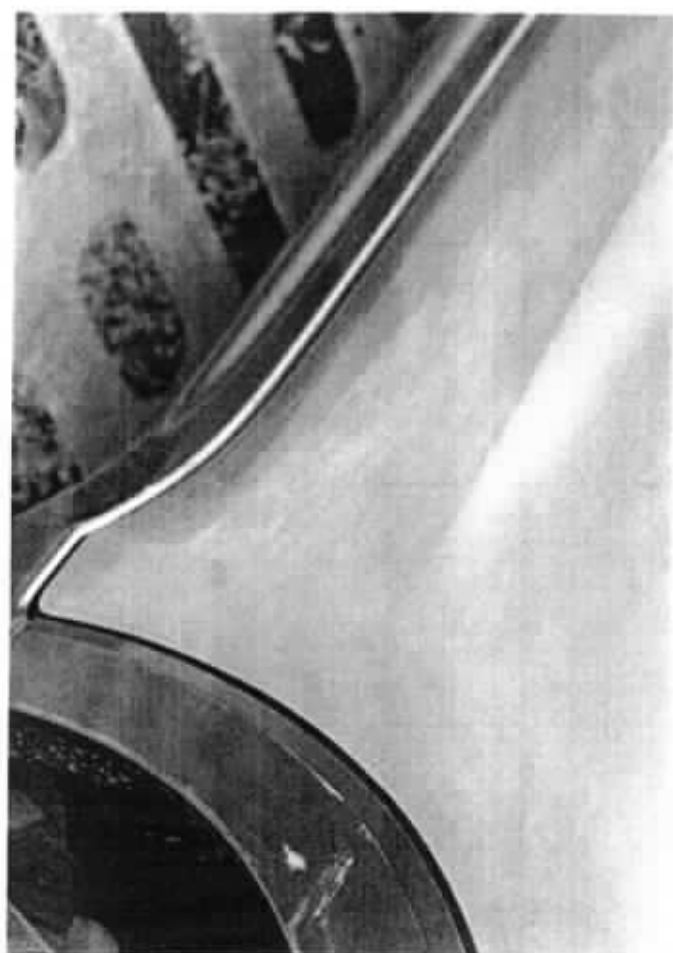
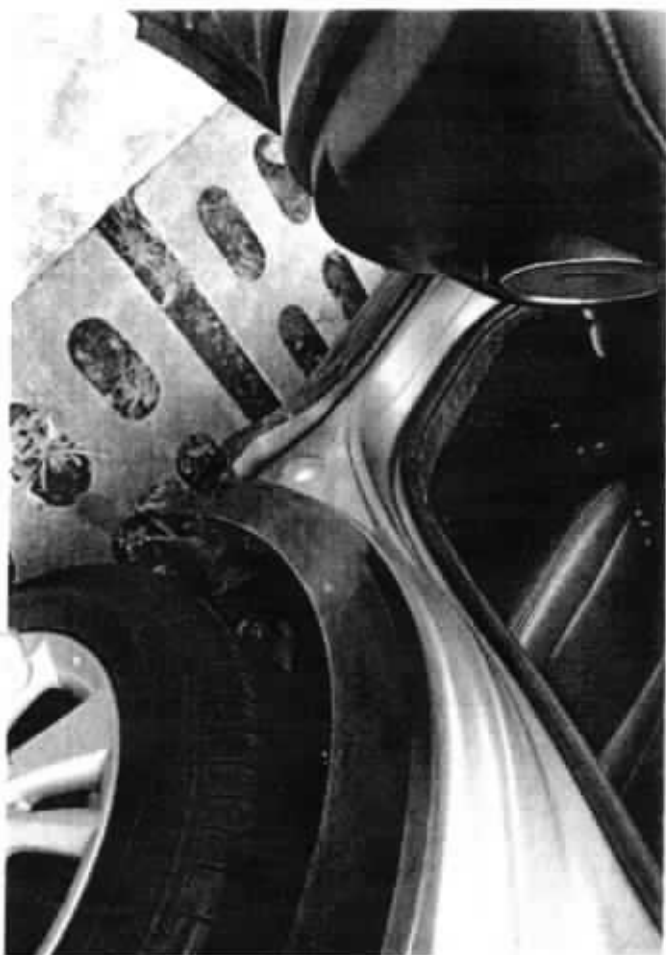
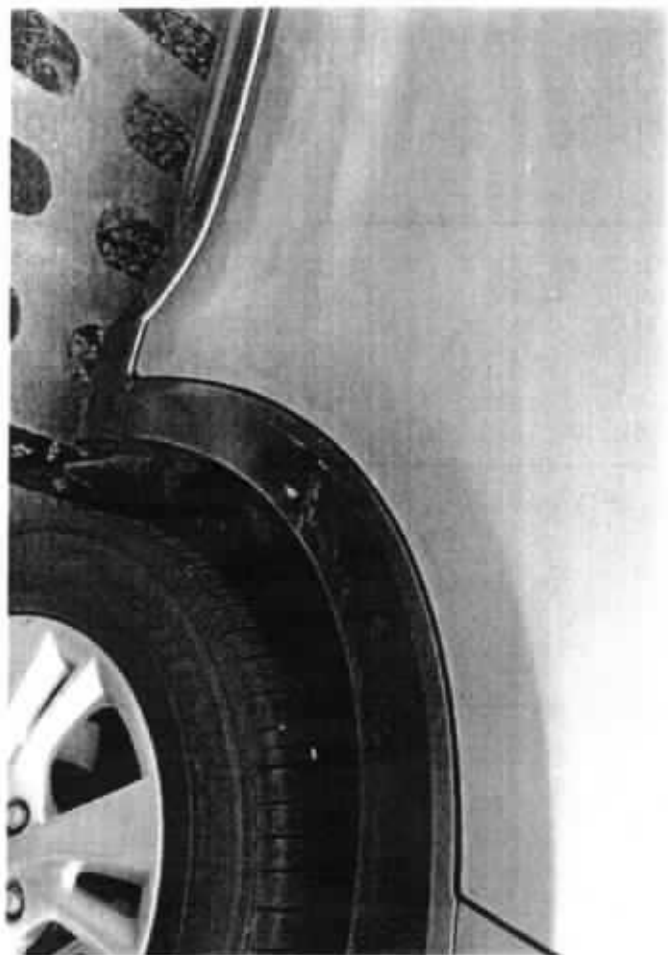
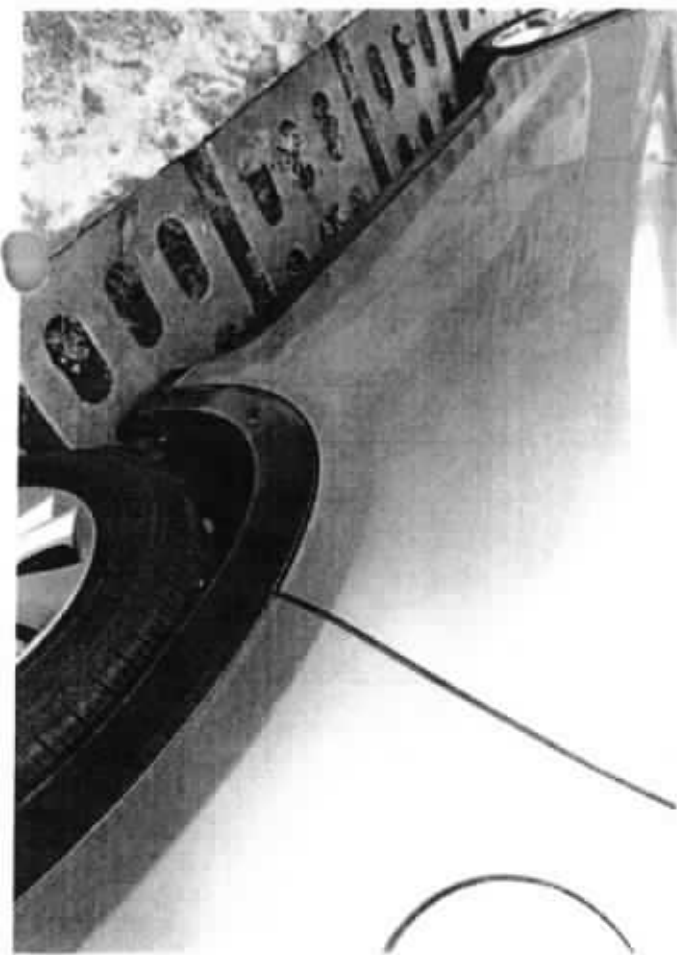
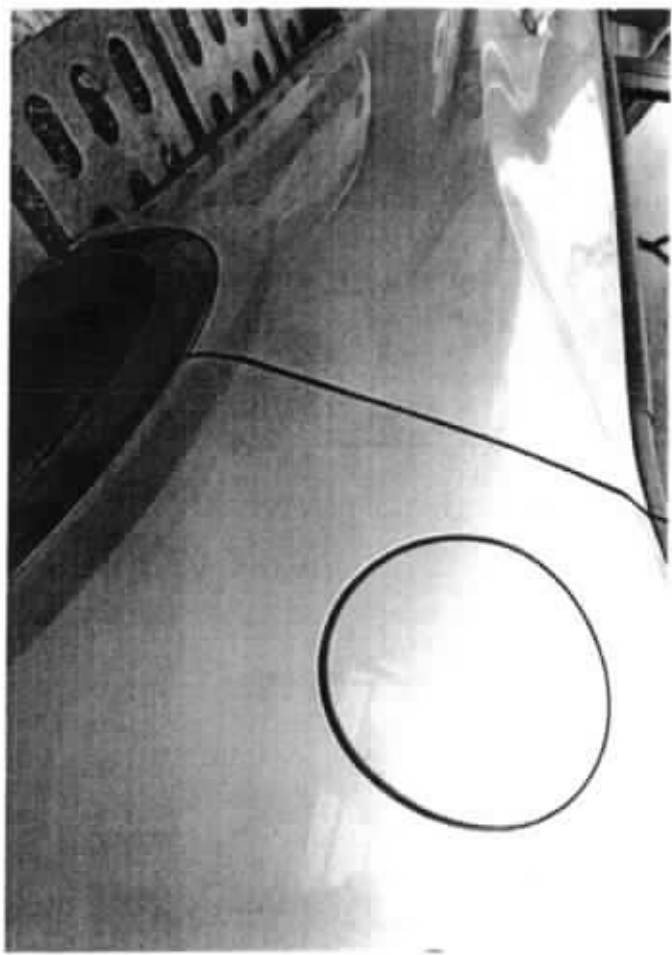
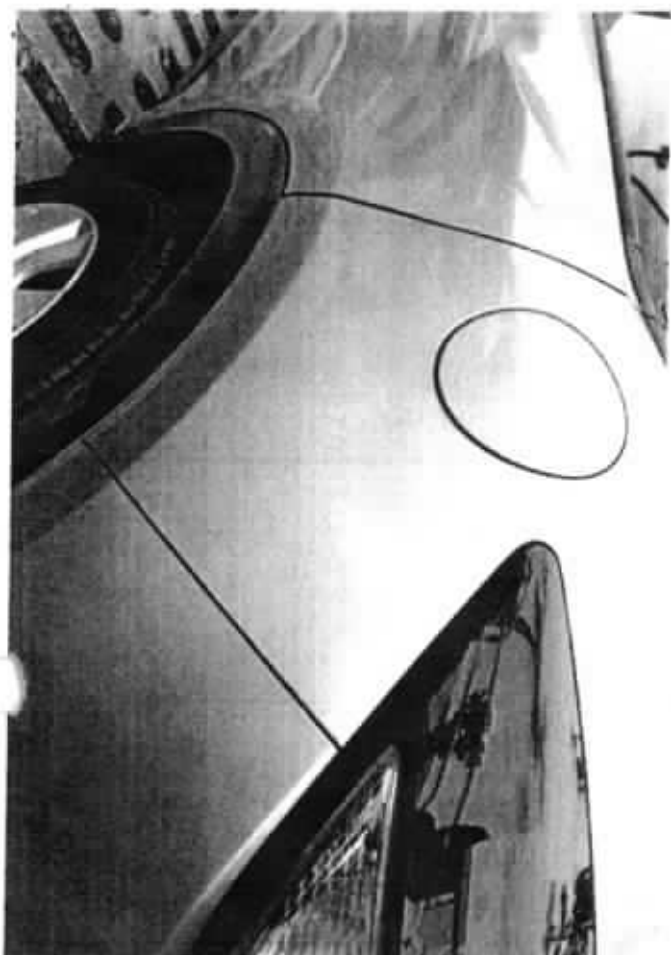
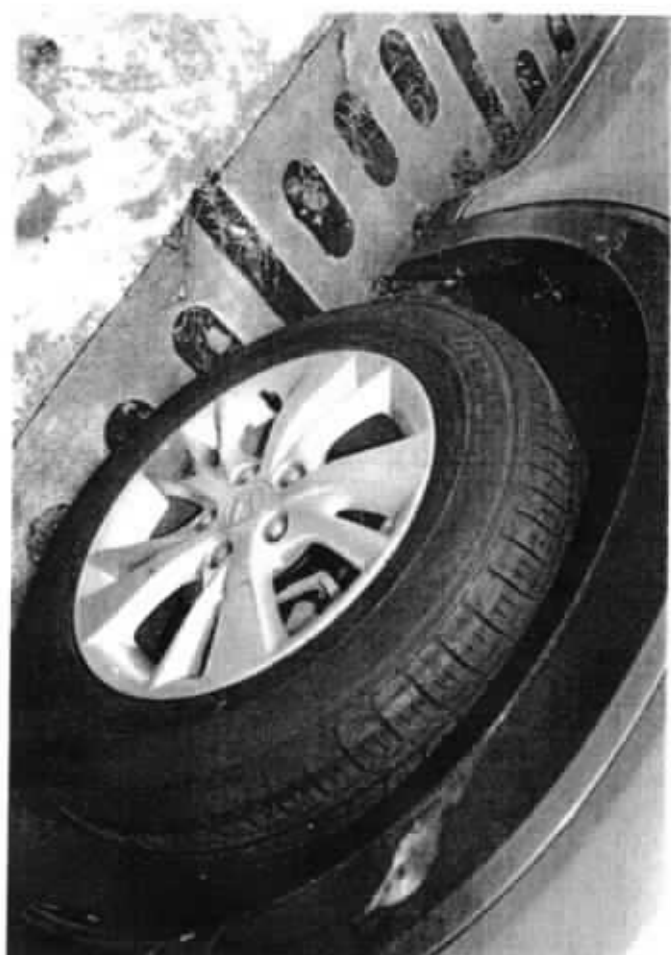
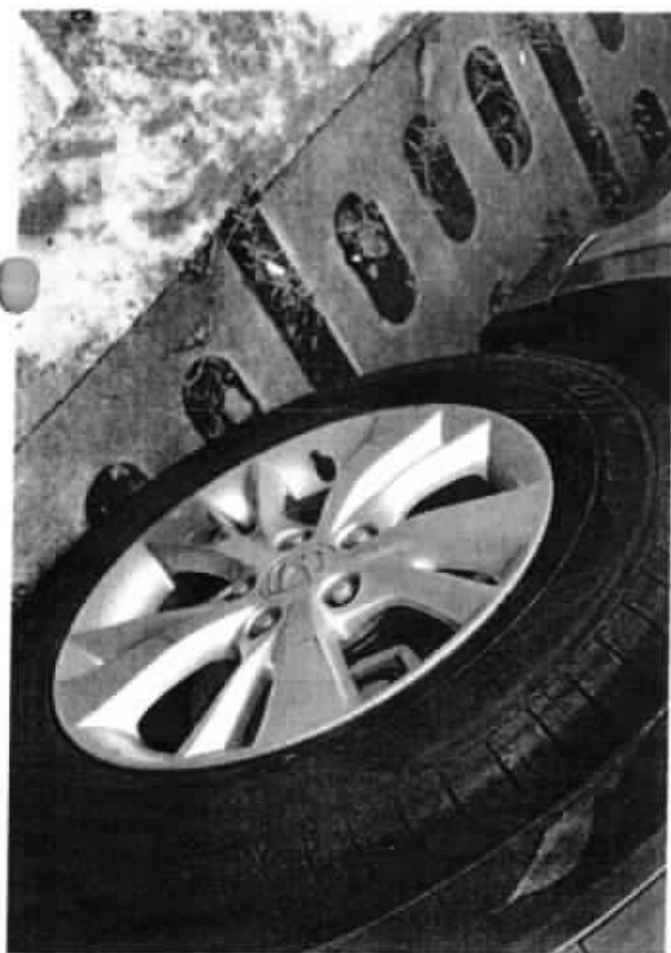
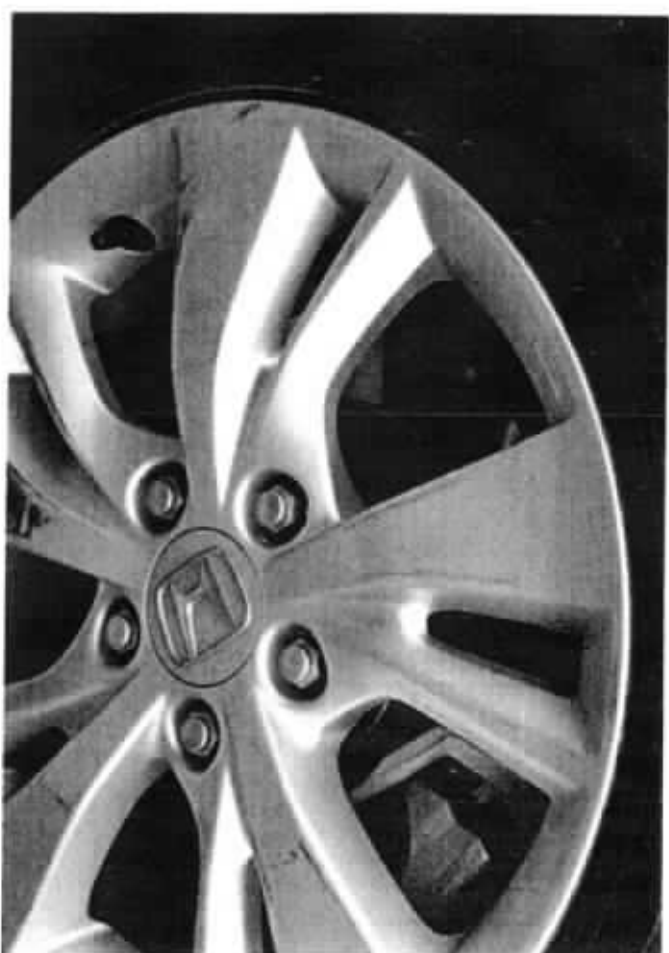
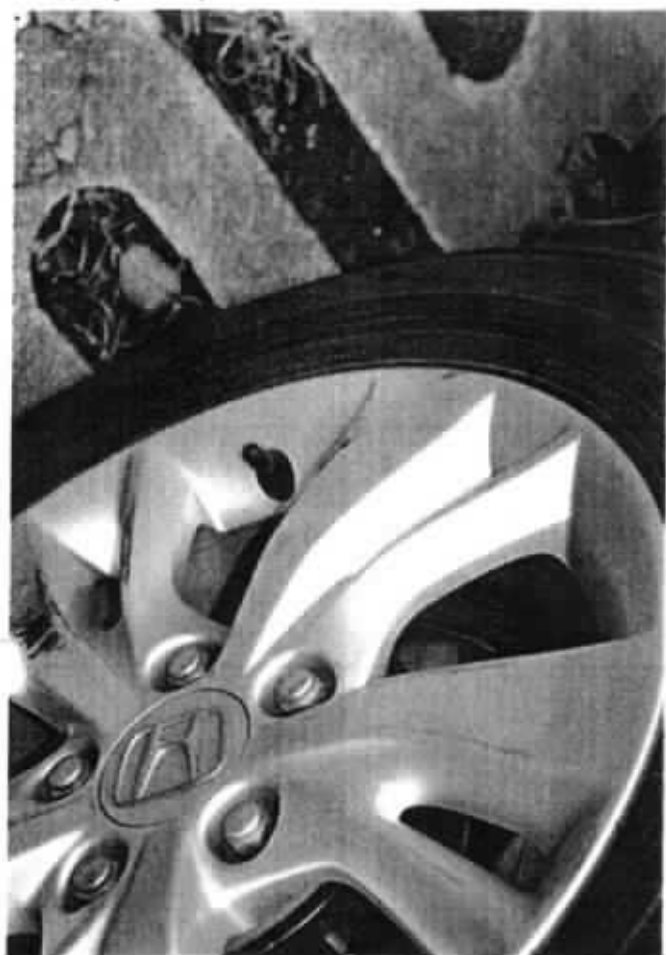
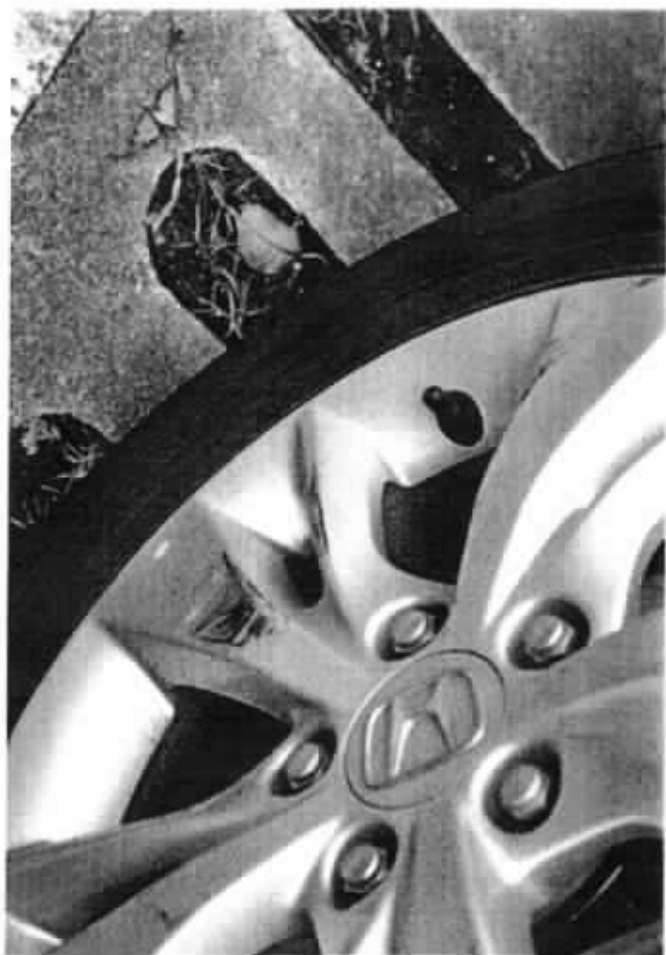
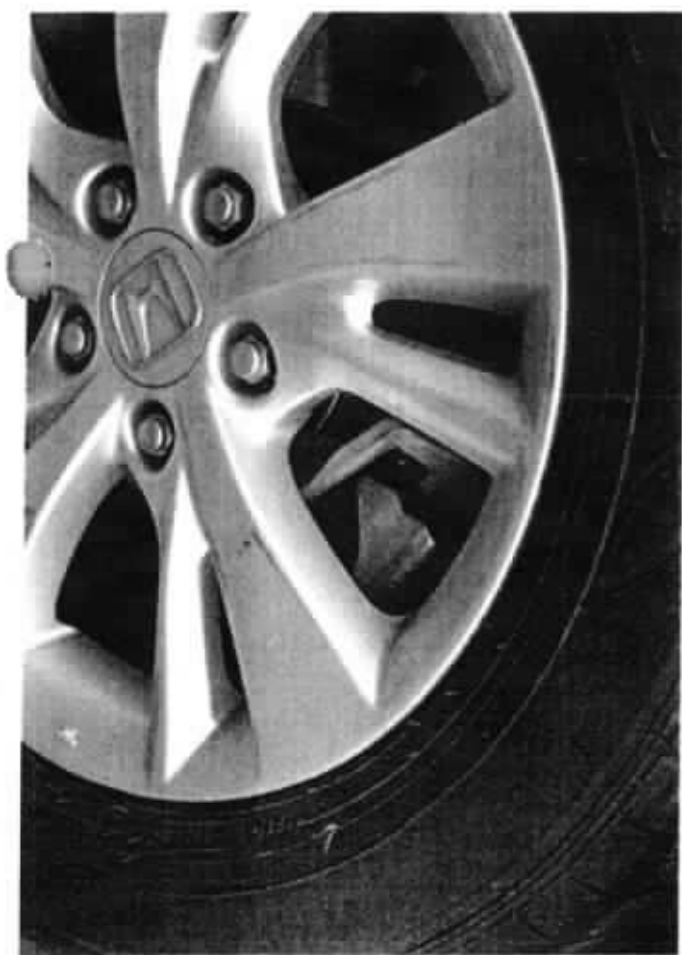
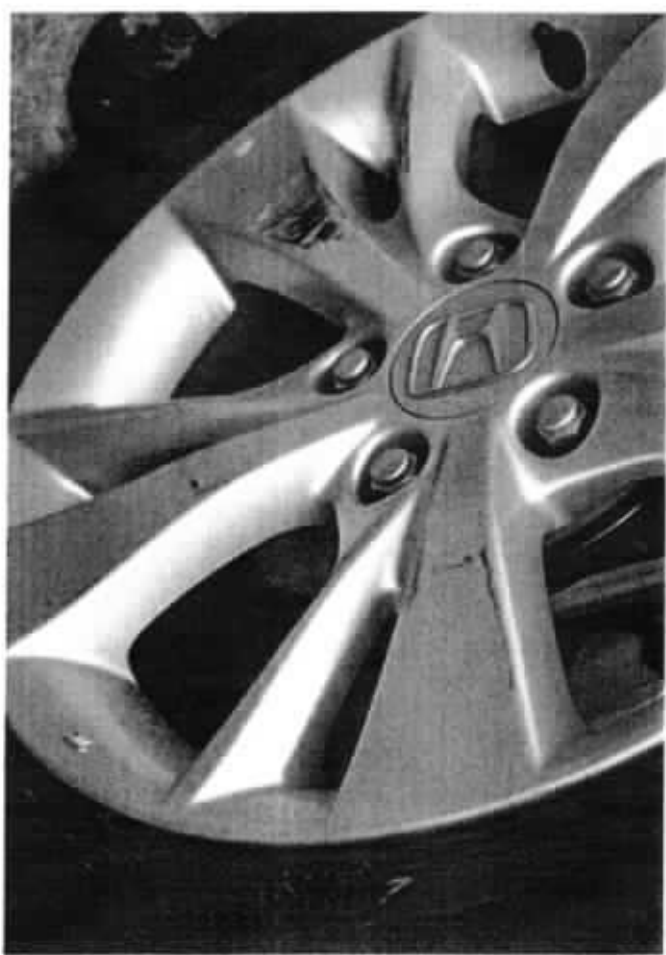
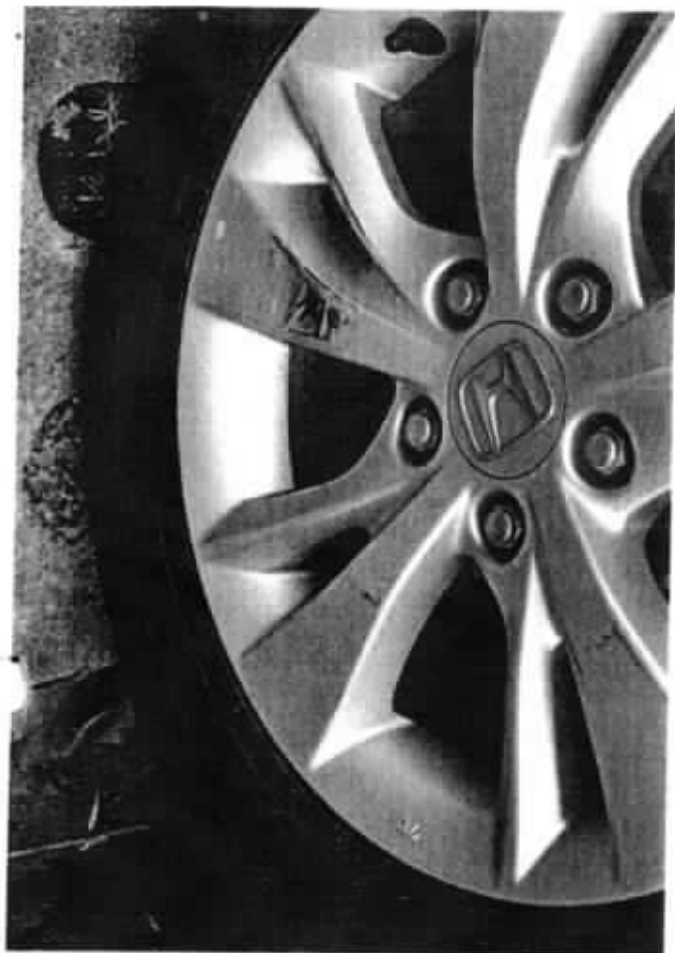
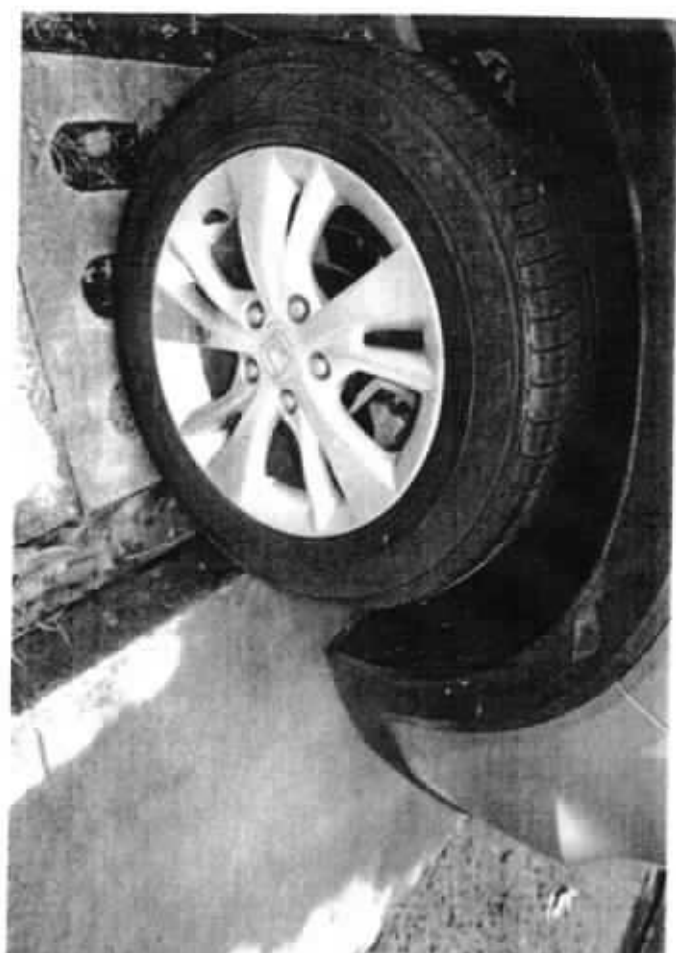
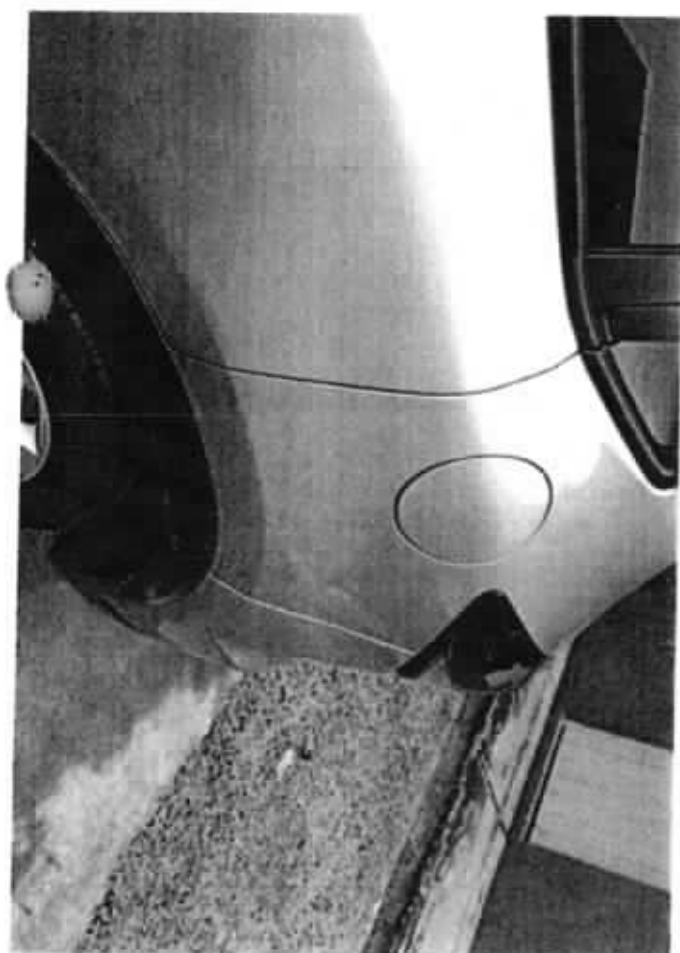
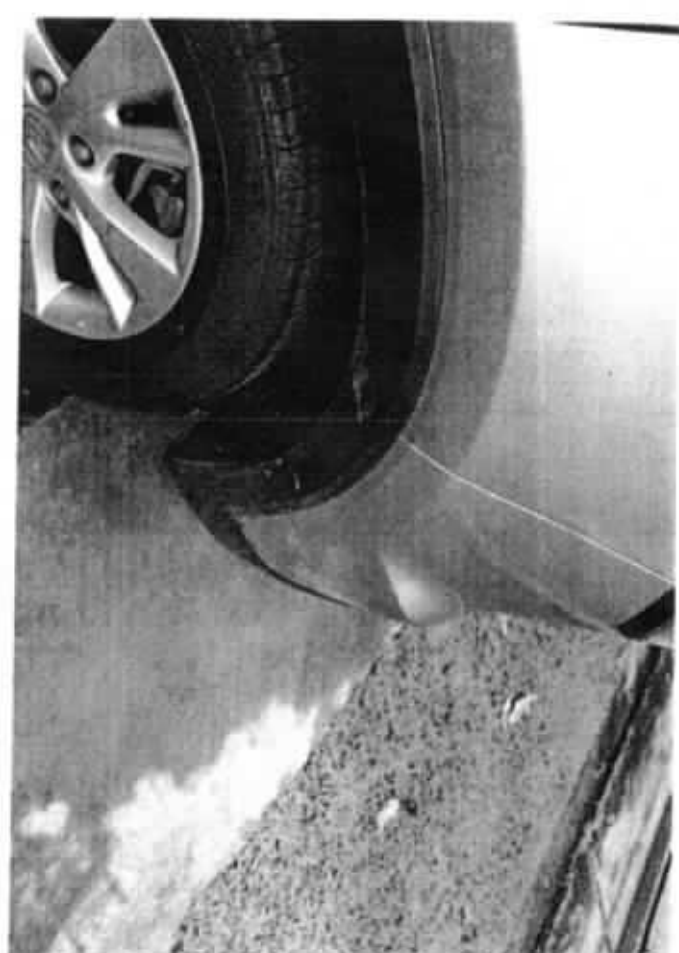
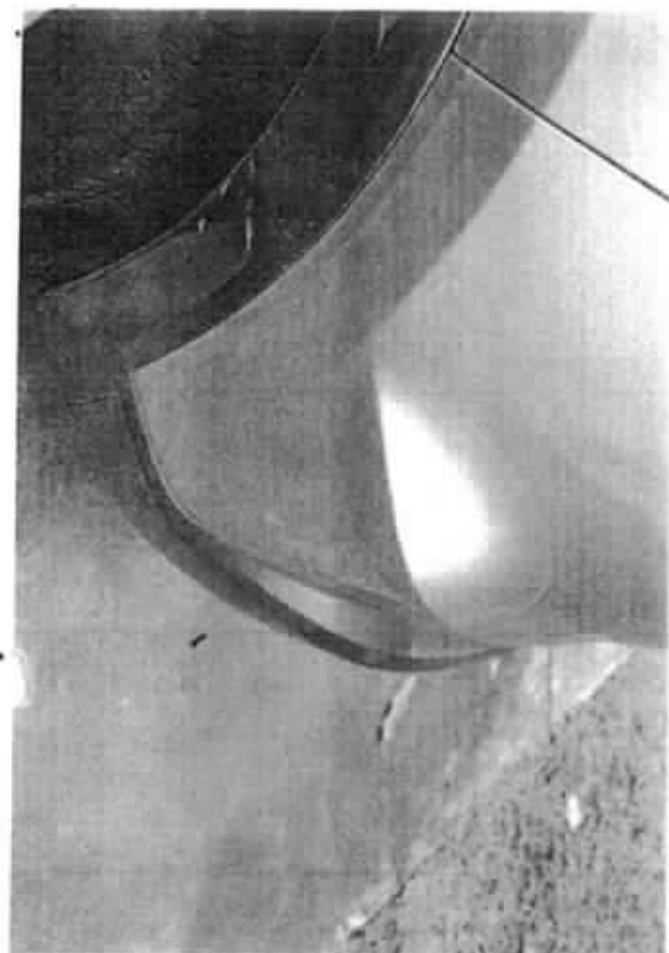
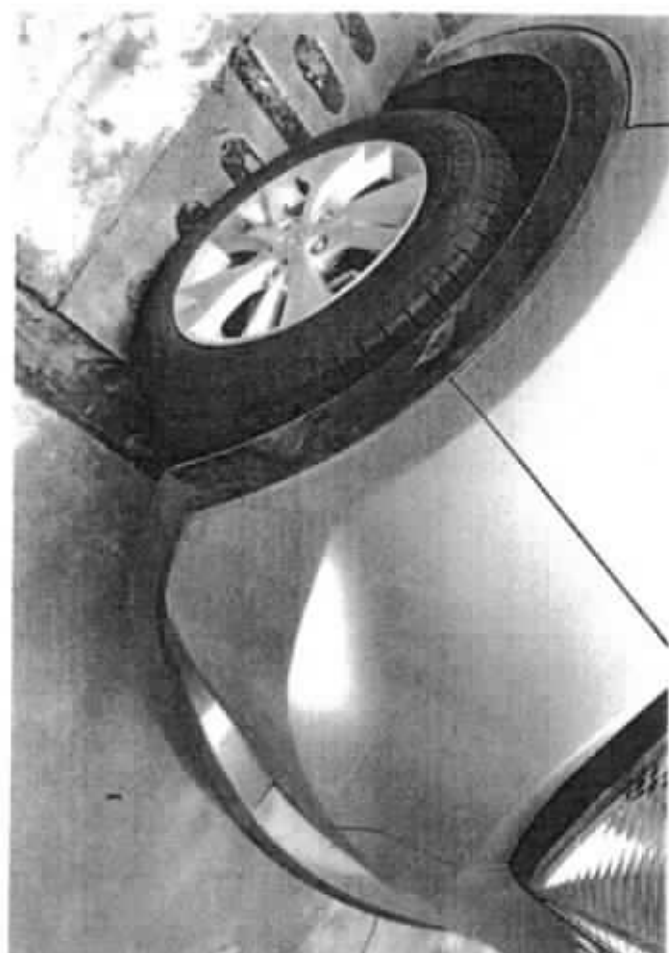
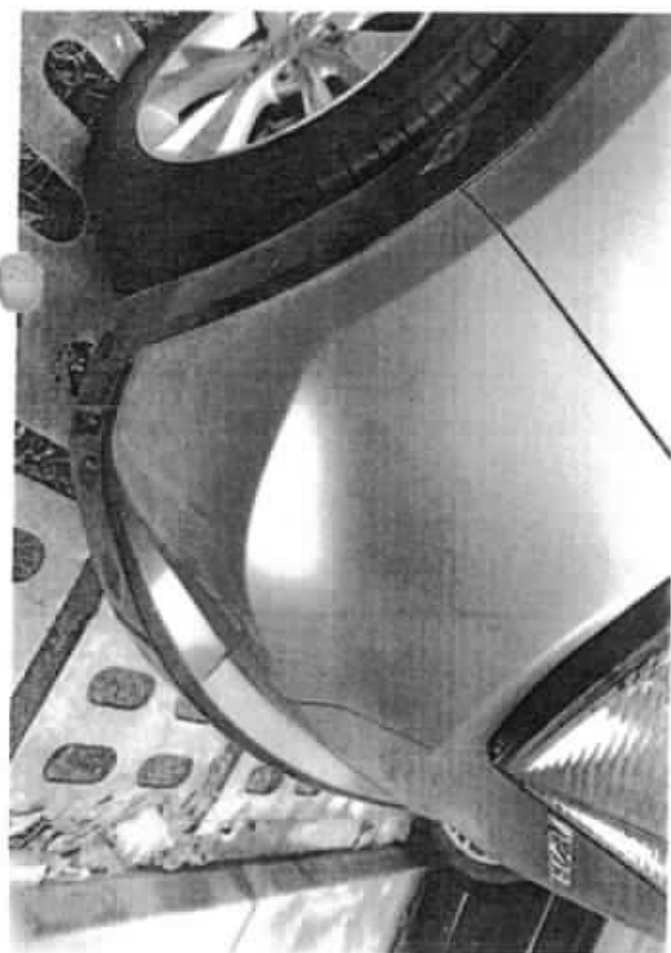
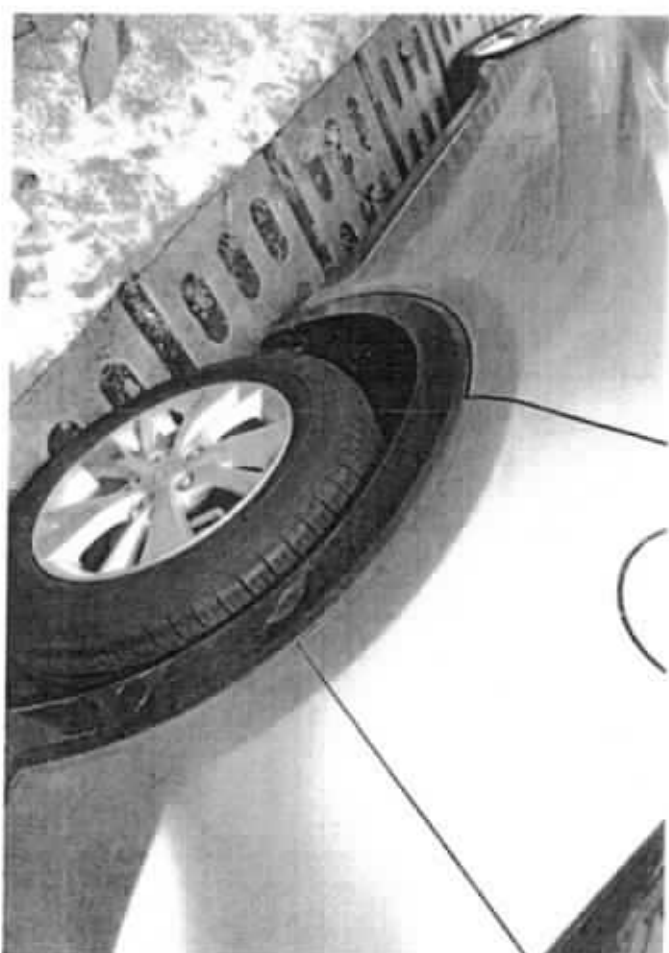
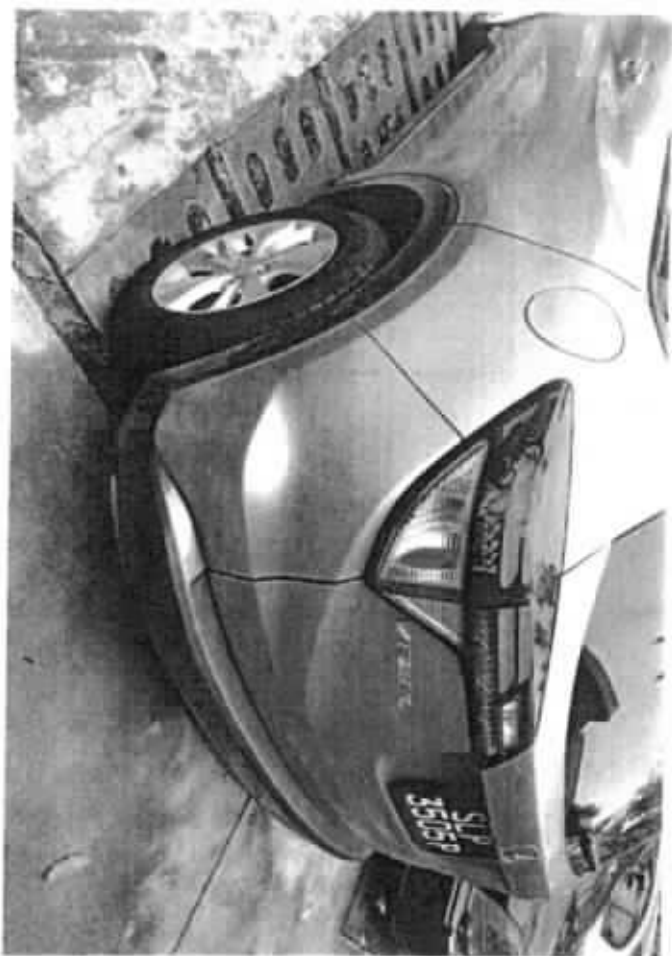
Photographs showing the damaged vehicle and reinspection pictures were enclosed.

| Affiliated to Federation Internationale Des Experts En Automobile | | | | |
|--|---|---|---|---|
| THE VEHICLE HAD COMPLETED ITS REPAIR WORKS. | | | | |
| REPAIR CONDITION SEE DETAILS. | | | | |

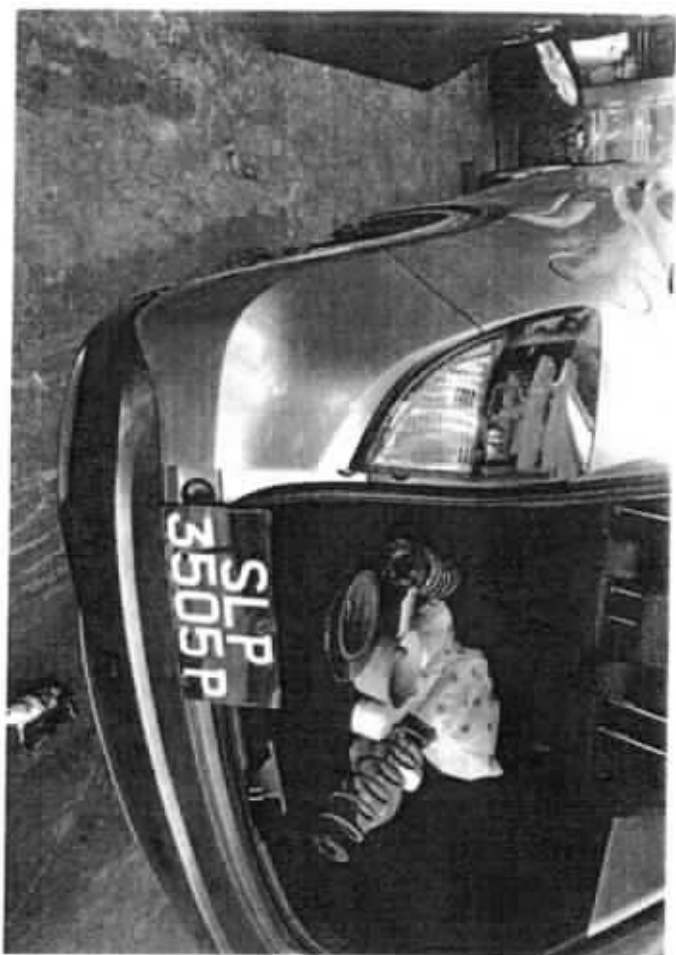
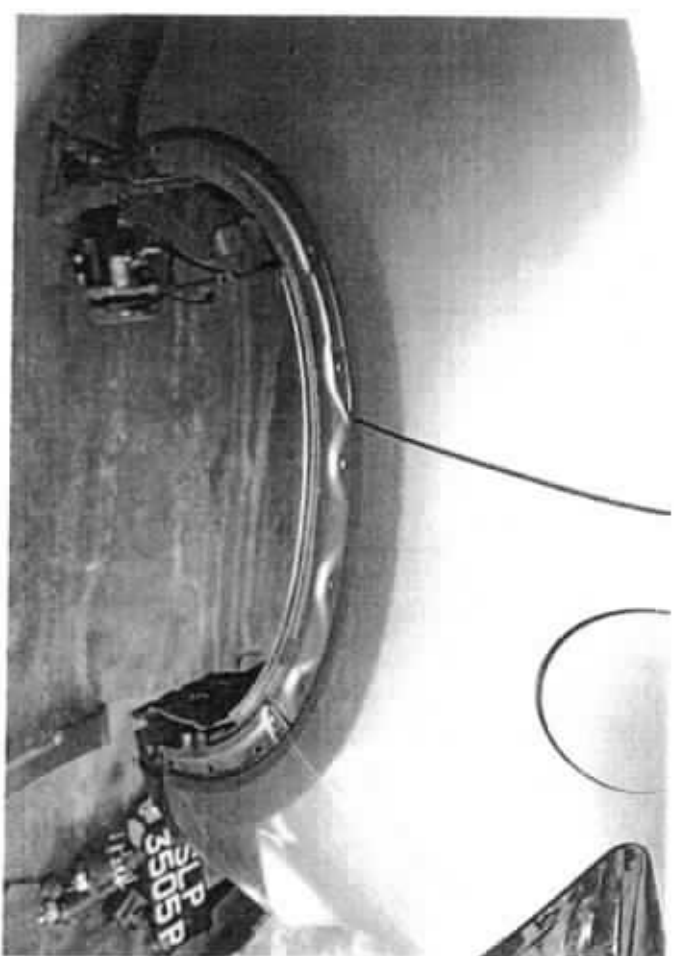
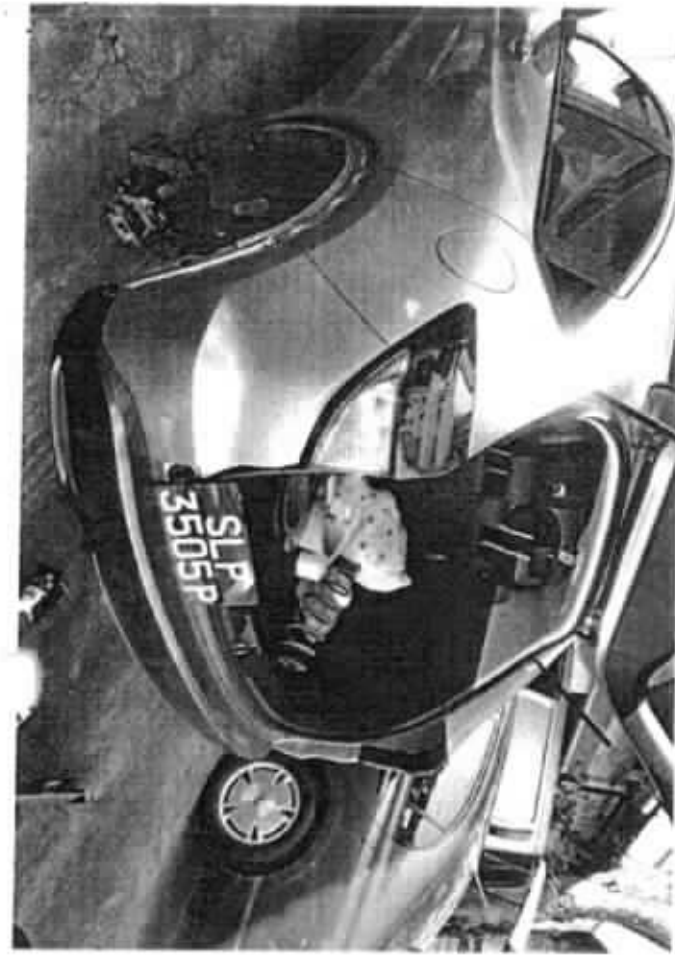
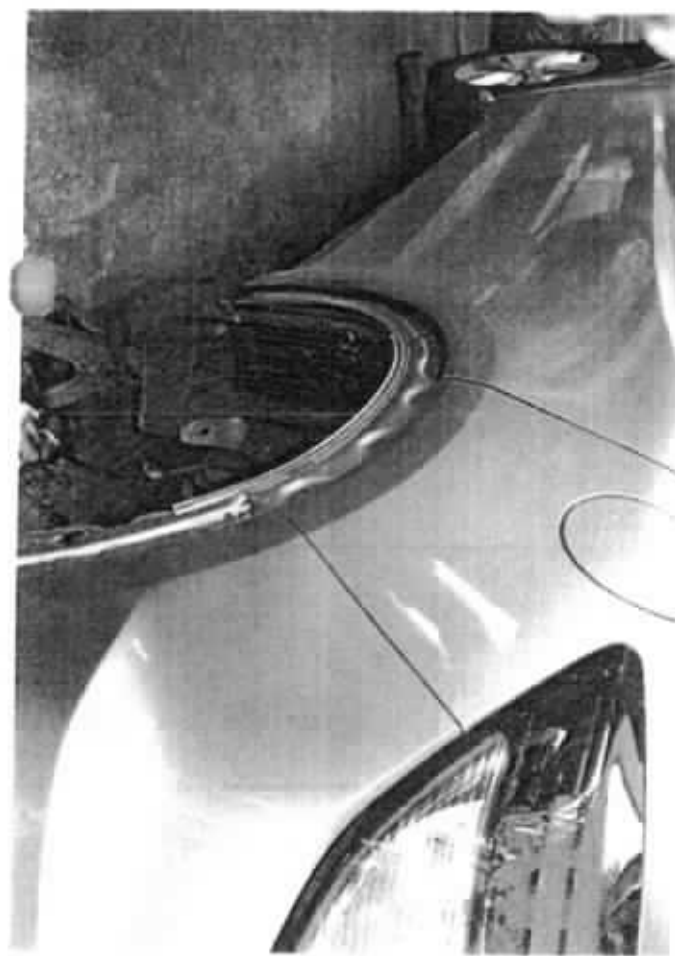
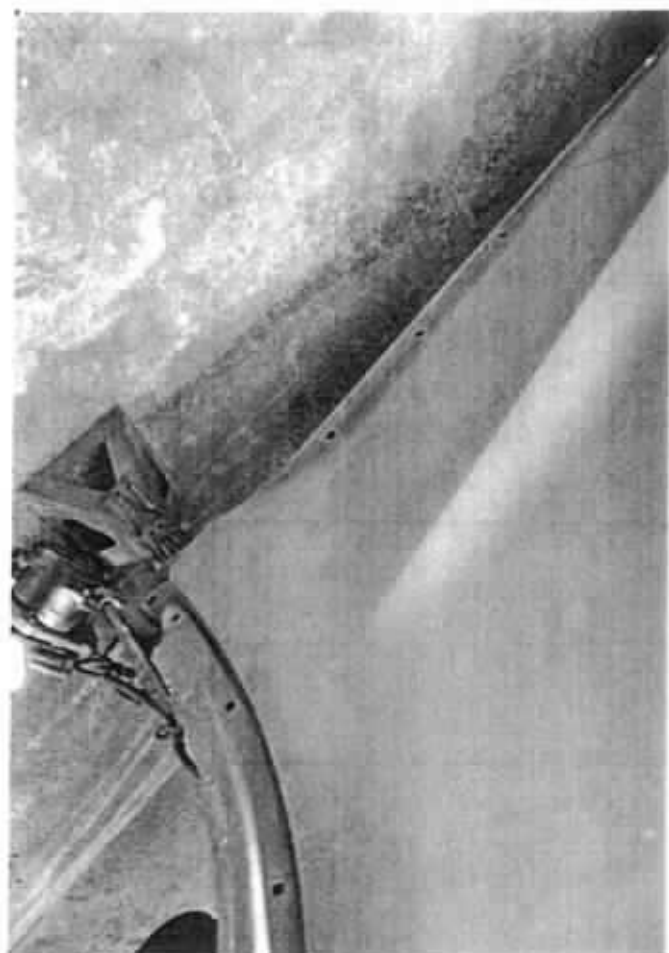
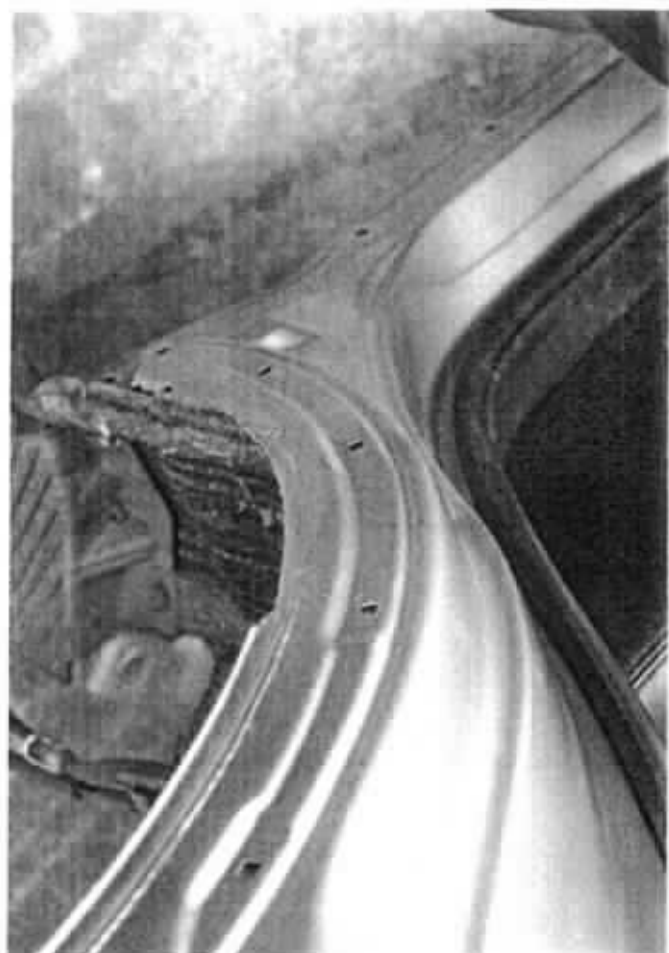
| Qty | Description of Parts | Condition | Estimate By Workshop (\$) | Our Adjusted (\$) |
|---|--|---|---|---|
| 1 | REAR AXLE BEAM ASSY | NOT CHANGED | 1,513.80 | - |
| 1 | REAR SHOCK ABSORBER N/S | NOT CHANGED | 280.80 | - |
| 1 | REAR TYRE N/S (SN) | NOT CHANGED | 320.00 | - |
