## SURVEY REPORT

| Affiliated to Federation Internationale Des Experts En Automobile | | | | |
|--|---|---|---|---|
| <b>1. Policy Particulars :- THIRD PARTY CLAIM (RESURVEY INSPECTION)</b> | | | | |

## ADJUSTMENT ON REPAIR COST FOR VEHICLE NO. SLP 3505P

REINSPECTION PHOTOGRAPHS

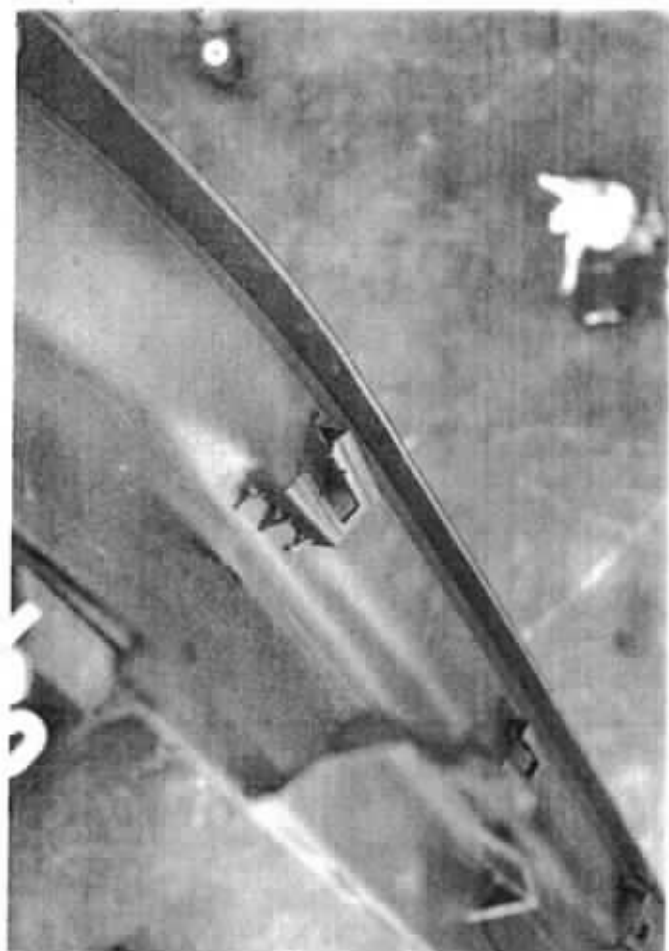
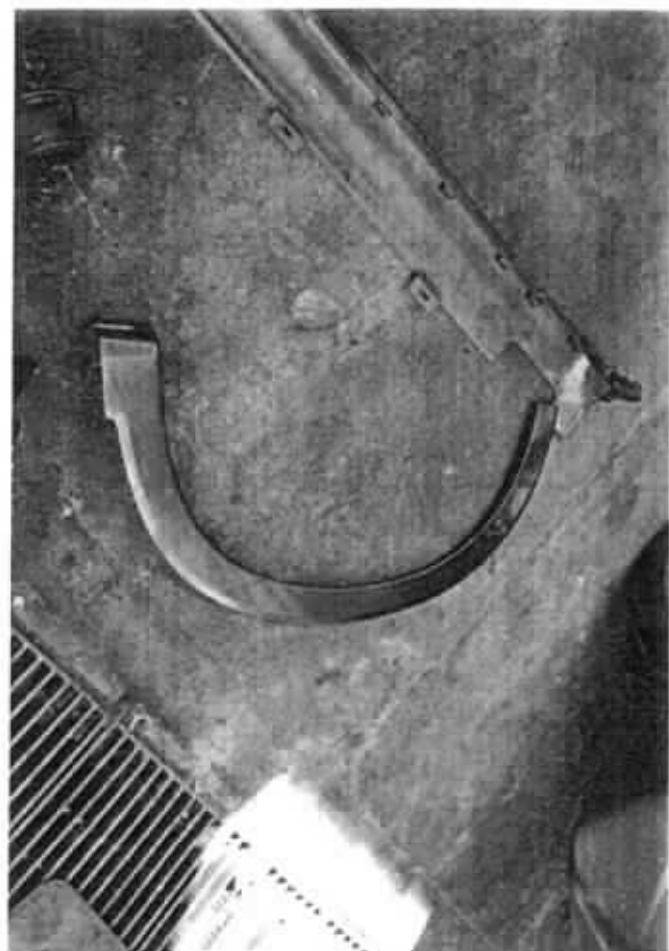
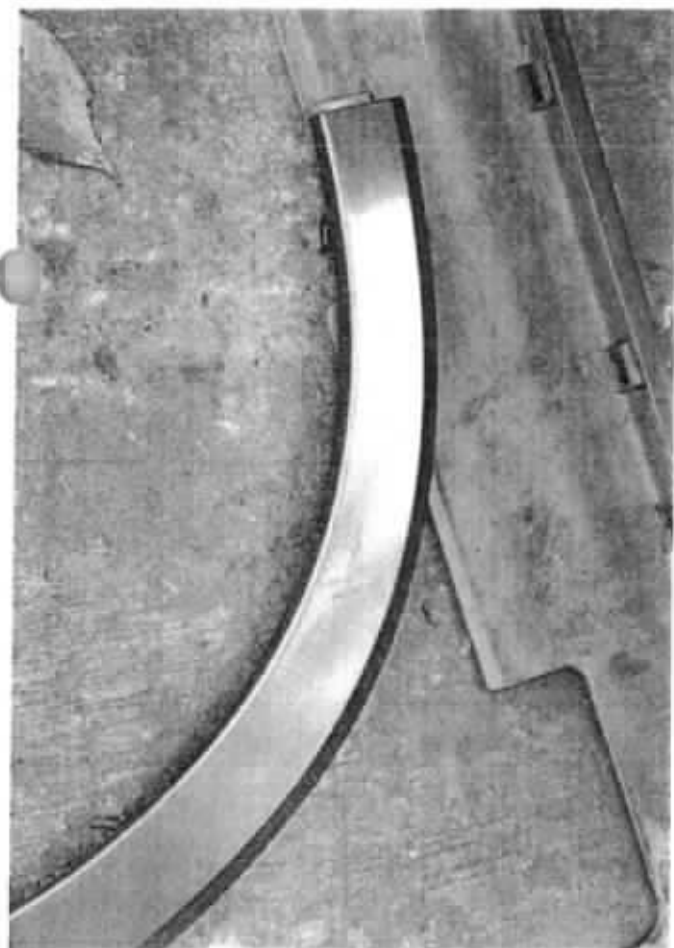
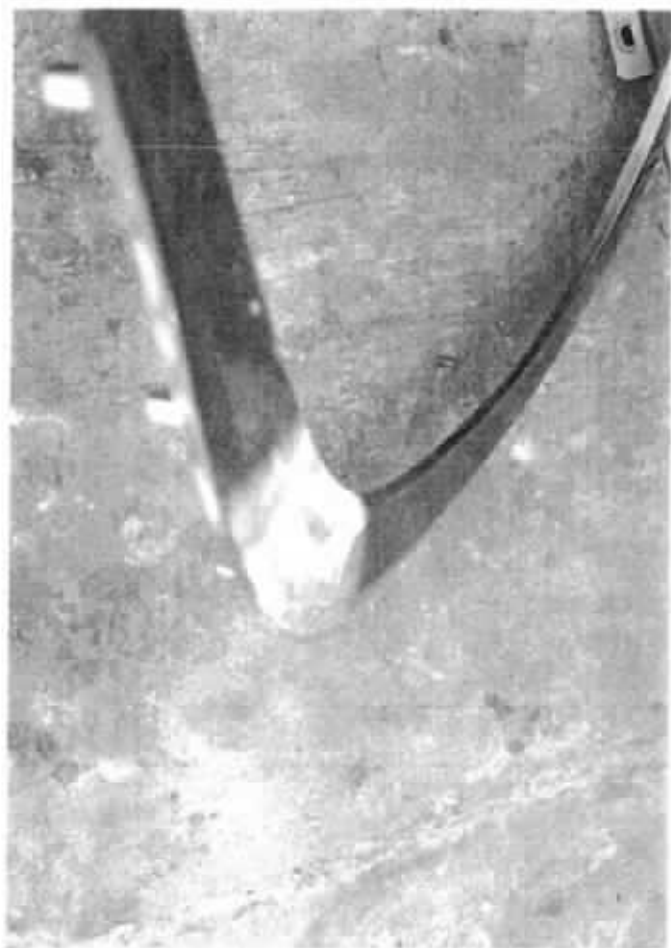
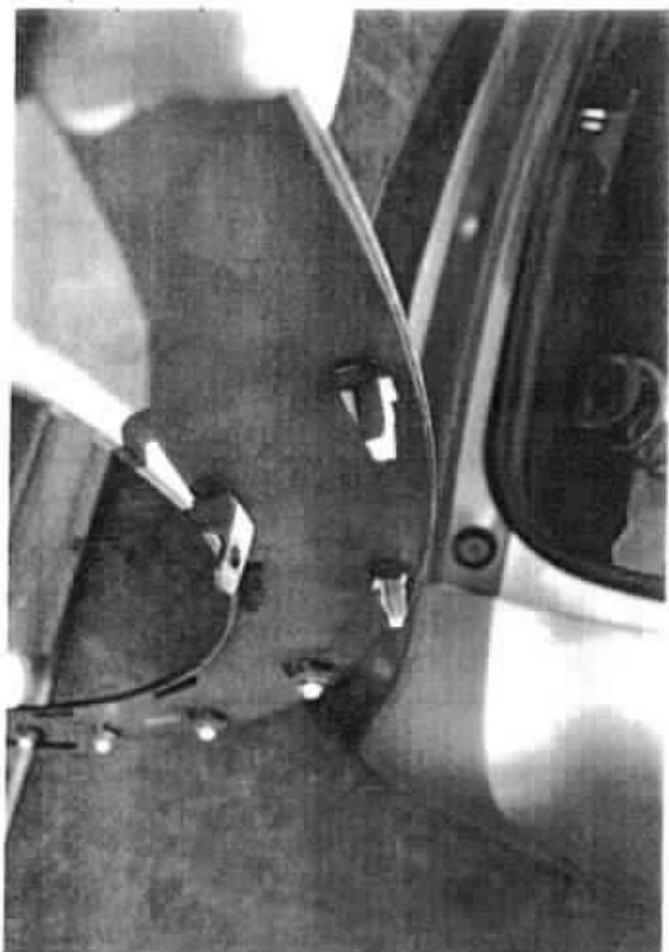
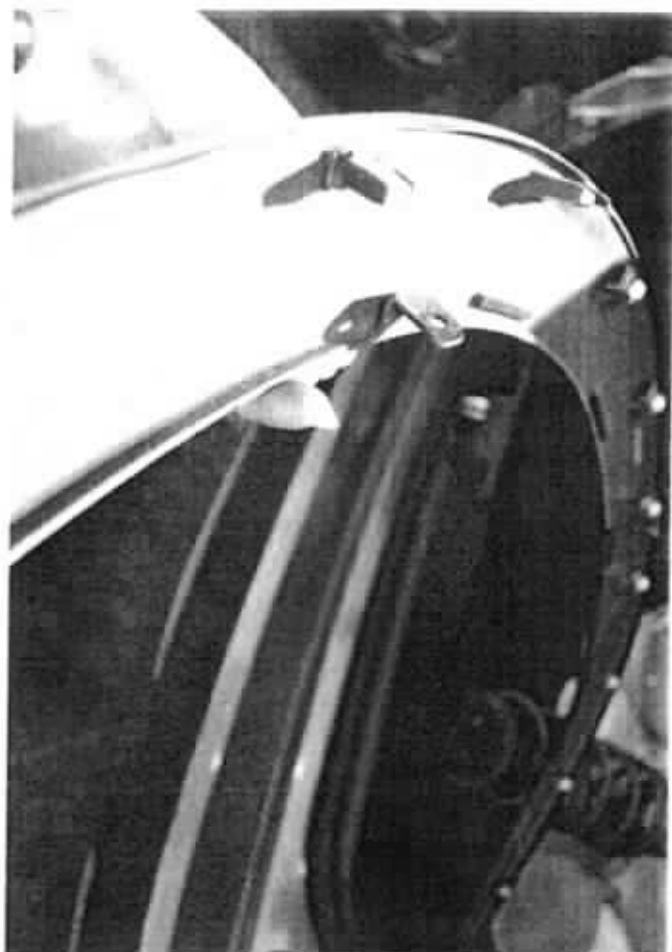
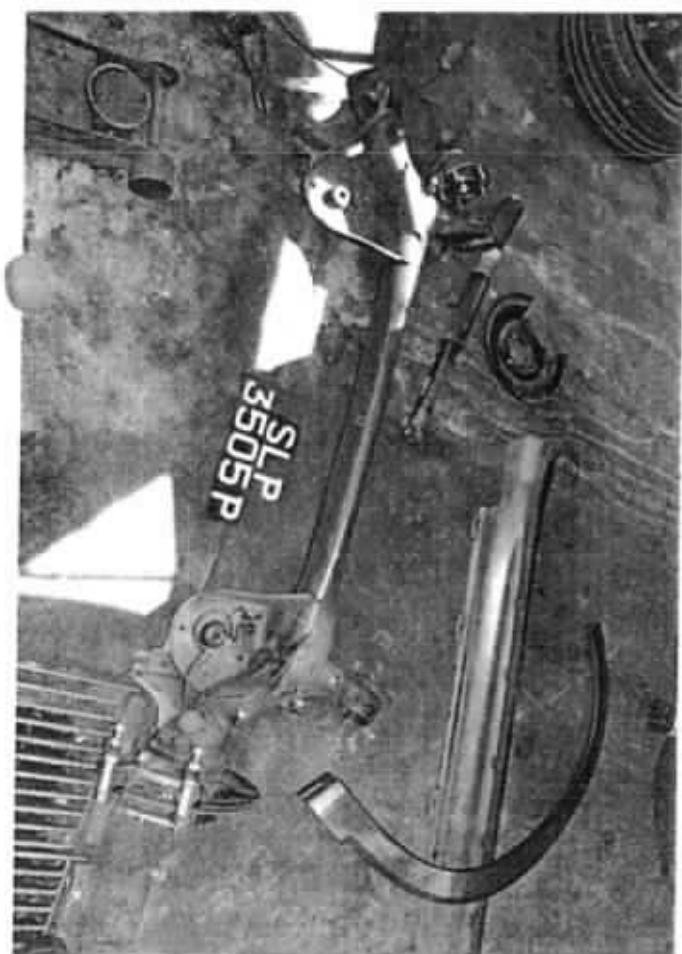
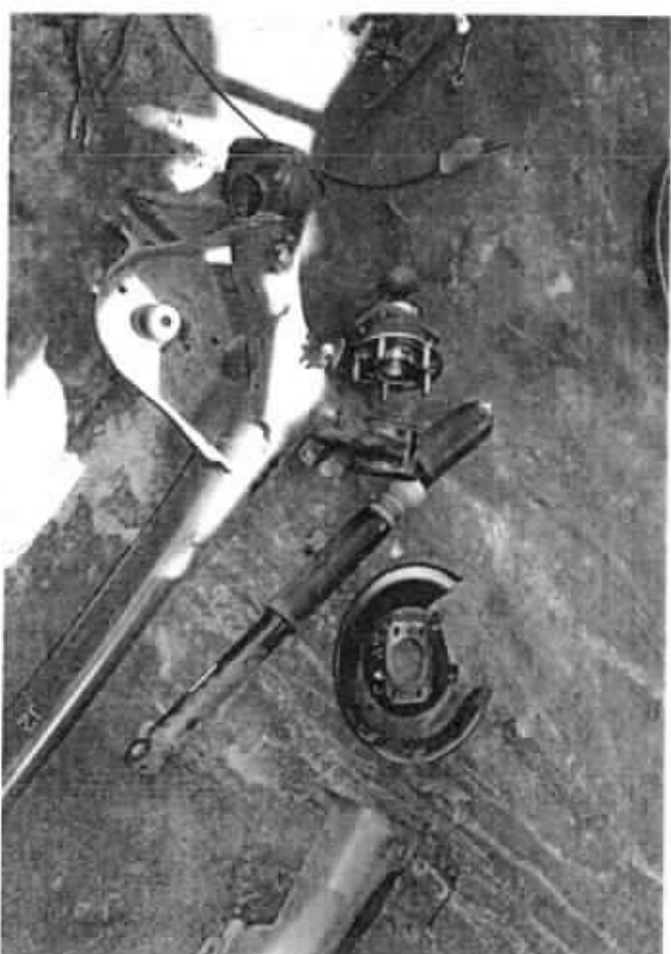
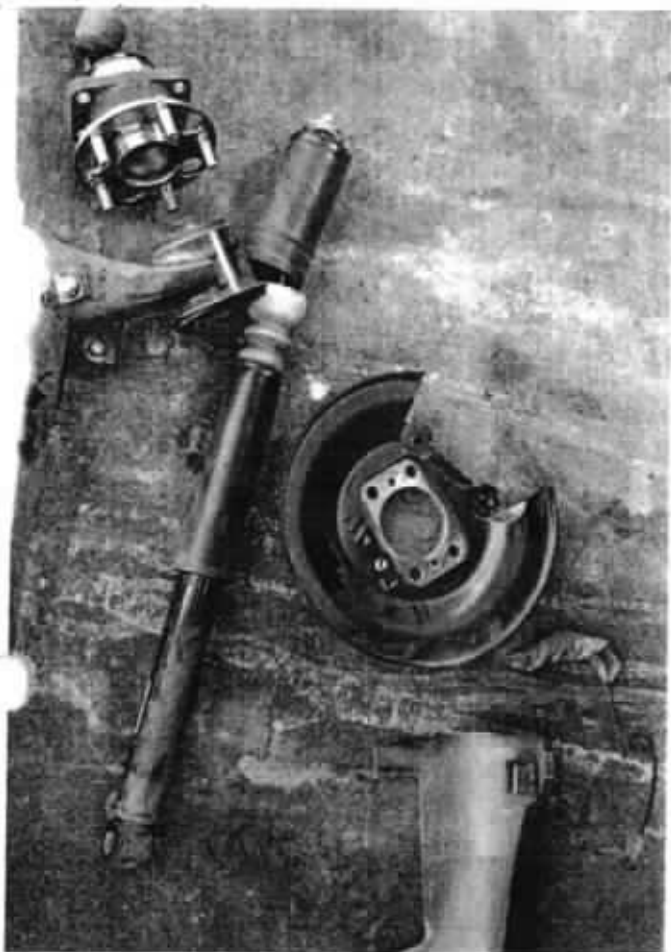
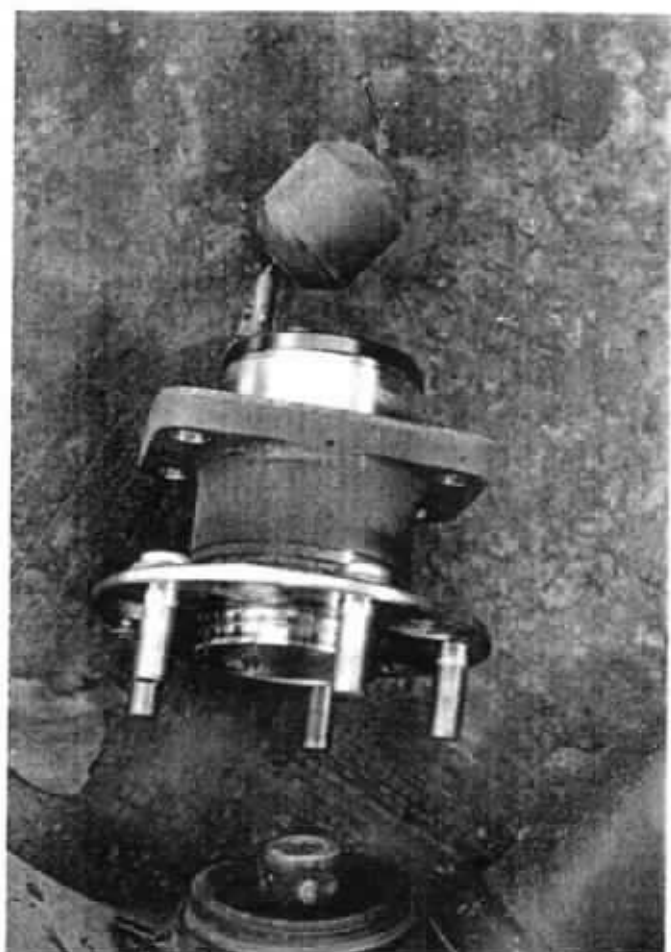
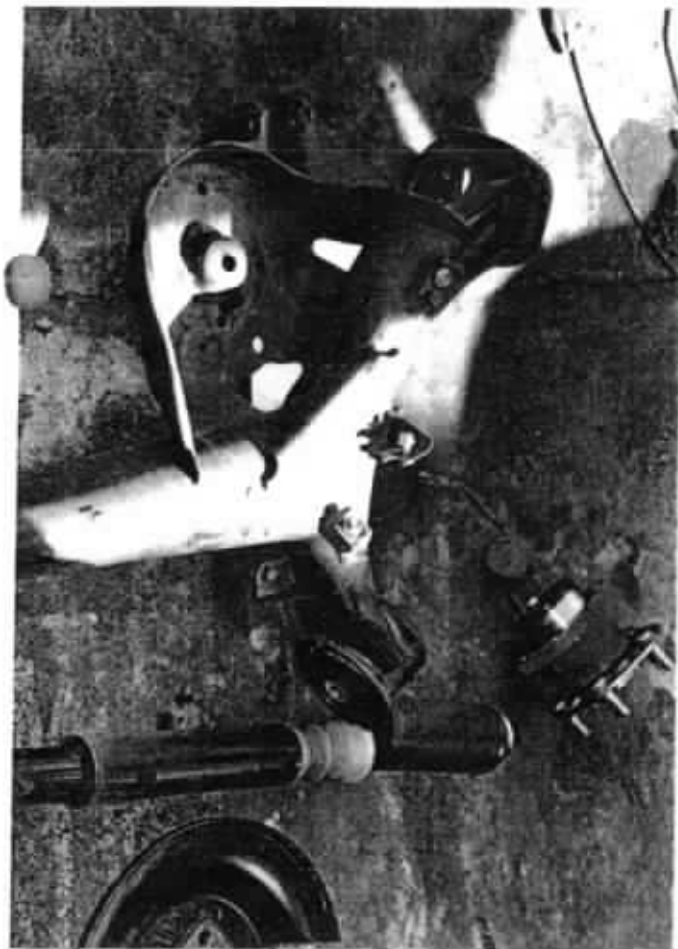
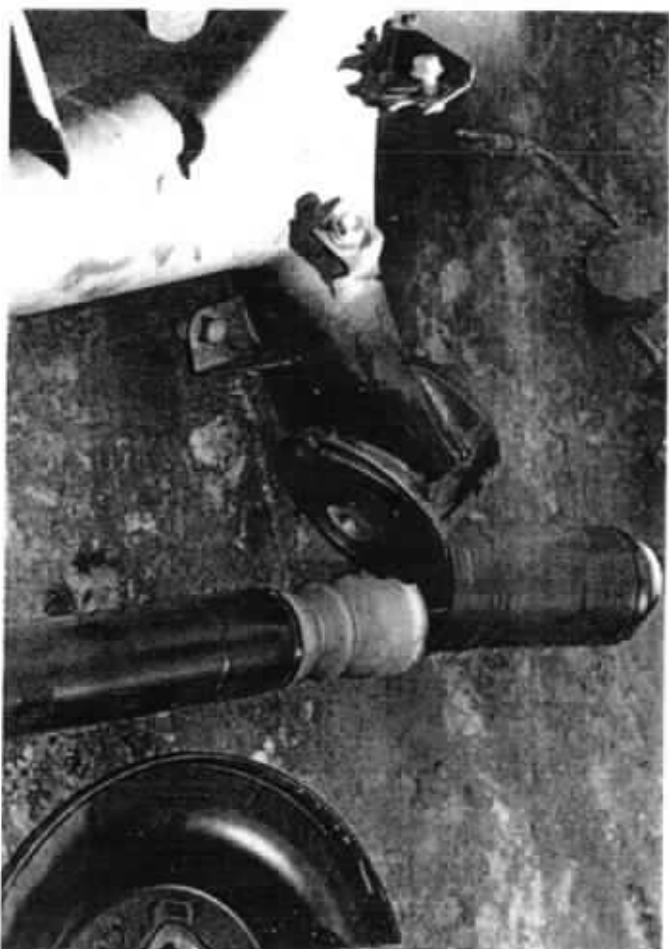
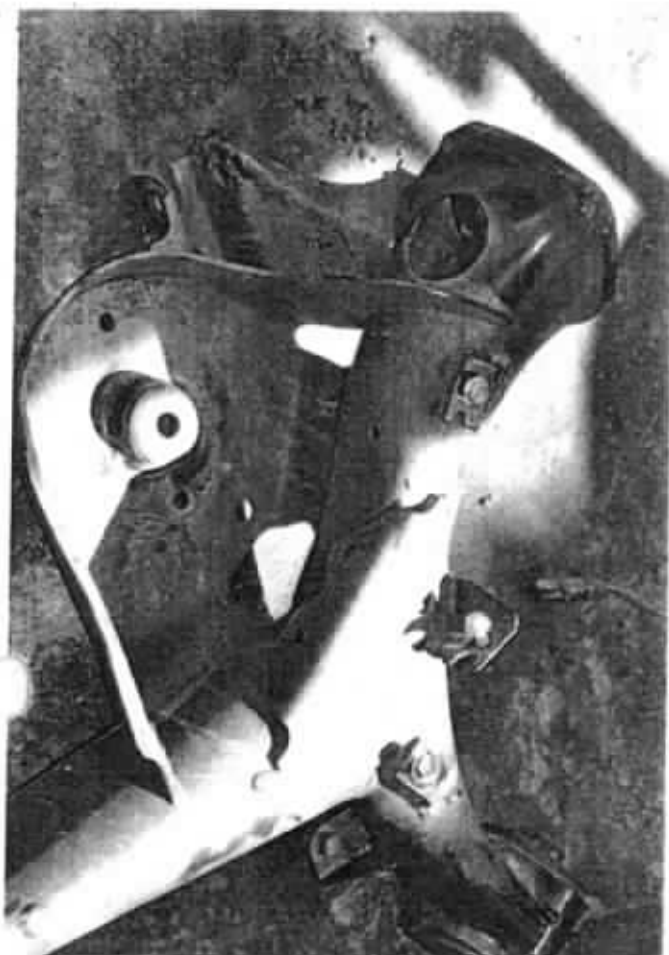
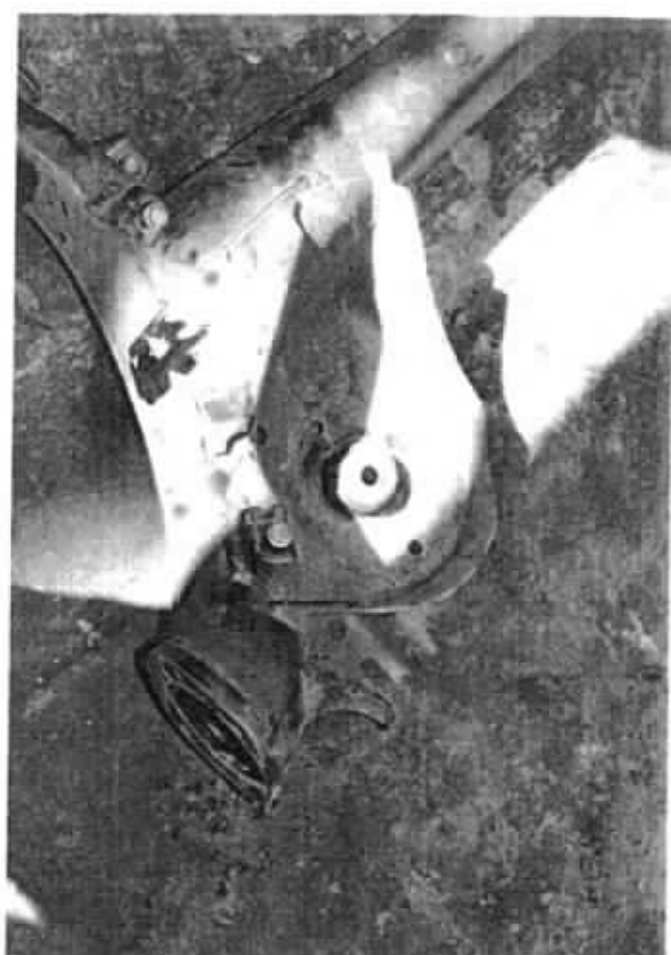
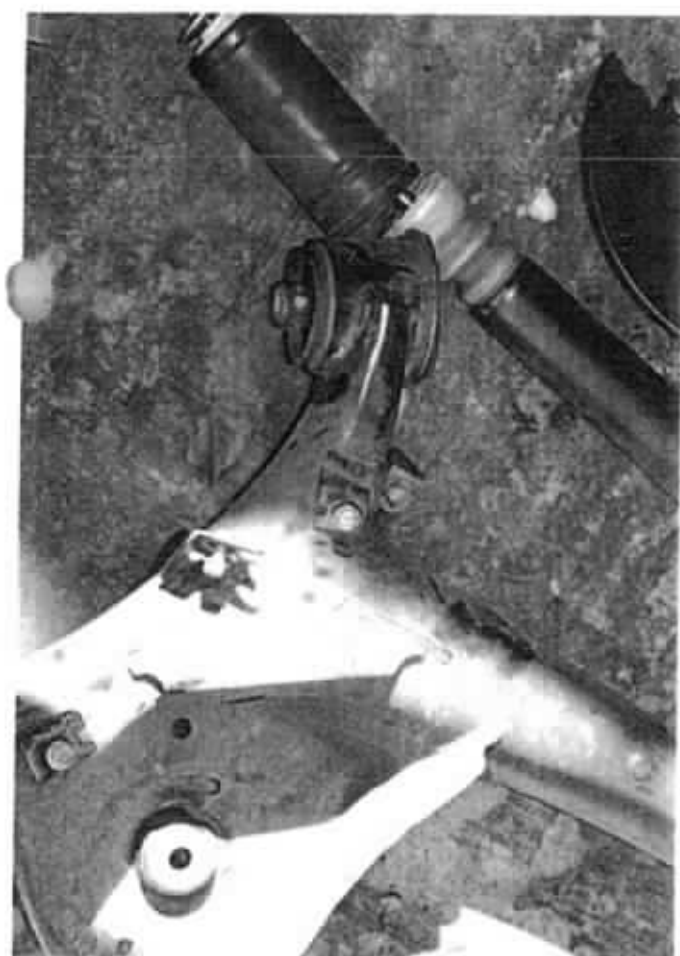
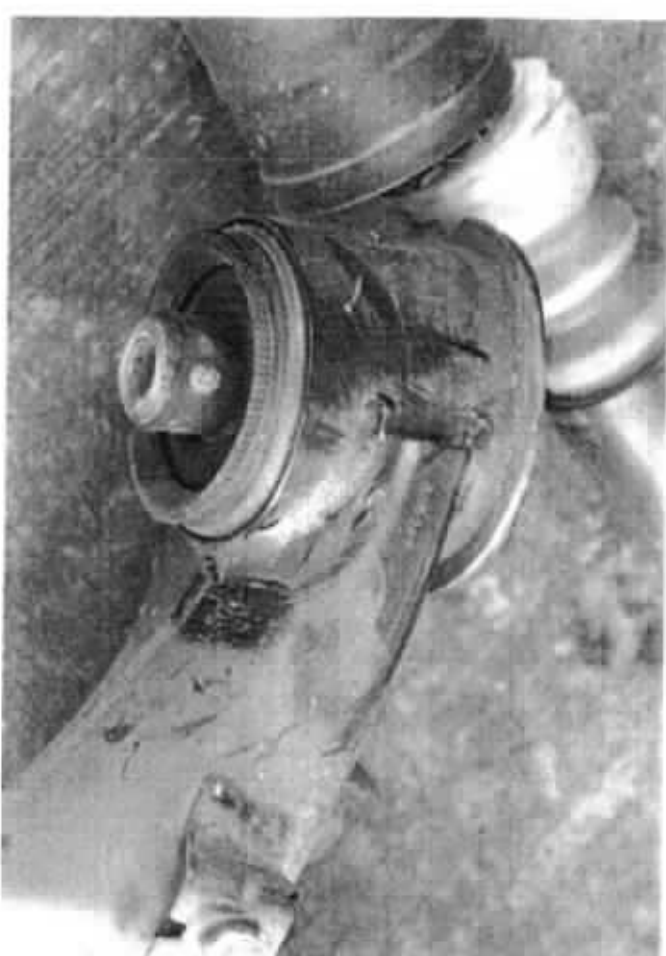
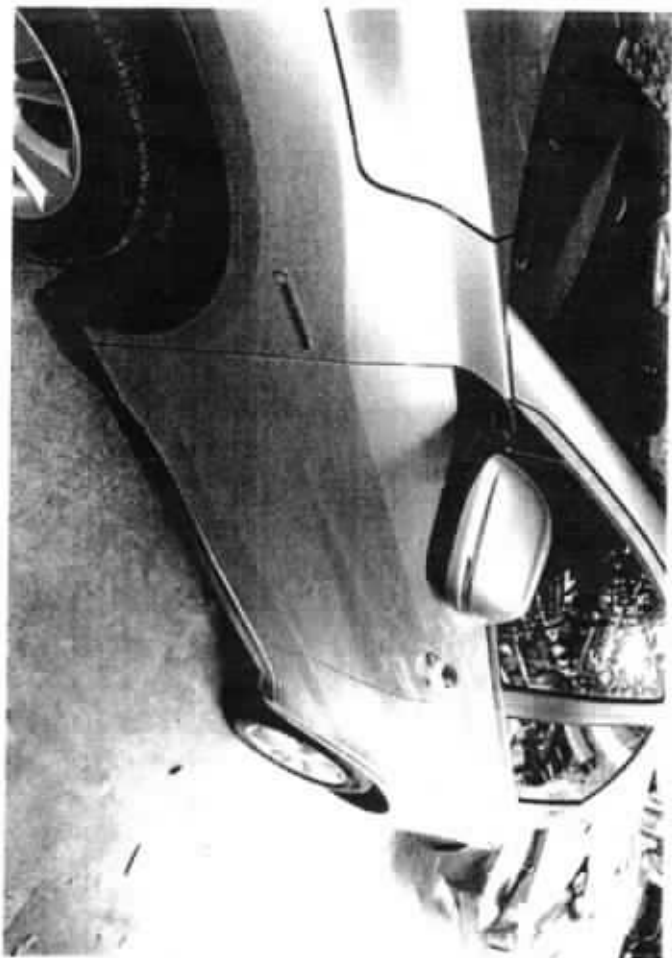
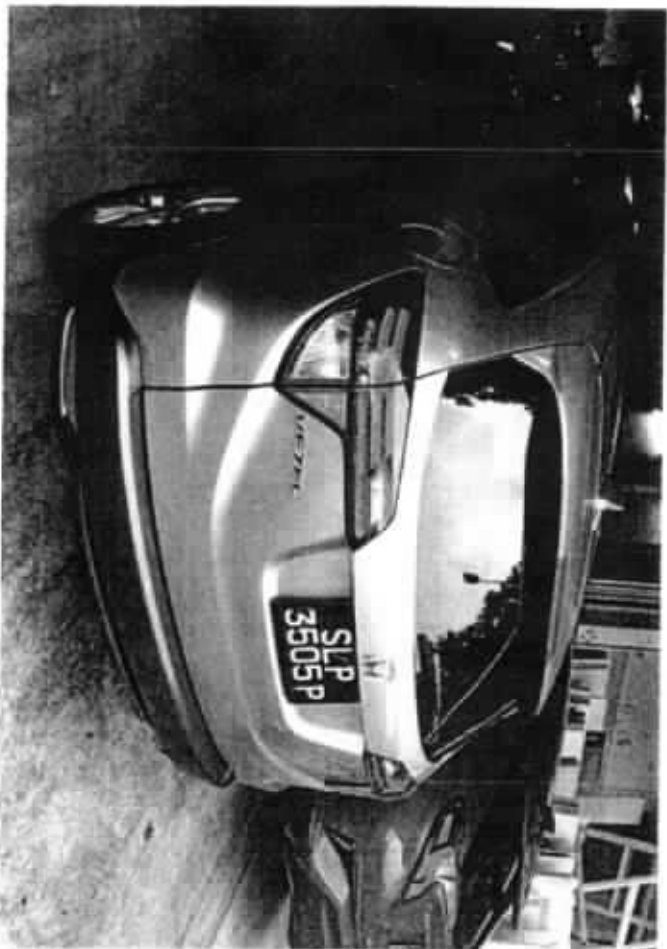
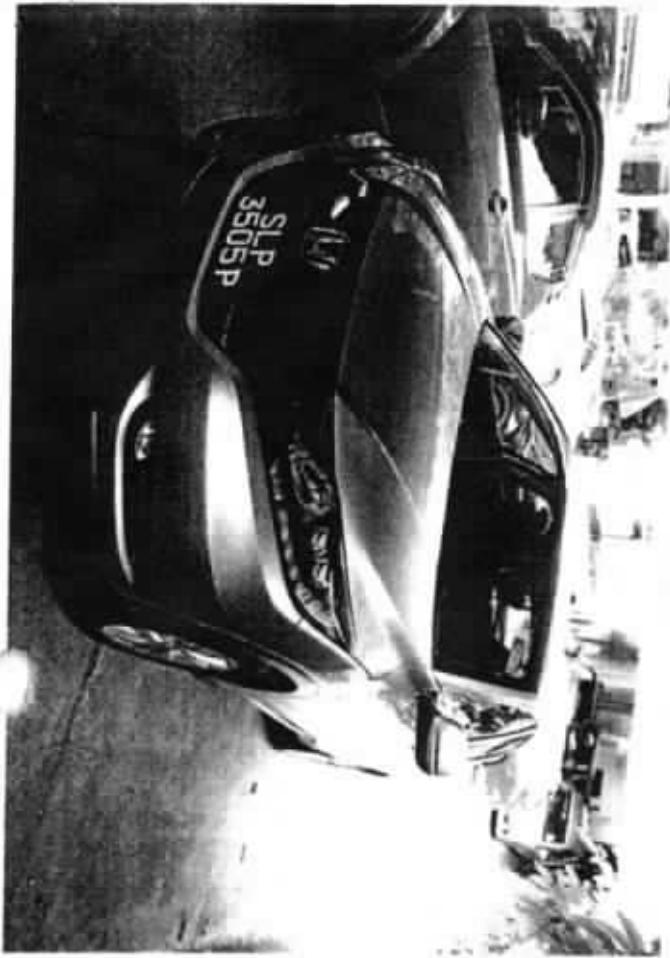
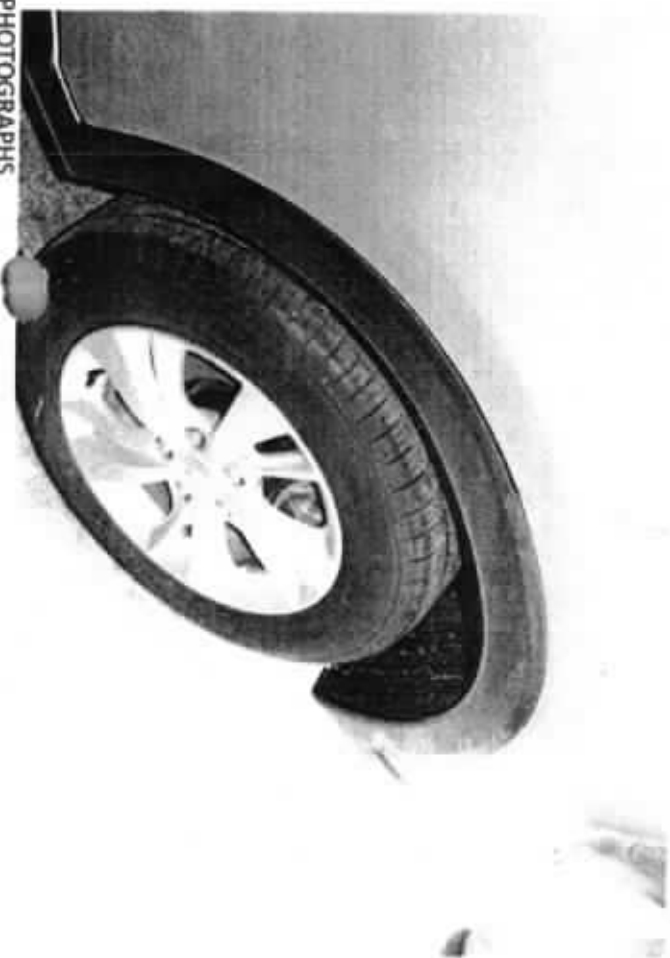
| Affiliated to Federation Internationale Des Experts En Automobile | | | | |
|--|---|---|---|---|
| THE VEHICLE HAD COMPLETED ITS REPAIR WORKS. | | | | |
| REPAIR CONDITION SEE DETAILS. | | | | |

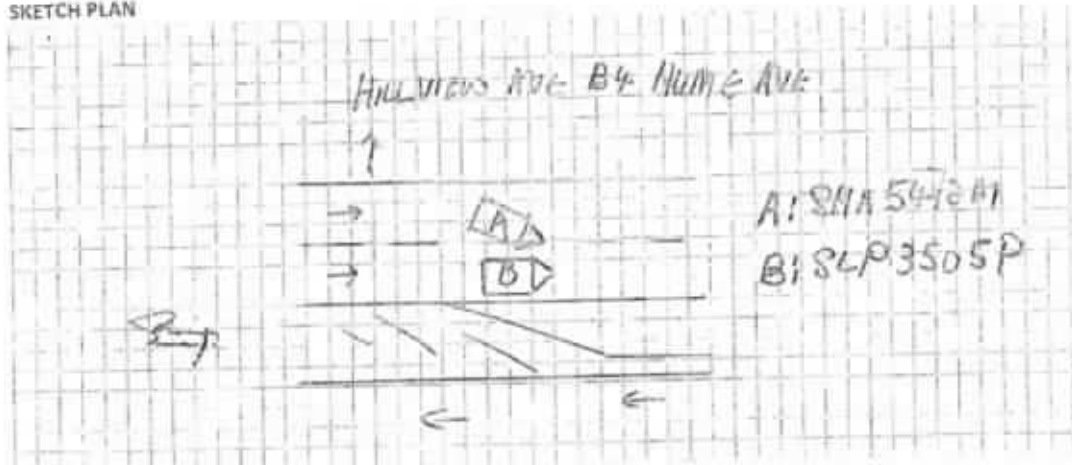
SKETCH PLAN

On 26 NOV 17 at about 0615H after checking for the traffic from my right is clear I slowly filter to my right.

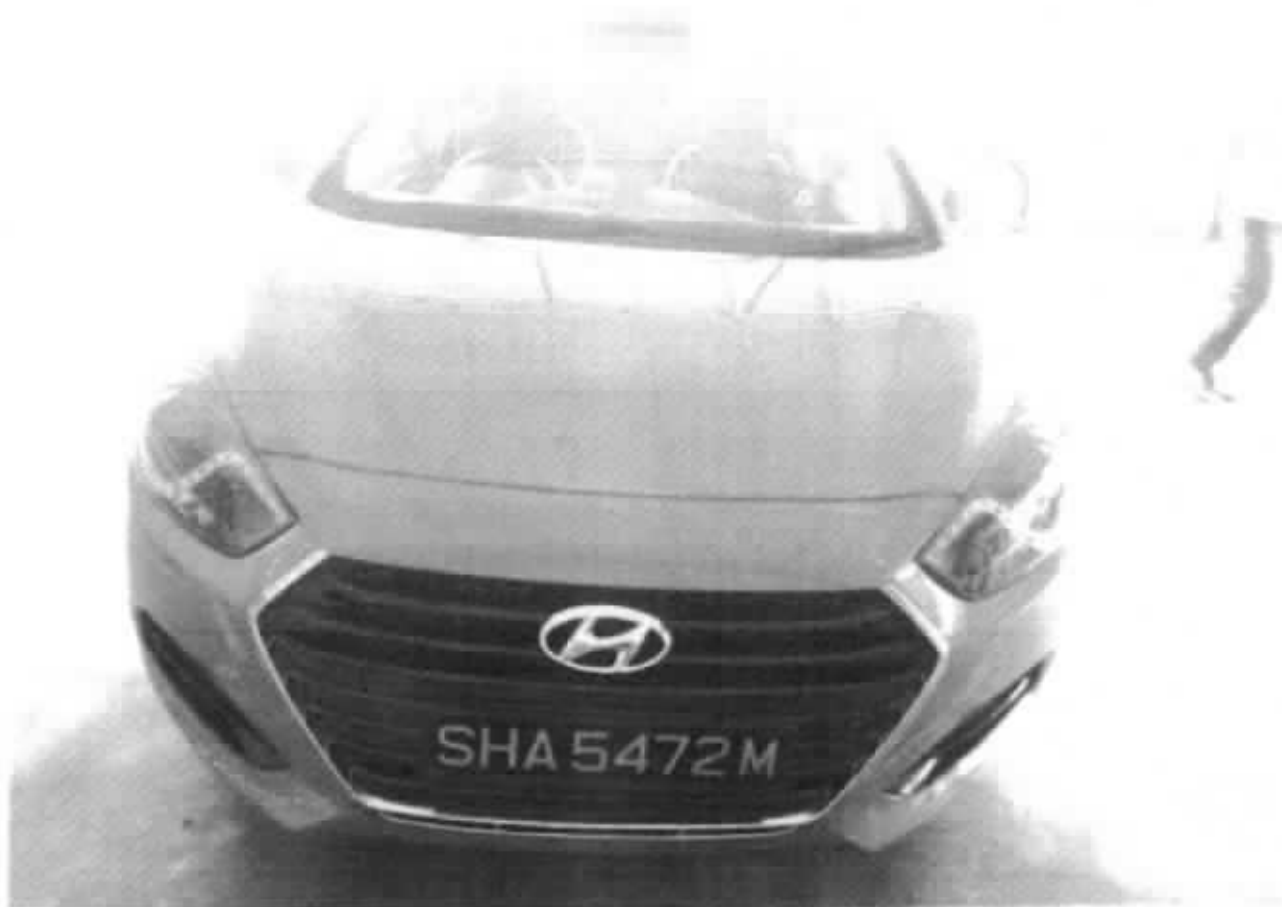
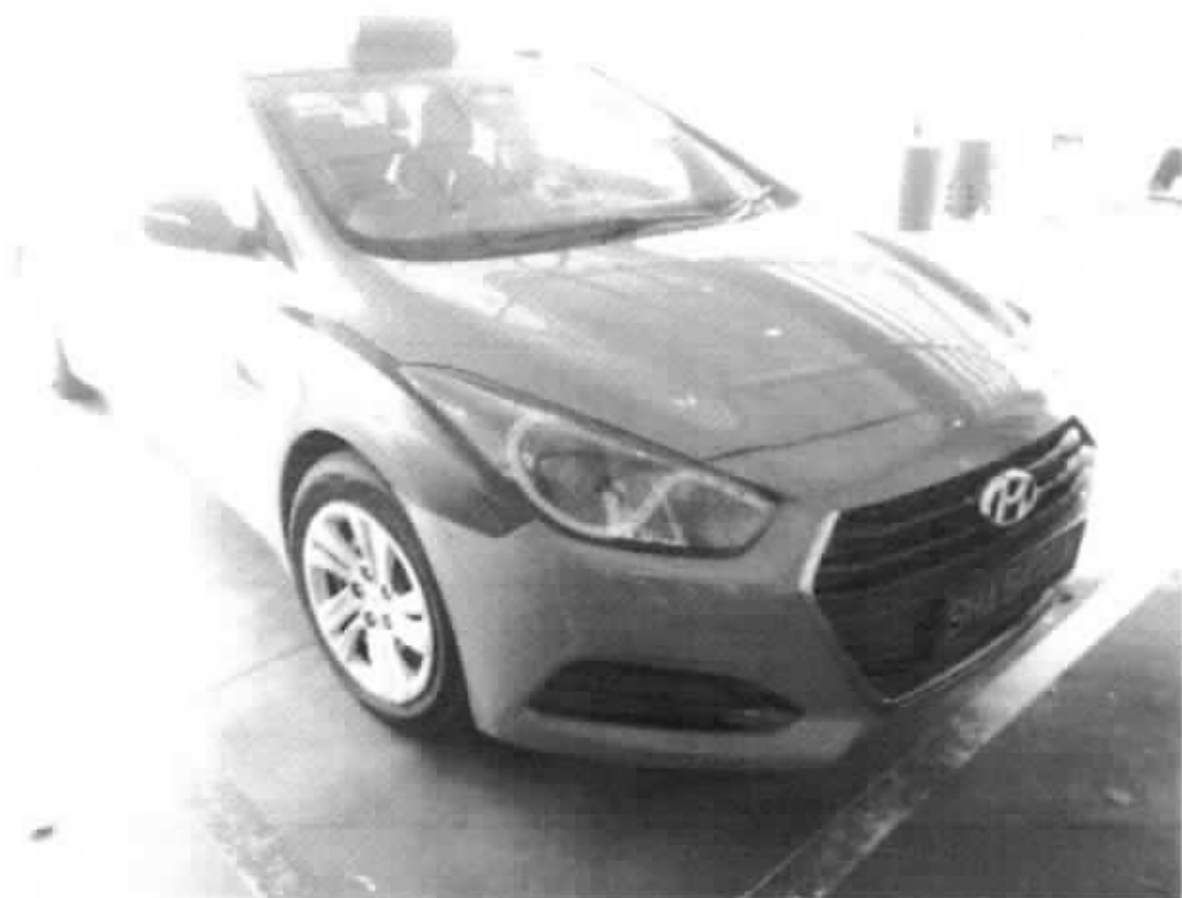
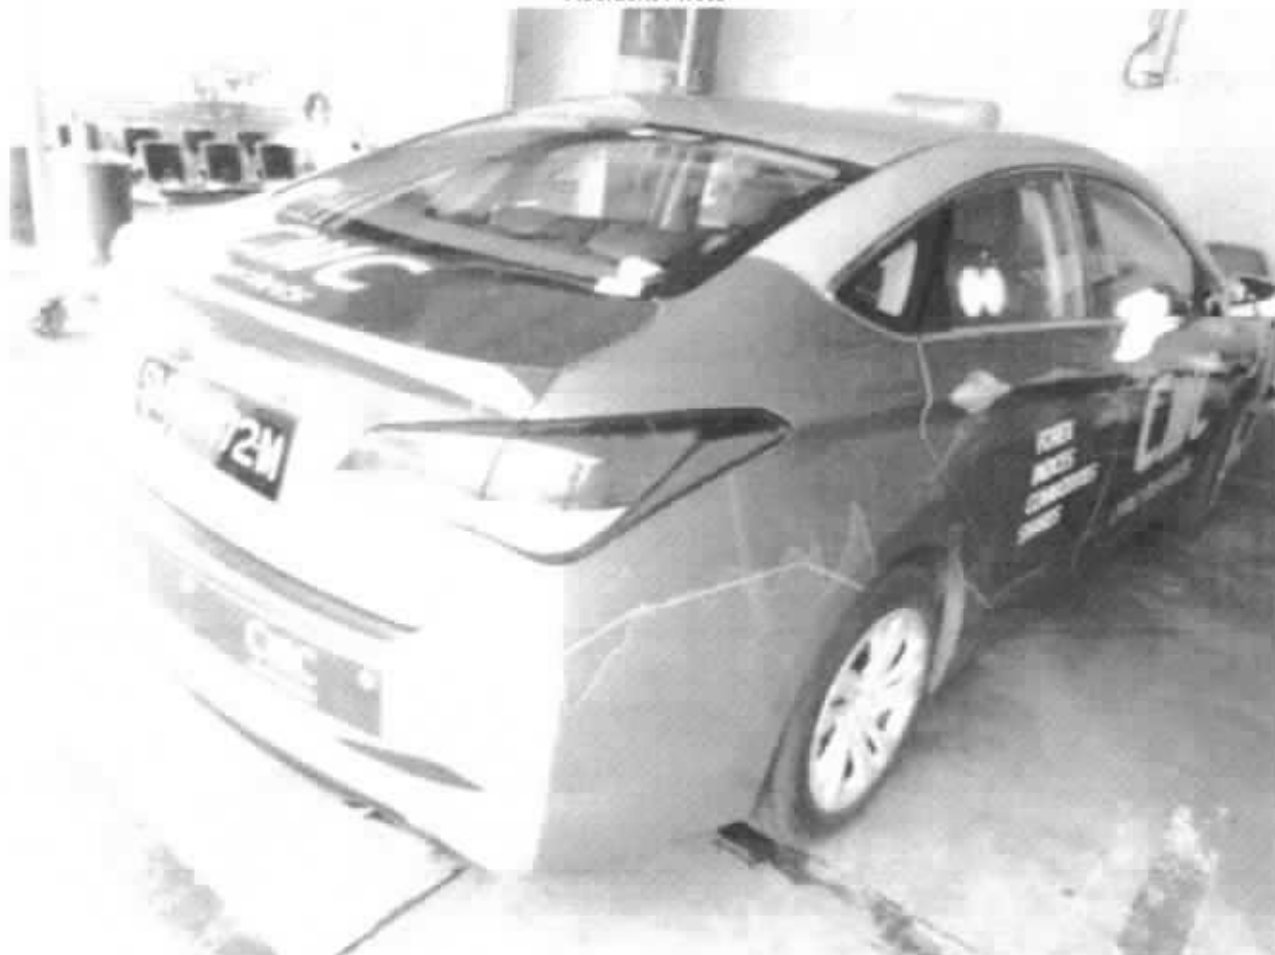
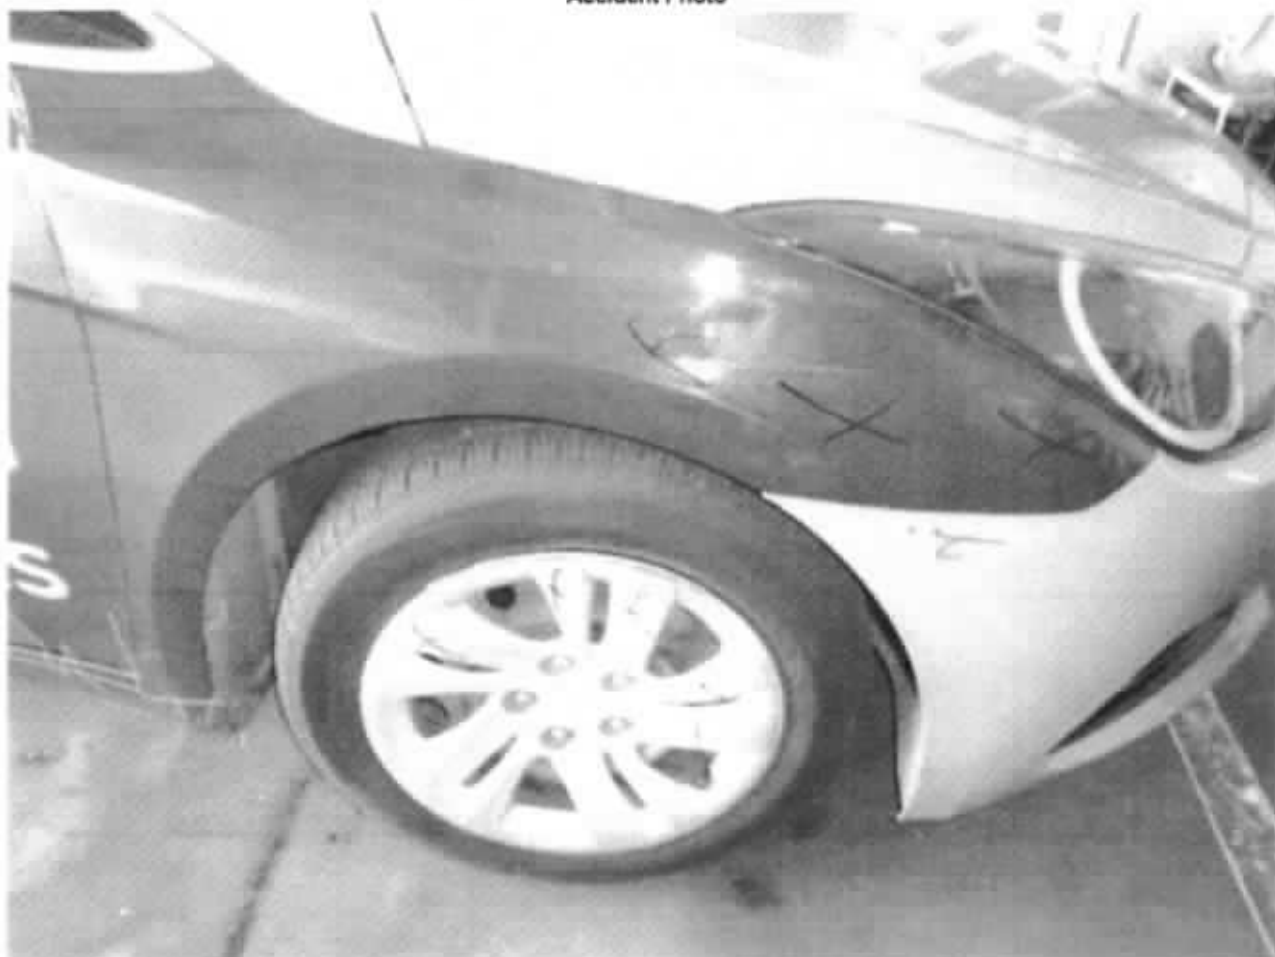
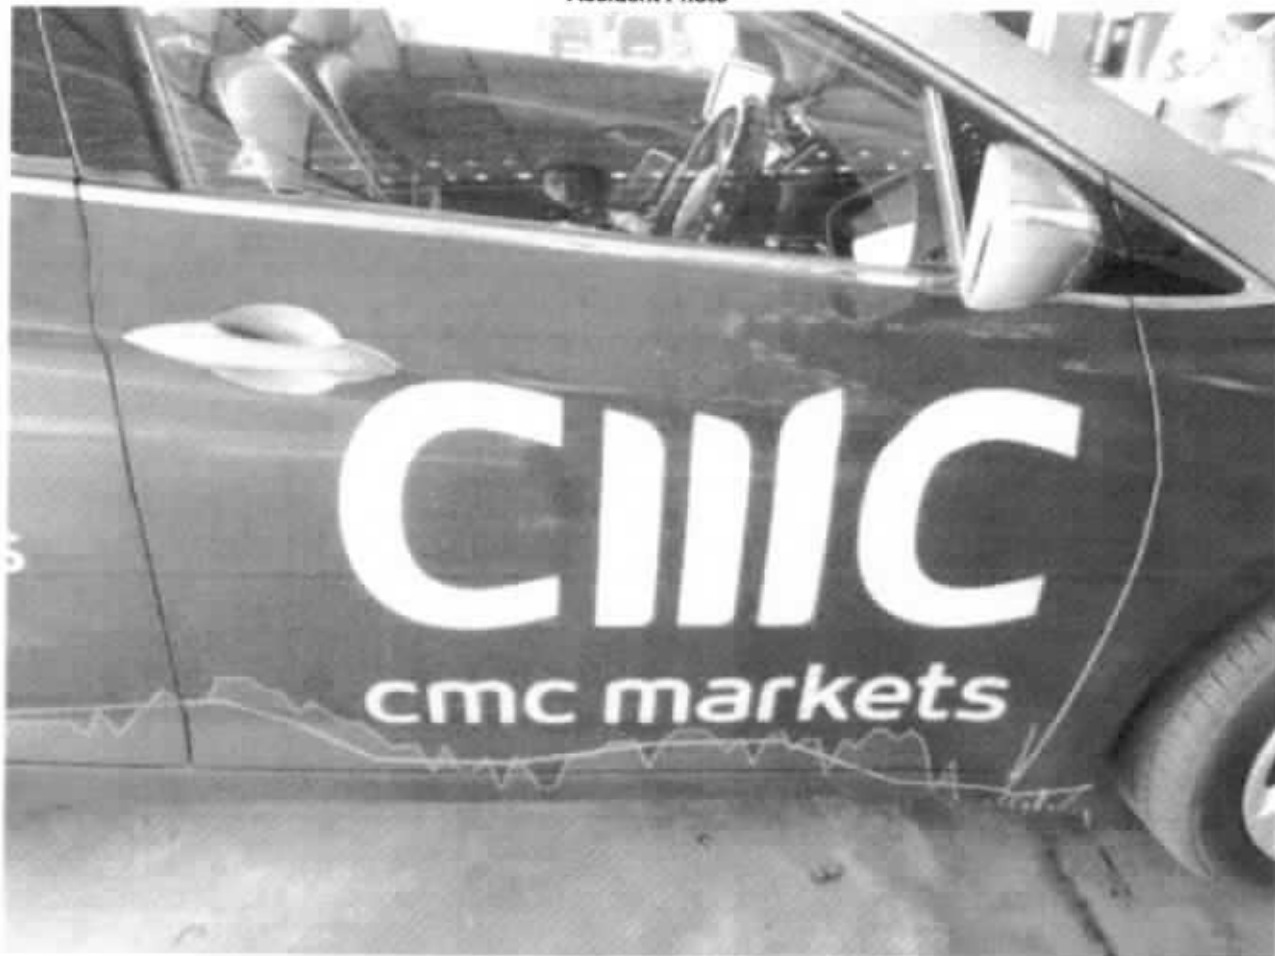
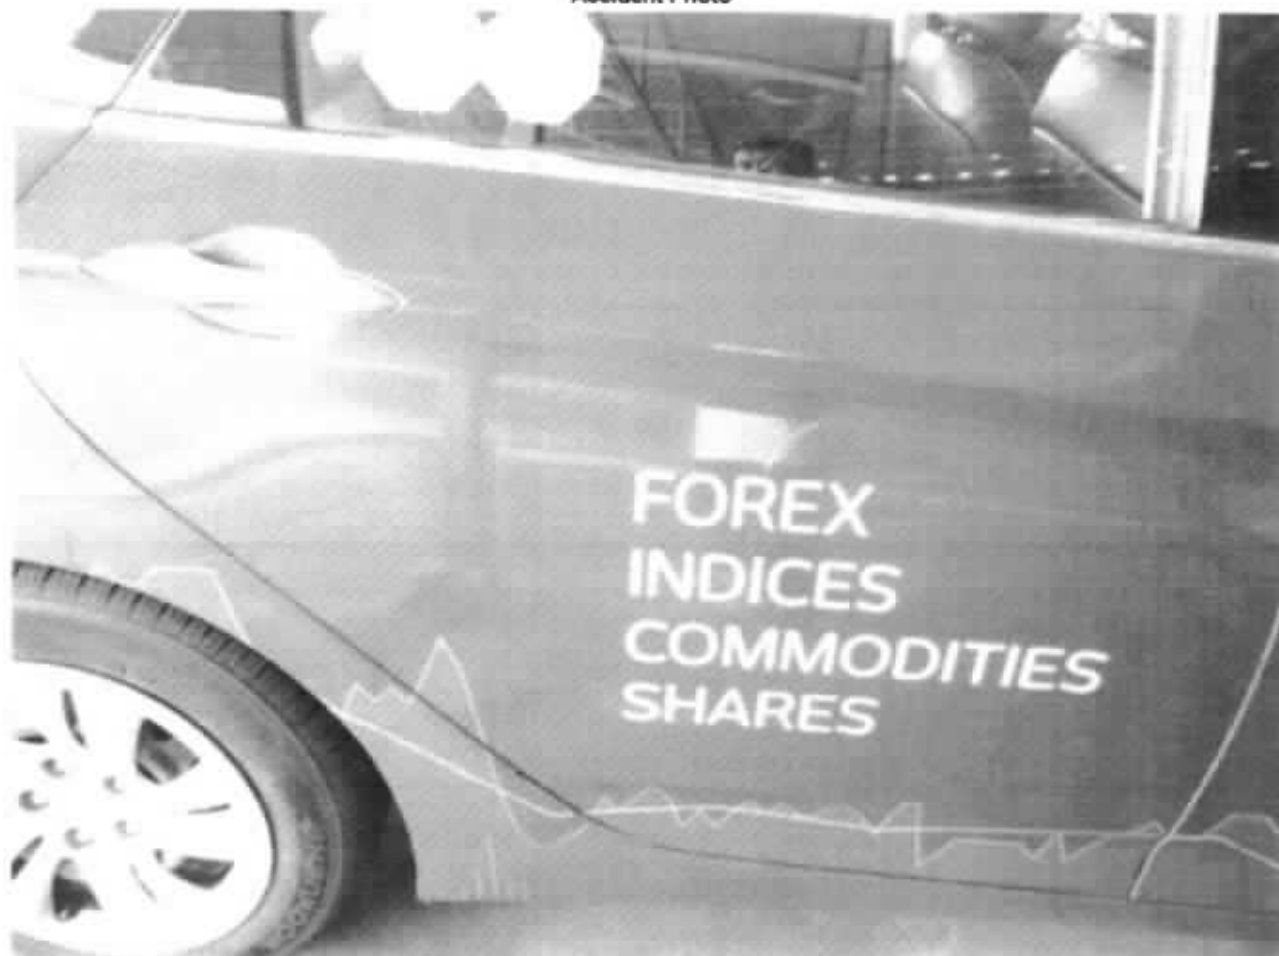
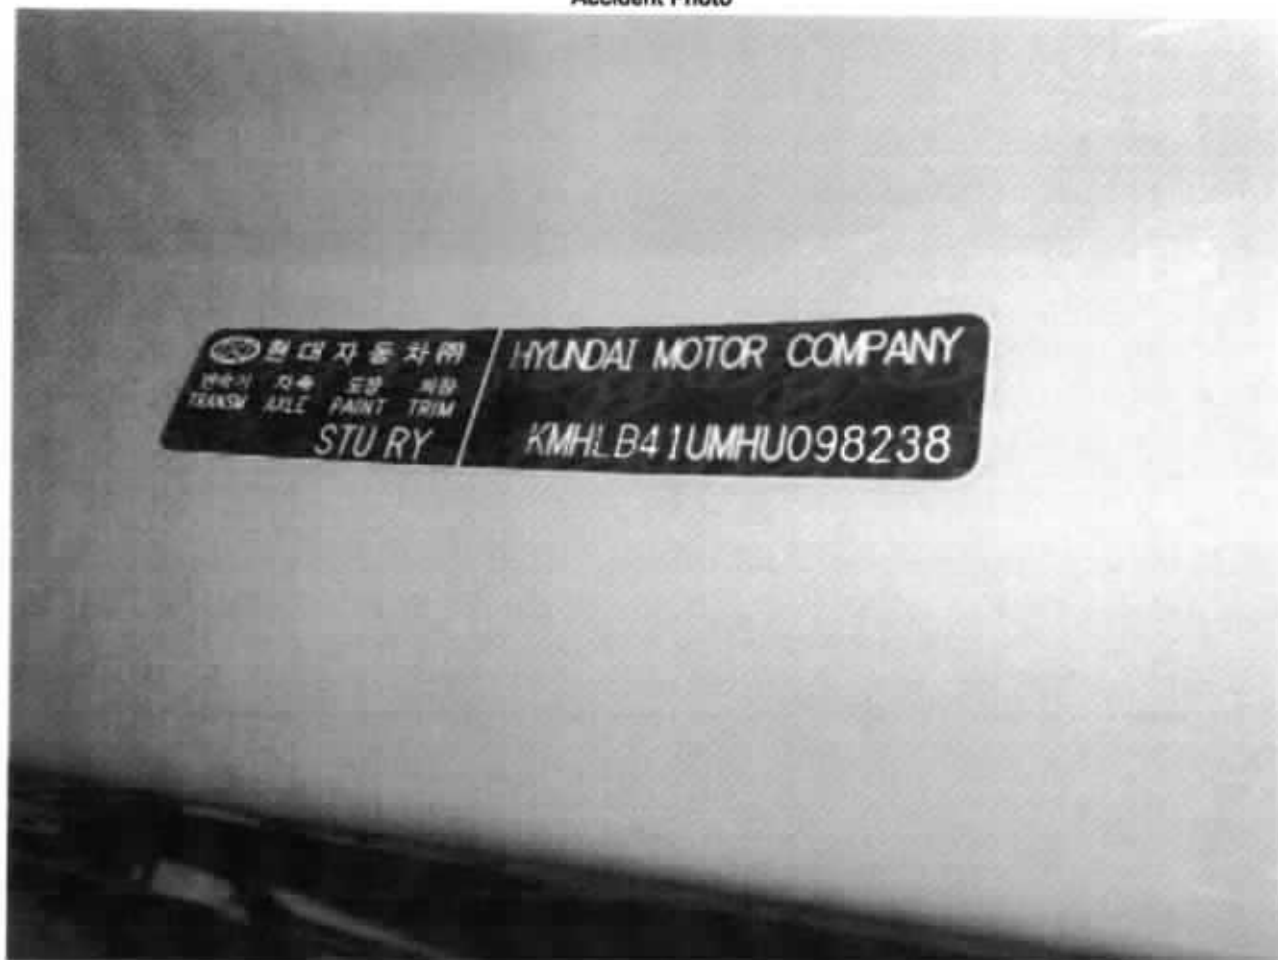
Accident Photo

The vehicle sustained impact along the nearside rear.

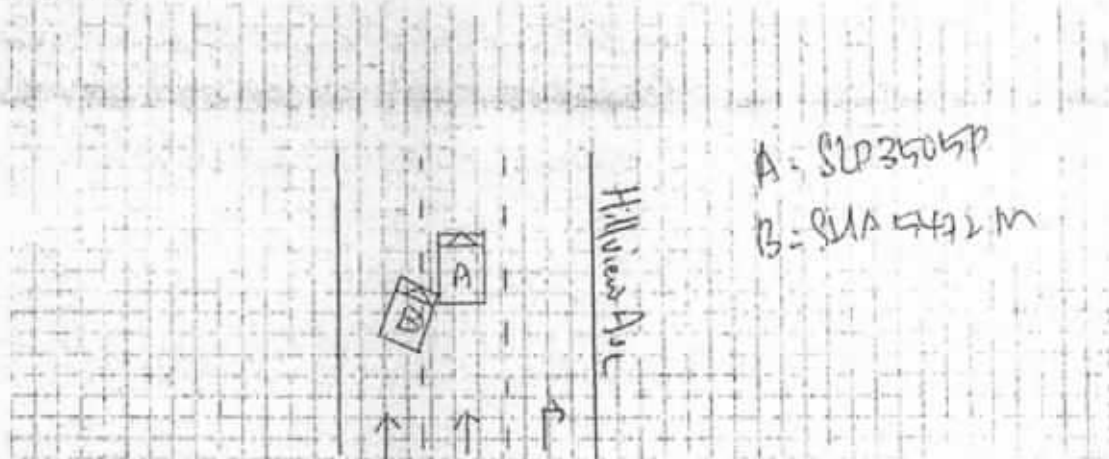
SKETCH PLAN

On 26/11/2017 @ about 0610hrs, I was travelling Hillview Ave towards Bukit Panjang Rd. I was travelling in lane 2 and suddenly, I felt an impact from the rear of my vehicle. I got out of my vehicle and realised that vehicle B (SIA 5722M) had swerved from the left lane and collided into my vehicle rear left side portion. I wish to state that I have dashboard camera that captured the whole incident.
