**- PRE-REPAIR INSPECTION - ACCIDENT INVOLVING OUR INSURE...**

ACCIDENT BETWEEN VEHICLE NO. SKX 76 A AND VEHICLE NO. EE 71 J ON  
02/06/2018 @ 1700 Hrs

| Insured Veh. | EE 71J | Veh. Inspected | SKX 76A |

## VEHICLE DAMAGE INSPECTION REPORT

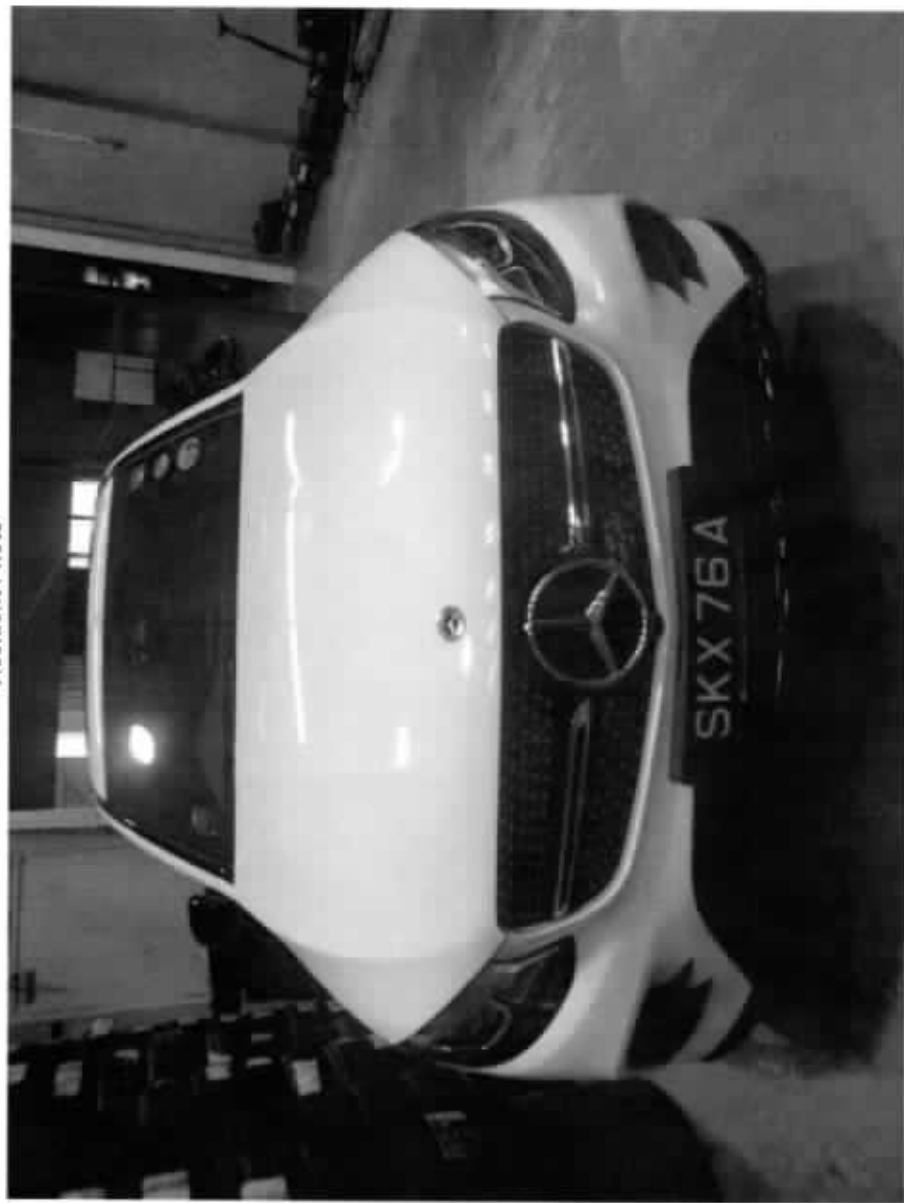
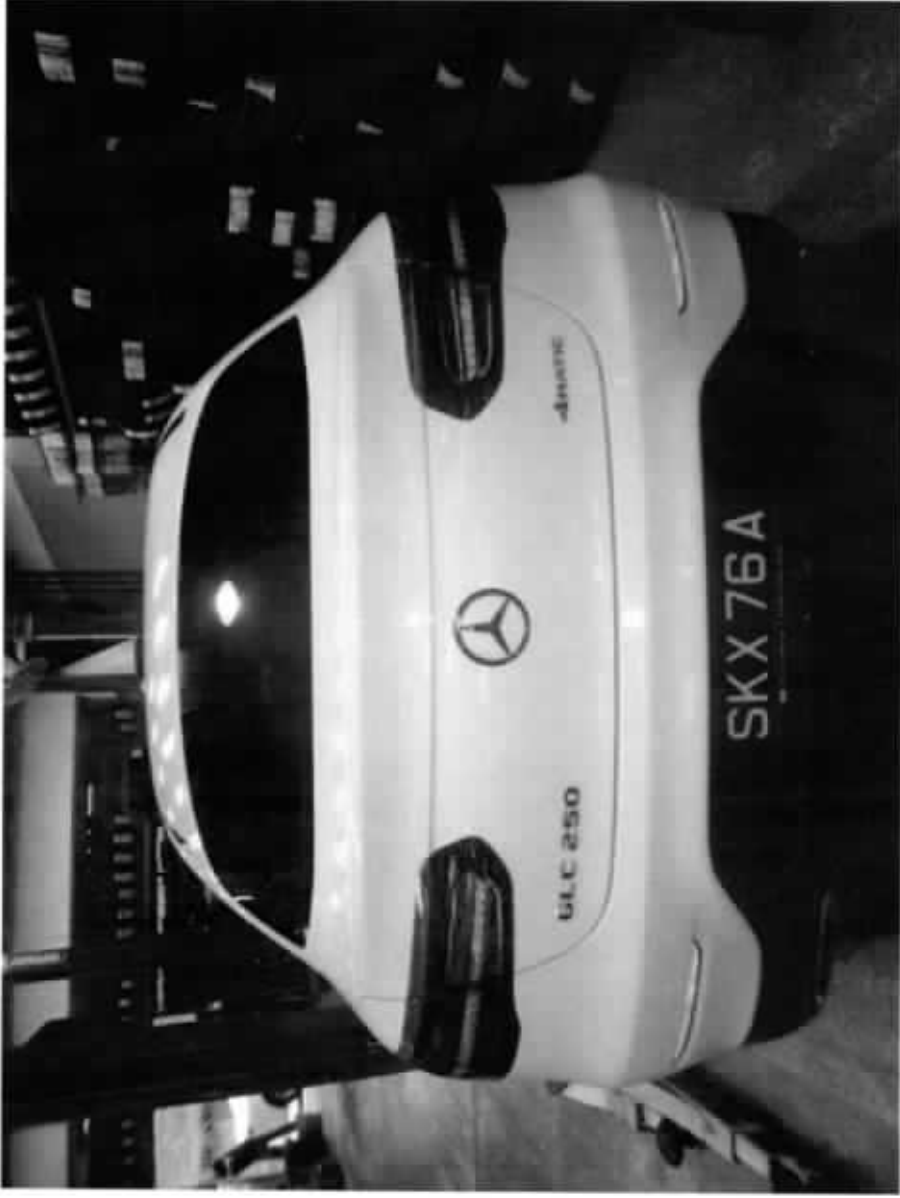
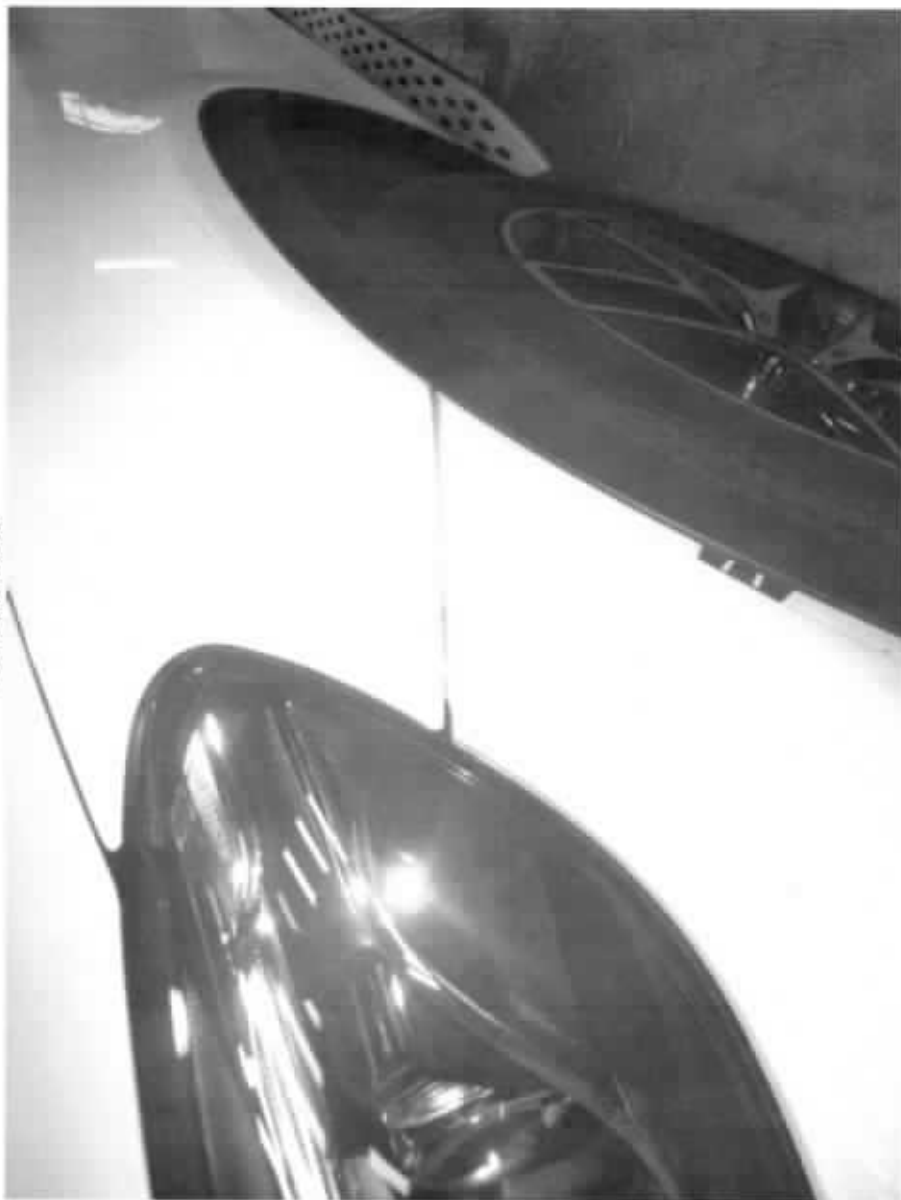
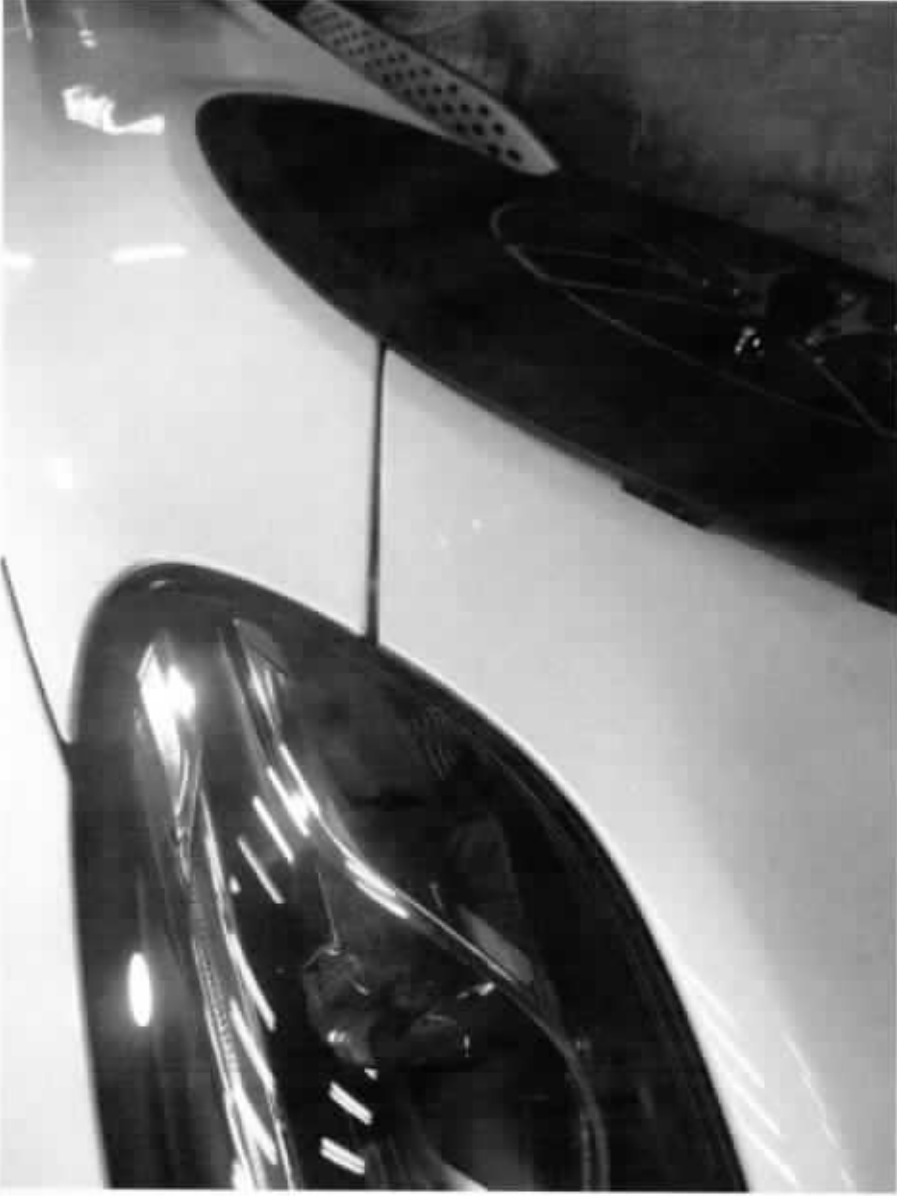
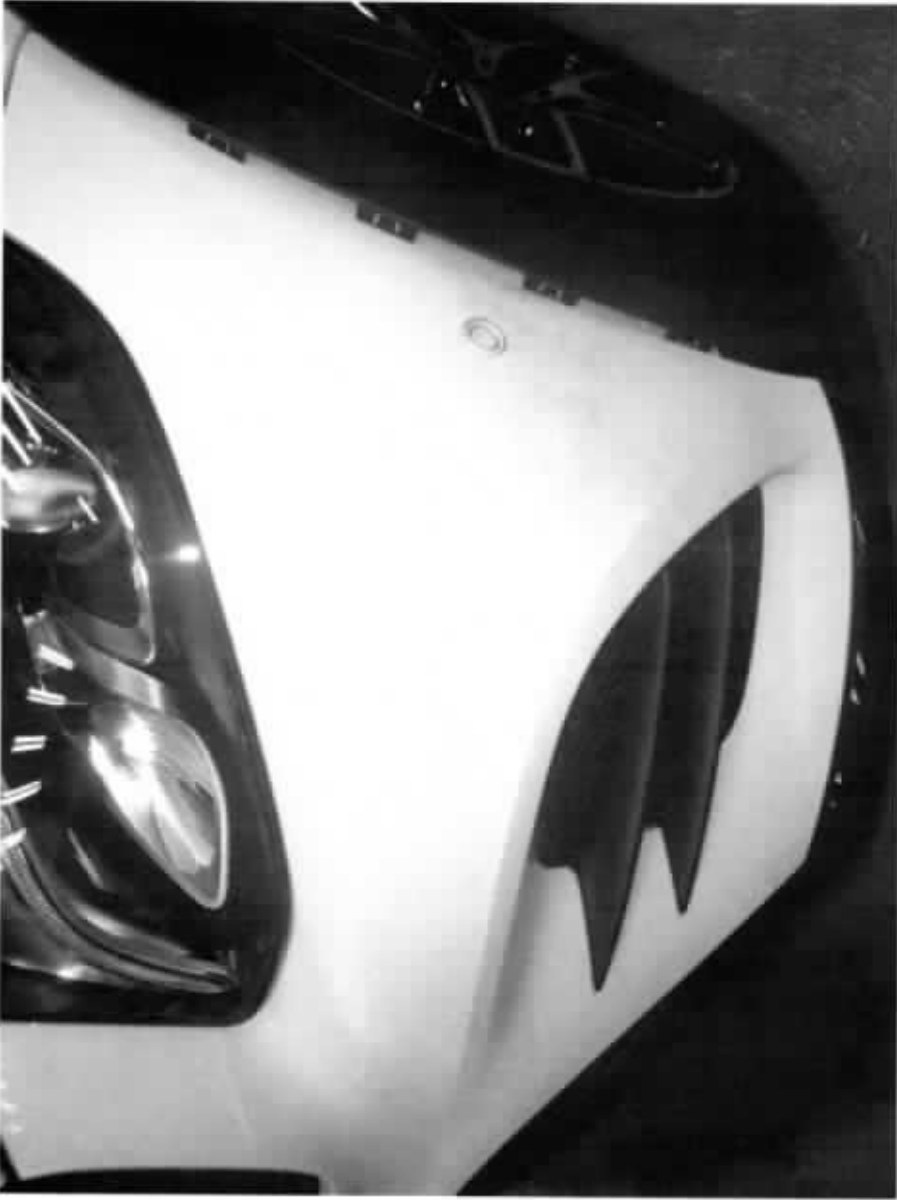
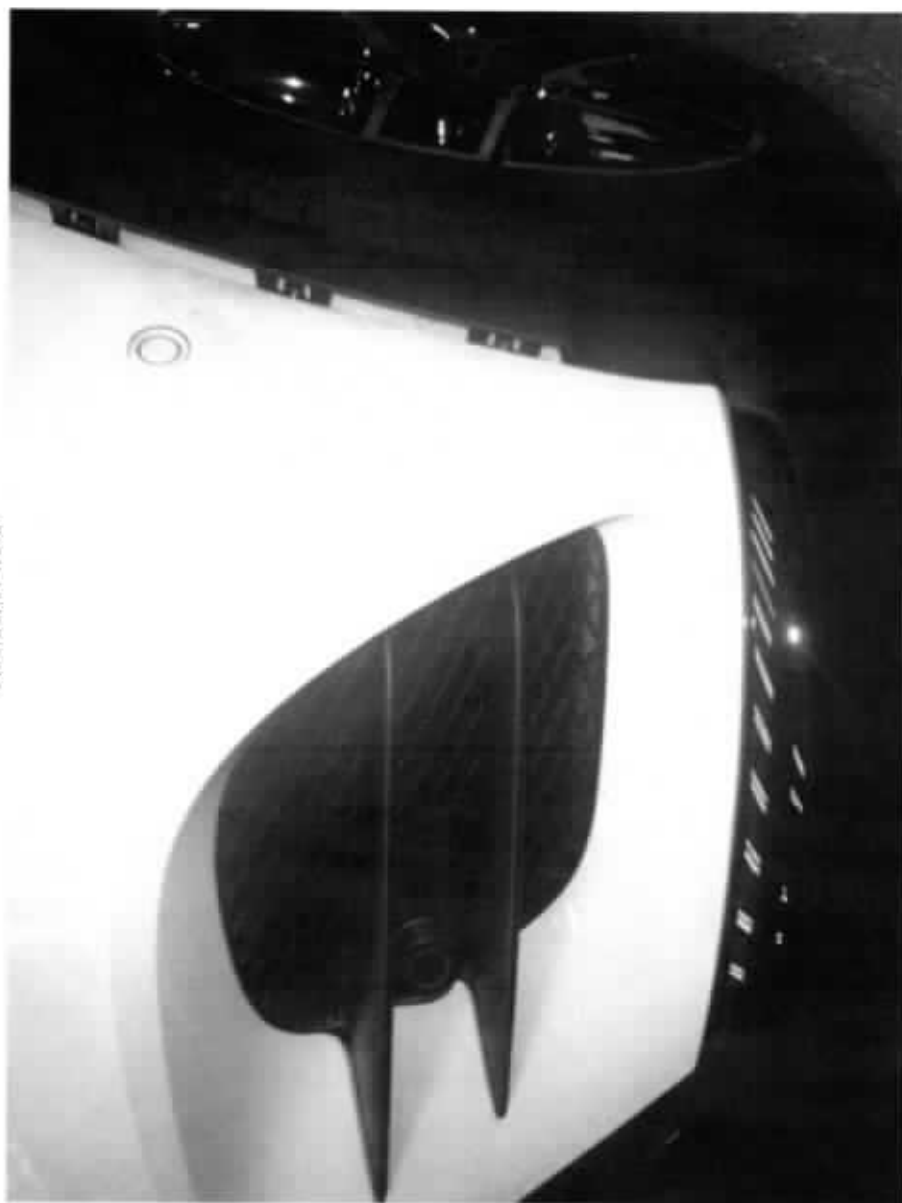
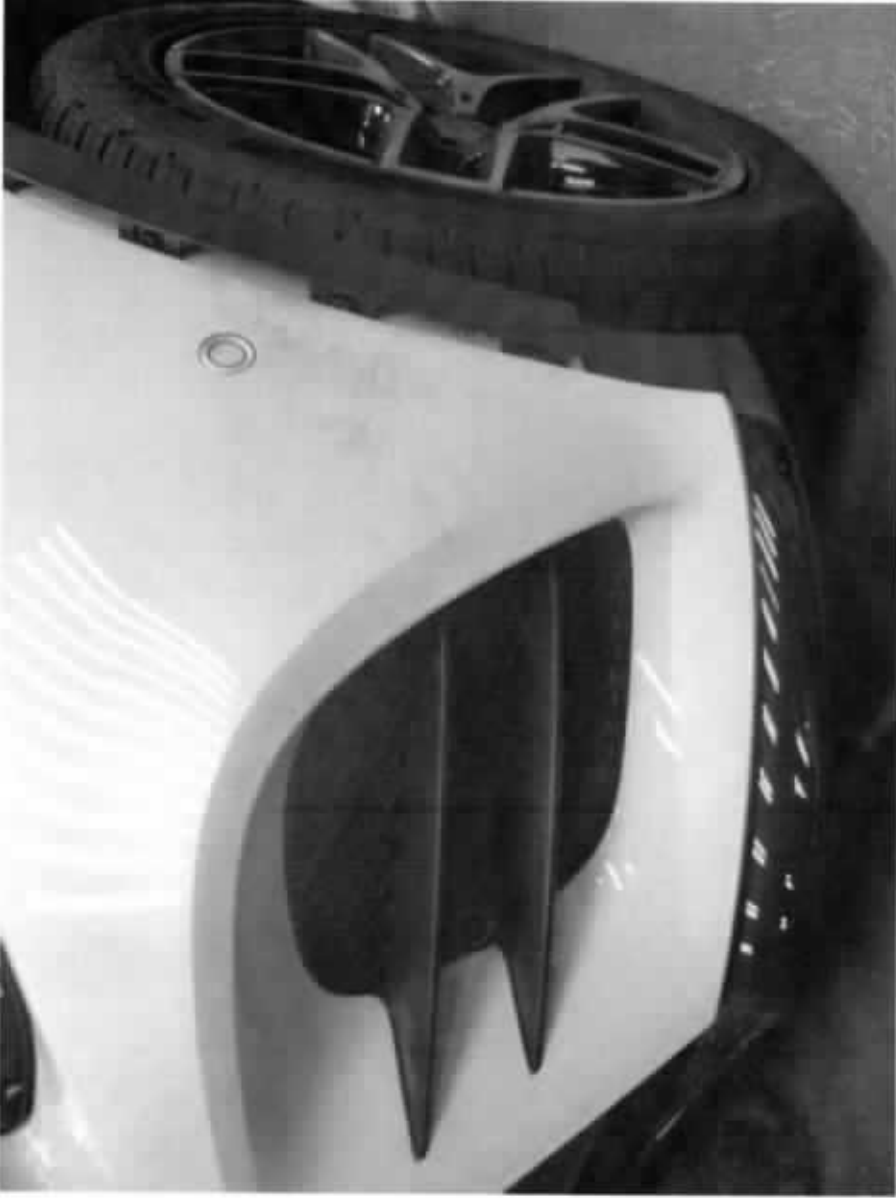
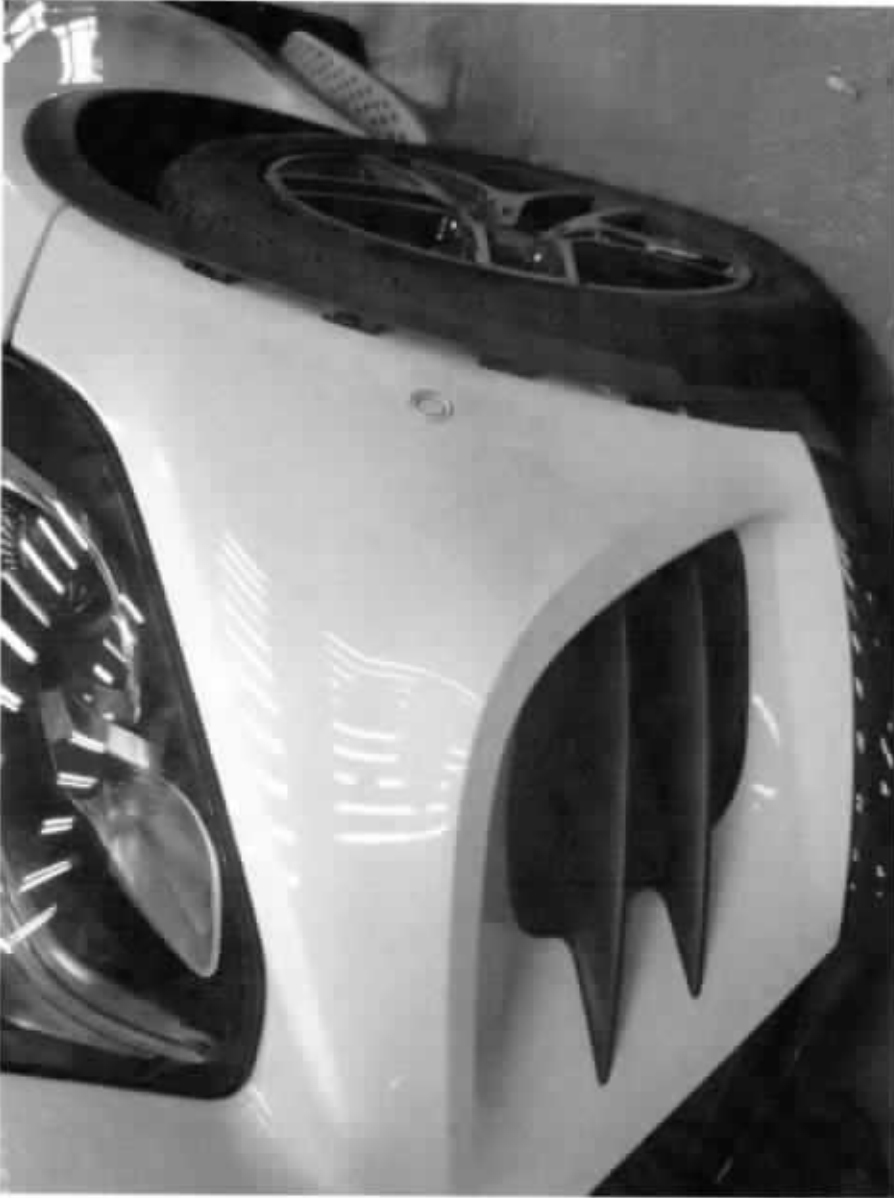
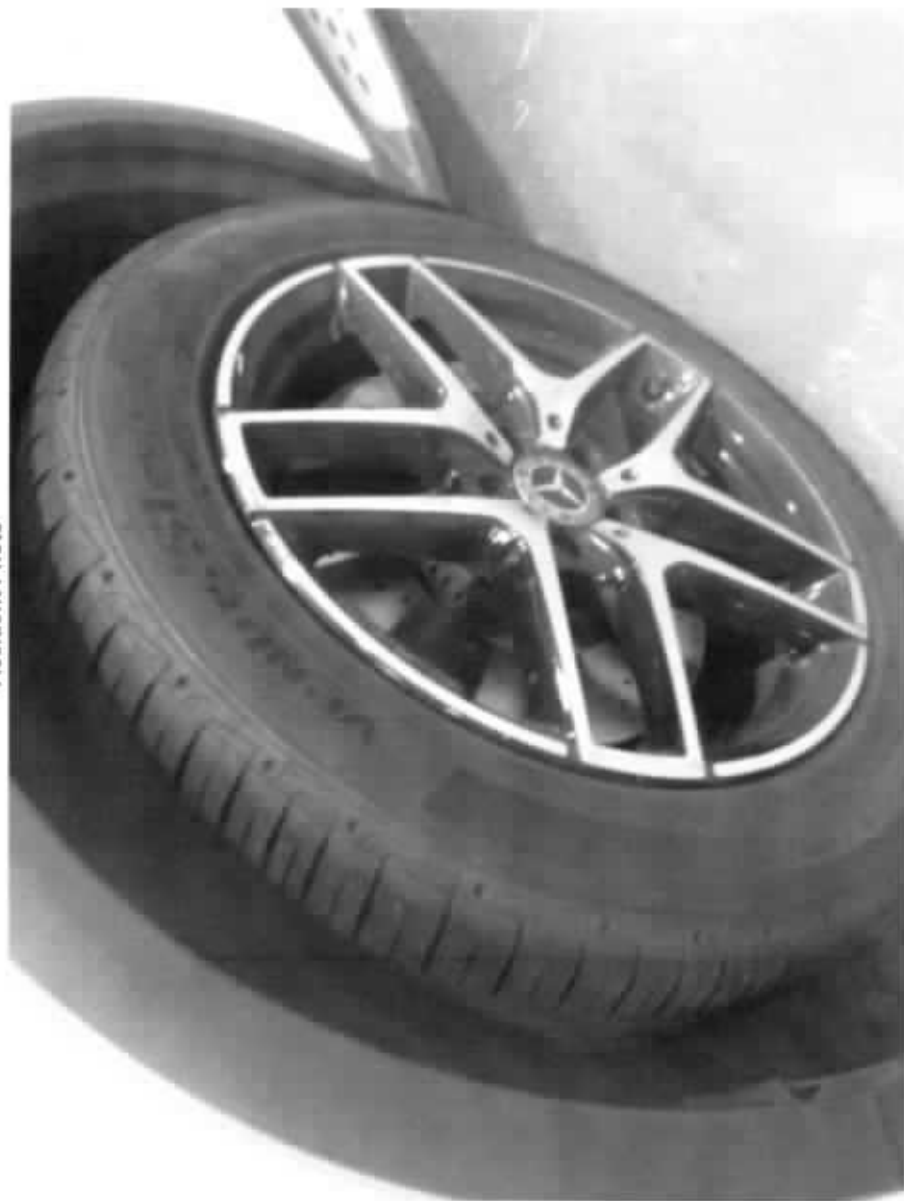
Remark: The veh had commenced its repair at the time of inspection.

Des. of Damages: Frt / Rear / O/S / N/S / D/C / Rooftop or

Frt N/S

The U/C / Chassis frame / Body Structure affected due to collision.

Accident Photo
